**QUALITY ASSURANCE  
MONTHLY SITE  
ASSESSMENT REPORT**

Airfield Modernization Program  
Runway 5L-23R Reconstruction  
Project 2 / Project 3

## QUALITY ASSURANCE SITE ASSESSMENT

## **AIRFIELD MODERNIZATION PROGRAM RUNWAY 5L-23R RECONSTRUCTION**

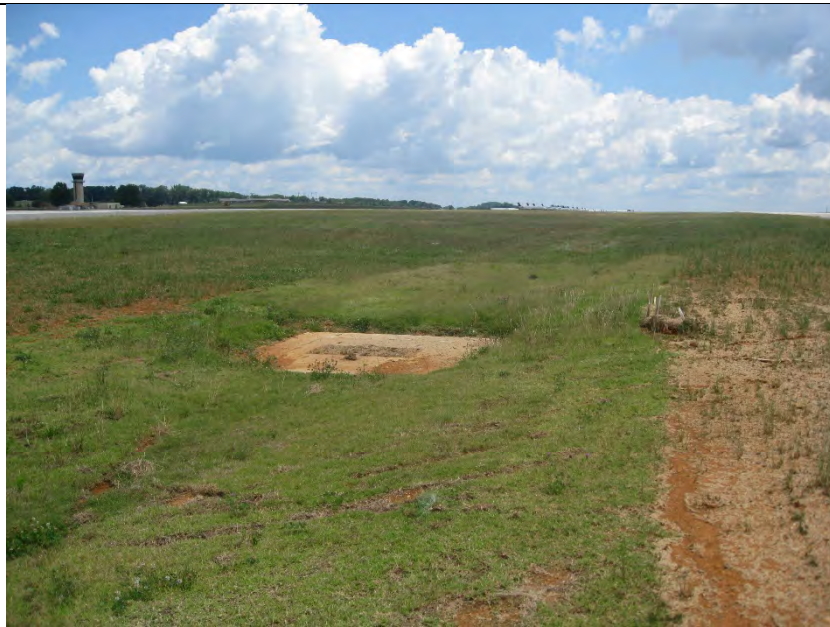
Photo 61  
Sta. 329+86 RT  
(RW 5L-23R)  
Structure 210  
Project 3

Structure 210.  
Bare areas recently stabilized.

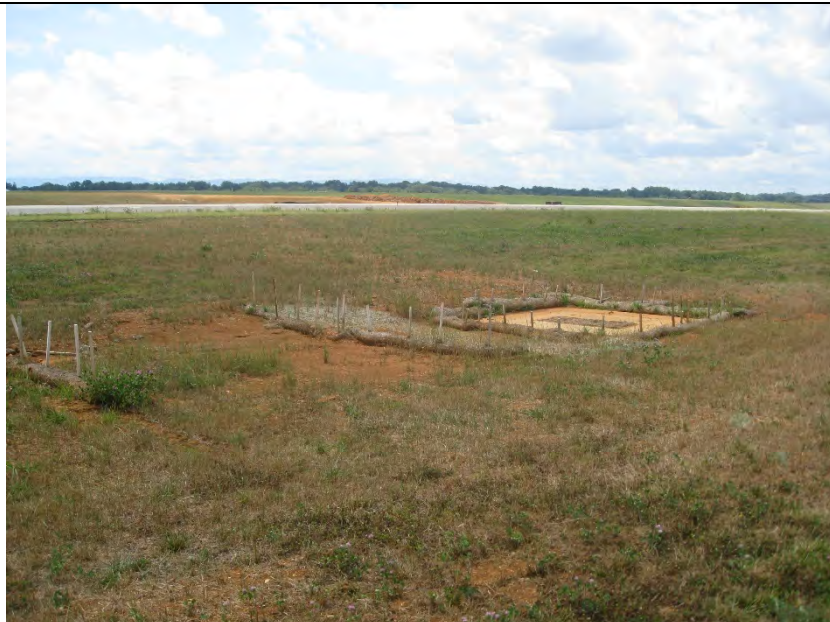
Photo 62  
Sta. 321+73 RT  
(RW 5L-23R)  
Structure 212  
Project 3

Structure 212.

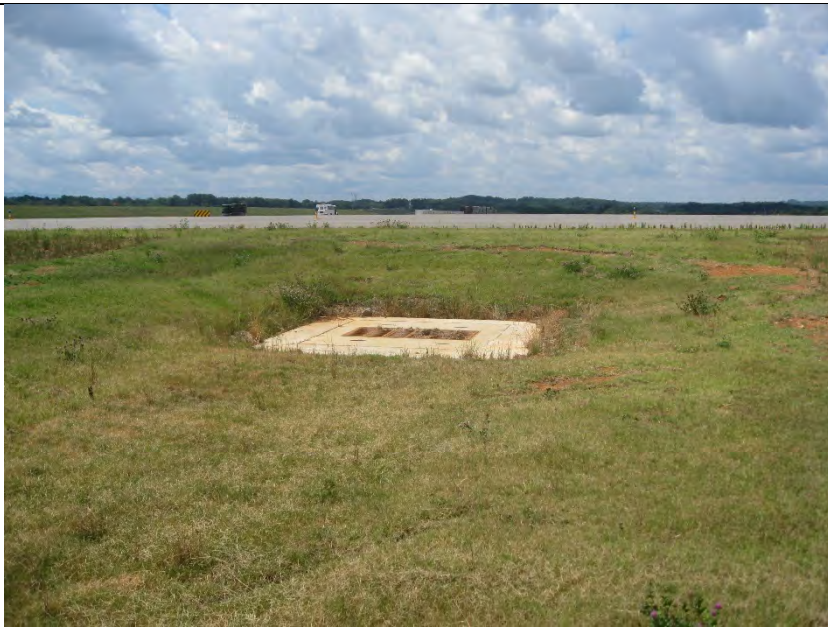
Photo 63  
Sta. 314+32 RT  
(RW 5L-23R)  
Structure 214  
Project 3

Structure 214.

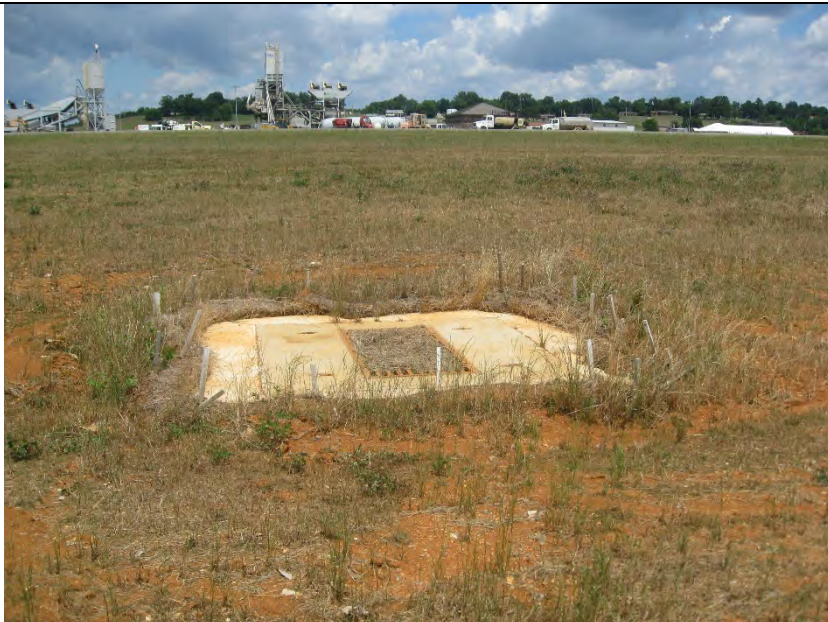
Photo 64  
Sta. 307+99 RT  
(RW 5L-23R)  
Structure 216  
Project 3

Structure 216.

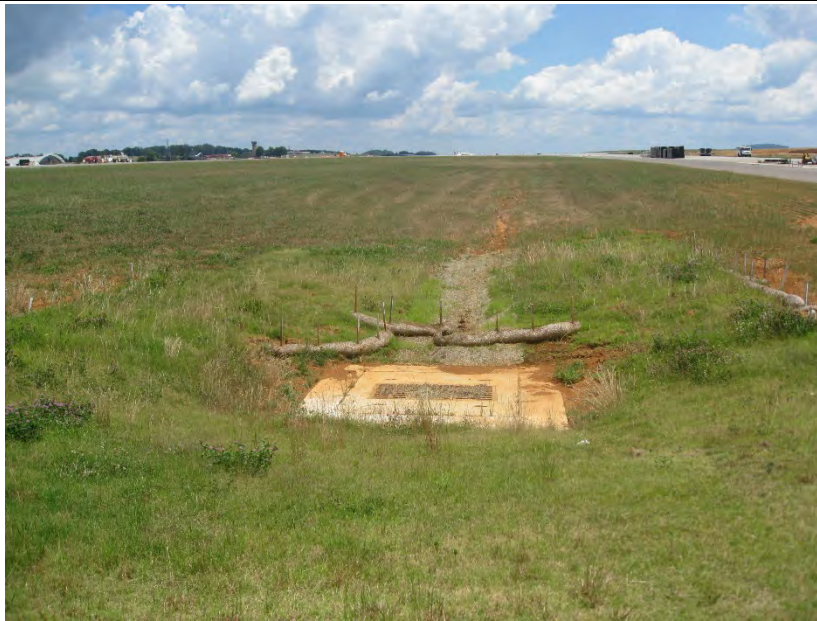
Photo 65  
Sta. 301+87 RT  
(RW 5L-23R)  
Structure 218  
Project 3

Structure 218.  
Erosion control blanket recently added.  
Recommend stabilizing bare areas.  
Recommend removing sediment from top of structure.

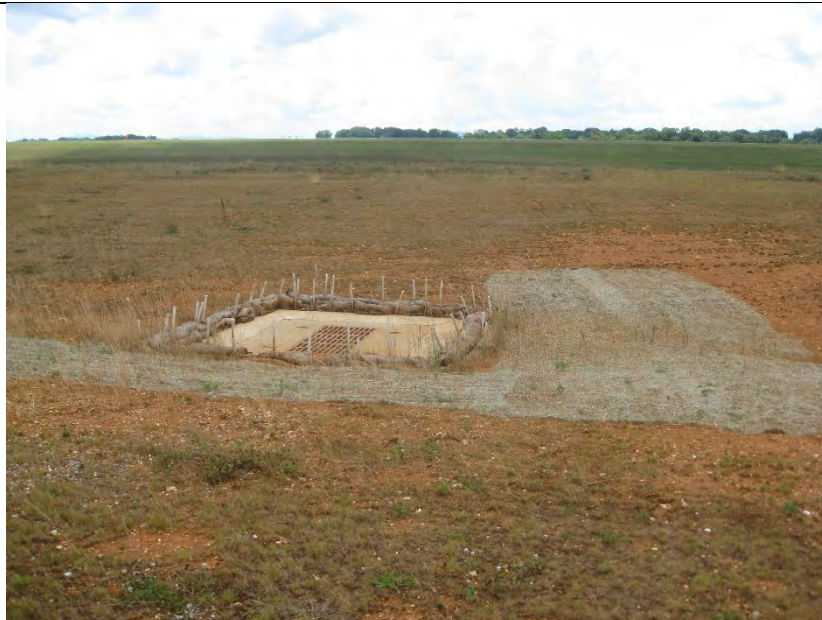
Photo 66  
Sta. 296+83 RT  
(RW 5L-23R)  
Structure 220  
Project 2

Structure 220.  
Recommend stabilizing remaining bare areas.

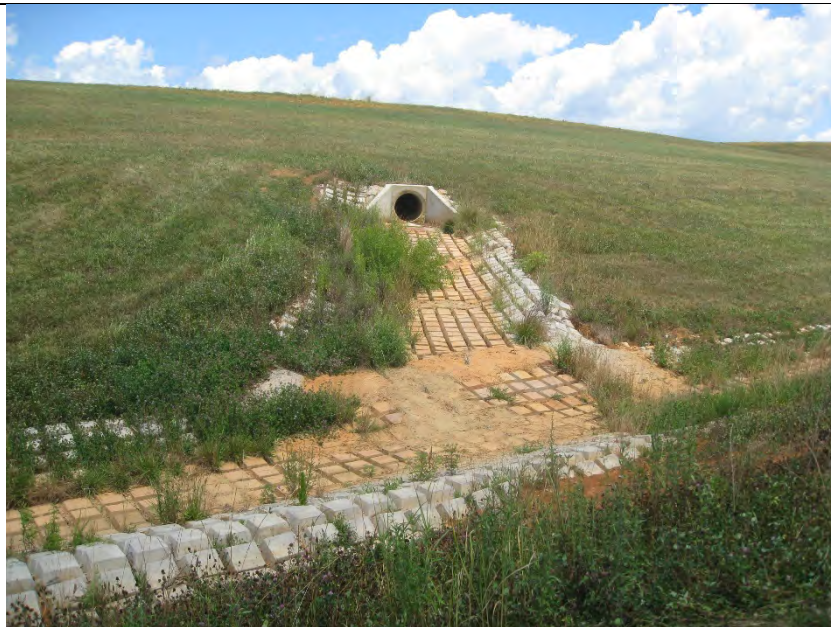
Photo 67  
Sta. 288+26  
(RW 5L-23R)  
Structure 224  
Project 2

Structure 224.

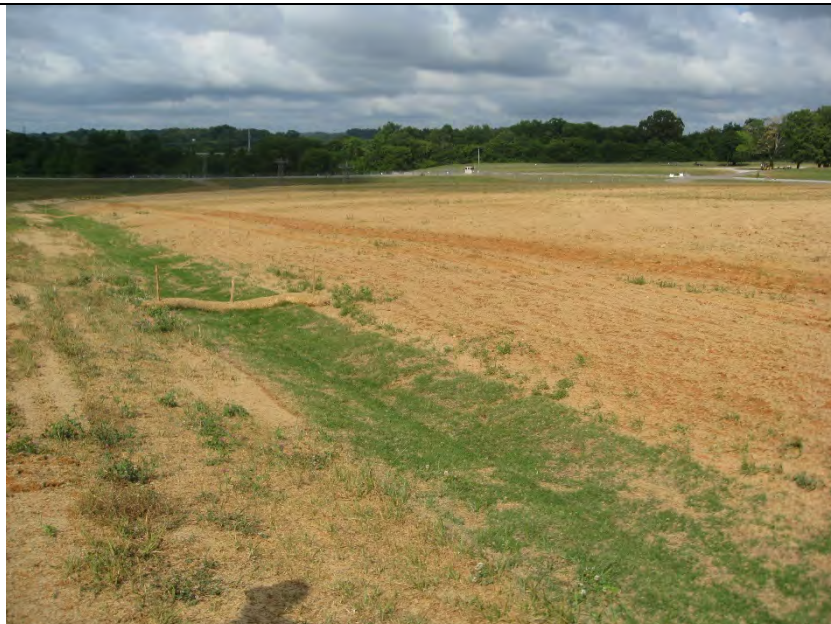
Photo 70  
Sta. 290+26 RT  
(RW 5L-23R)  
Structure 600 Ditch  
Project 2

Structure 600 ditch.  
Bare areas recently stabilized.

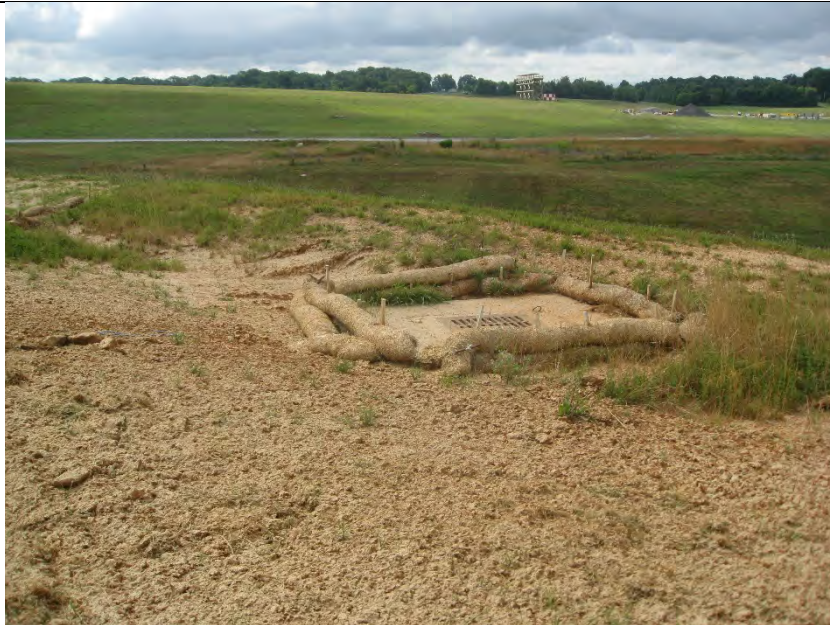
Photo 71  
Sta. 284+59  
(RW 5L-23R)  
Structure 600  
Project 3

Structure 600.  
Bare areas recently stabilized.

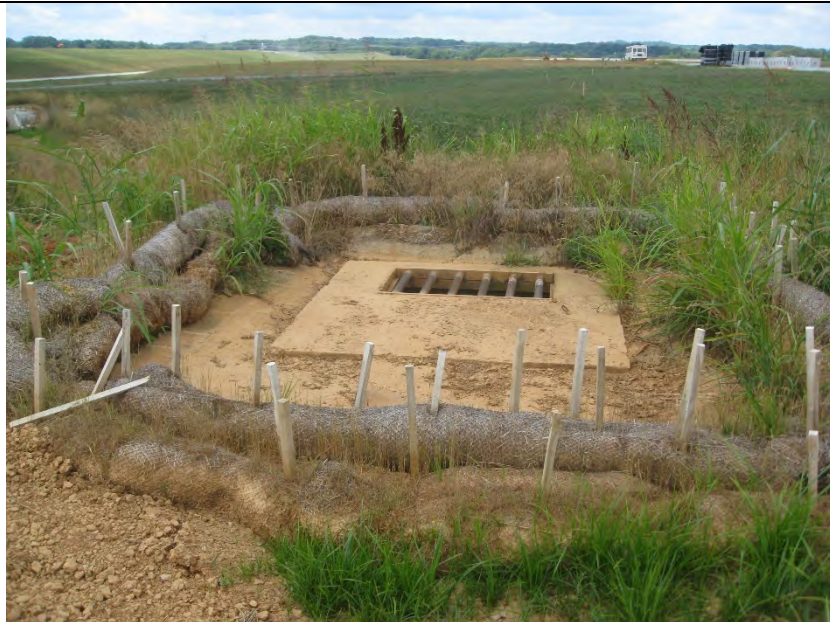
Photo 72  
(RW 5L-23R)  
Project 3

Existing structure at stone stockpile area.

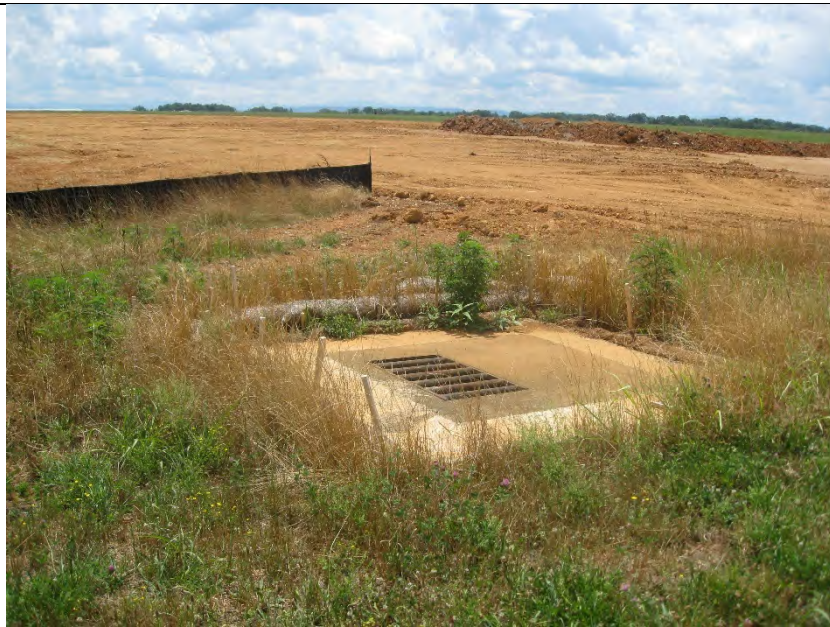
Photo 73  
(RW 5L-23R)  
Project 3

Existing structure.

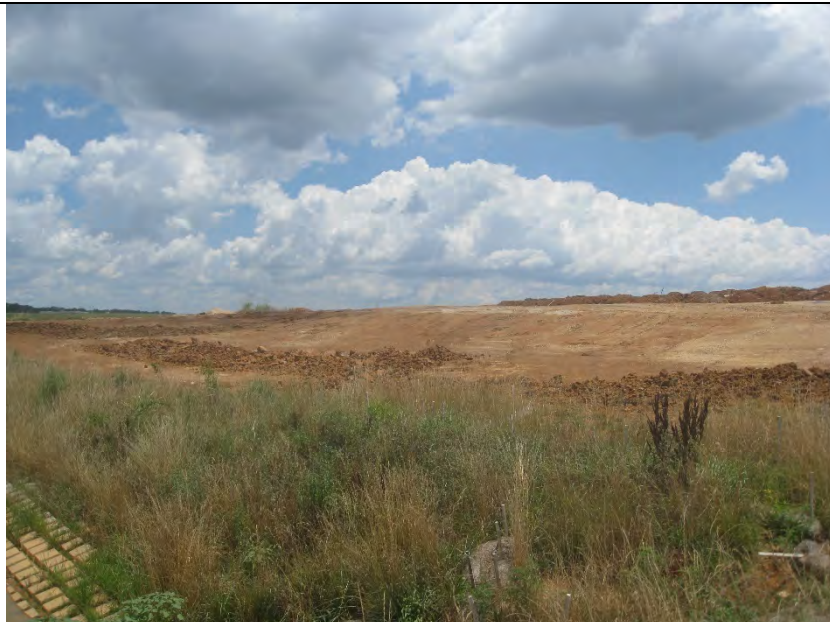
Photo 74  
(RW 5L-23R)  
Project 3

Trenching in place for proposed silt fence.  
Recommend adding silt fence on contour and stabilizing bare areas.

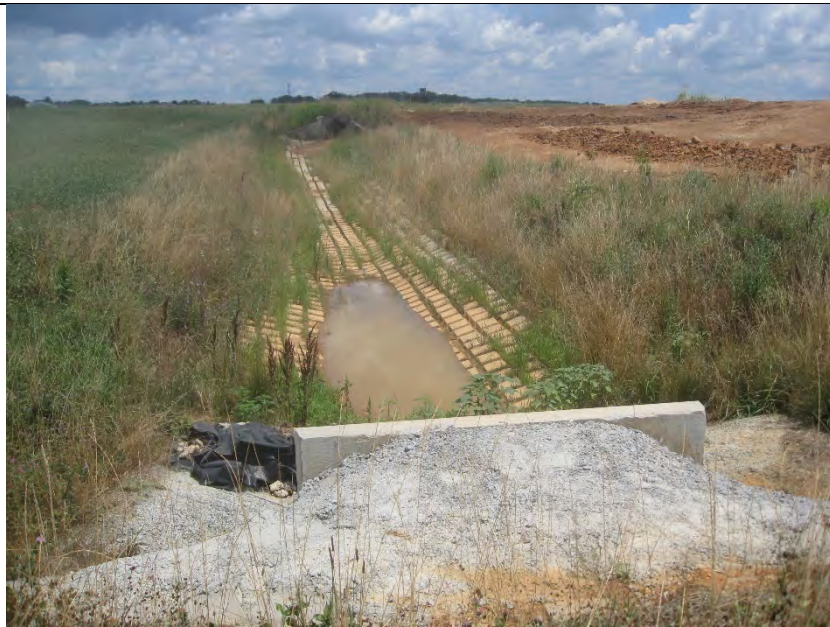
Photo 75  
Sta. 39+00 CL  
Proposed Haul Route  
Project 3

Inlet side of 54" haul route crossing culvert.

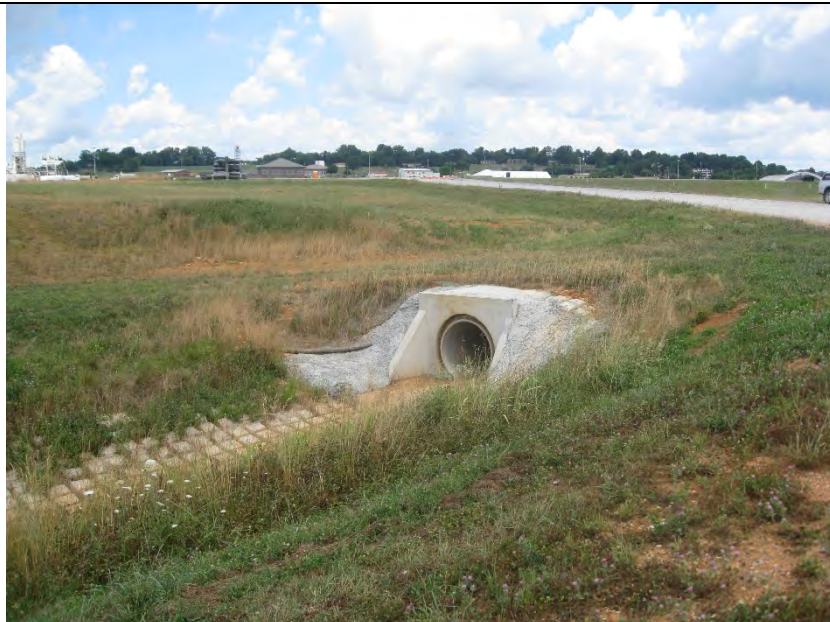
Photo 76  
Sta. 39+00 CL  
Proposed Haul Route  
Project 3

Outlet side of 54" haul route crossing culvert.

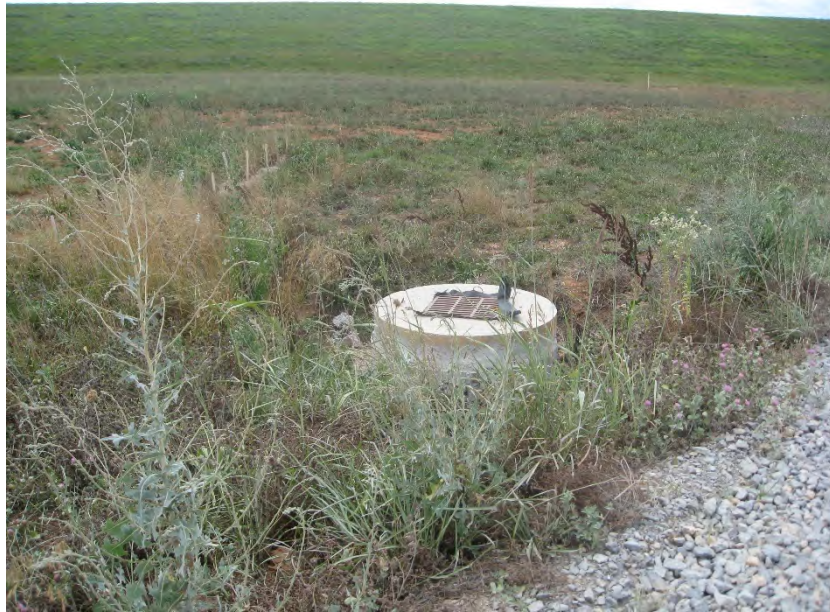
Photo 77  
Sta. 37+25 RT  
Proposed Haul Route  
Project 3

Inlet structures along haul road.  
Structures undergoing reconstruction into traditional man holes at time of inspection.

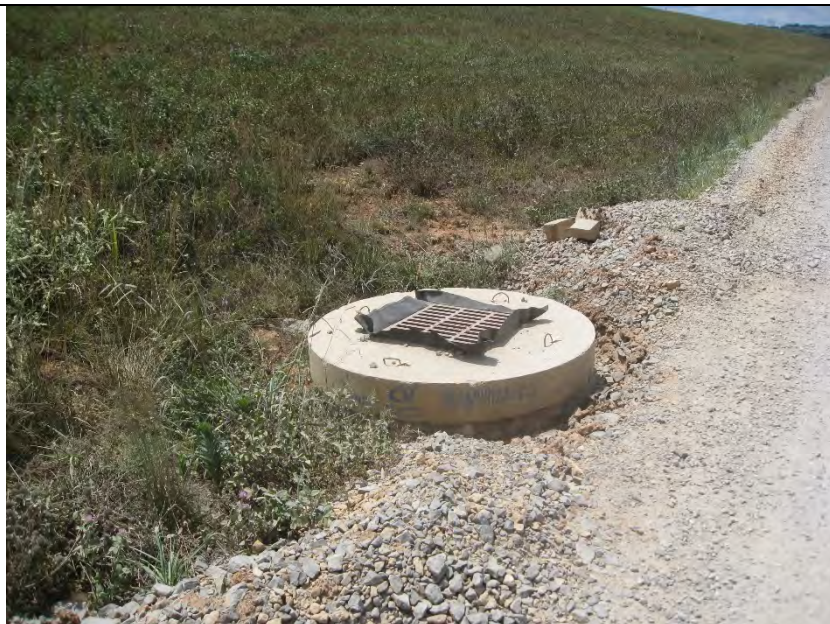
Photo 78  
Sta. 32+50 RT  
Proposed Haul Route  
Project 3

Inlet structures along haul road.  
Structures undergoing reconstruction into traditional man holes at time of inspection.

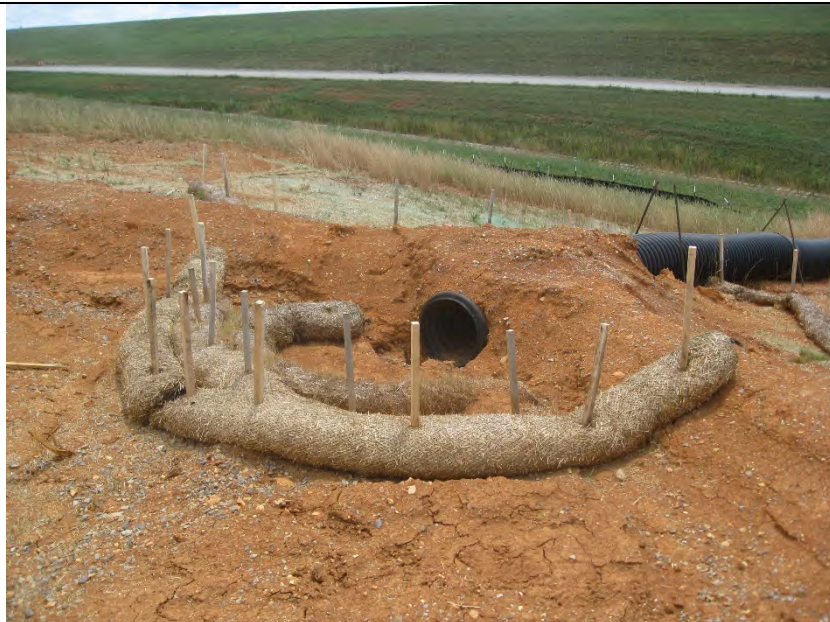
Photo 80  
Sta. 302+54  
(RW 5L-23R)  
Project 2

Soil stockpile area next to haul road at Taxiway B.  
Additional sediment tubes recently installed.  
Recommend stabilizing bare areas.

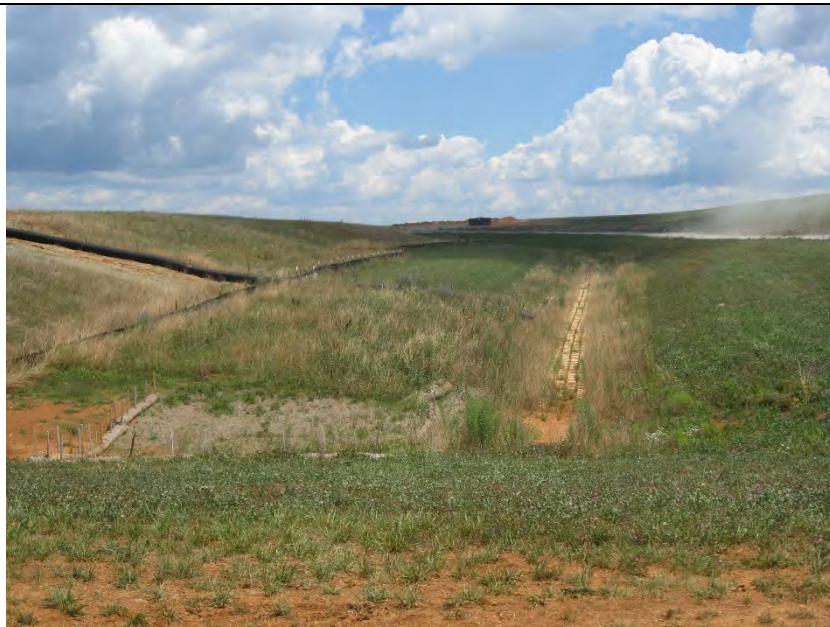
Photo 81  
Sta. 302+54 to Sta. 313+50  
(RW 5L-23R)  
Project 2

North Lateral Endwall 100.  
Erosion control blanket and sediment tubes recently added.  
Recommend stabilizing bare areas.

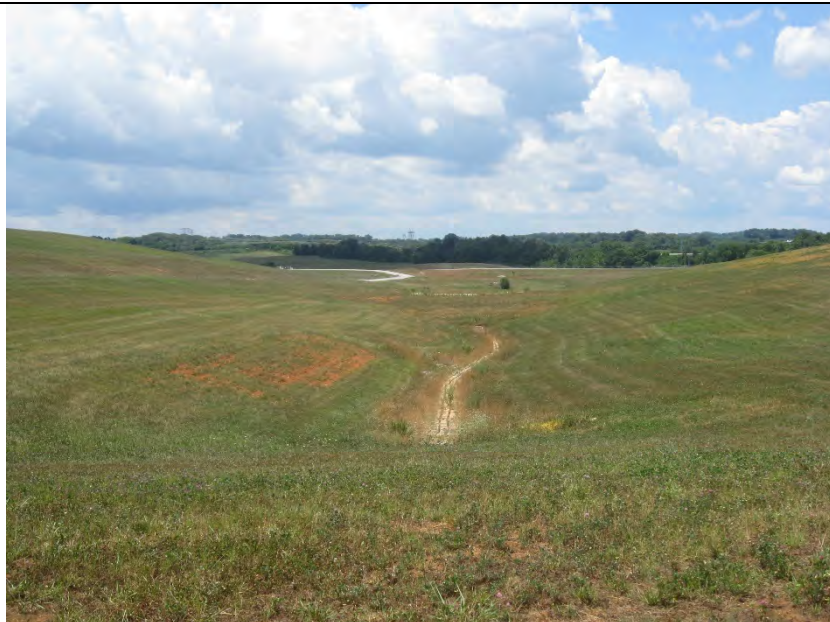
Photo 82  
Sta. 300+60  
(RW 5L-23R)  
Project 2

North Lateral Endwall 102.

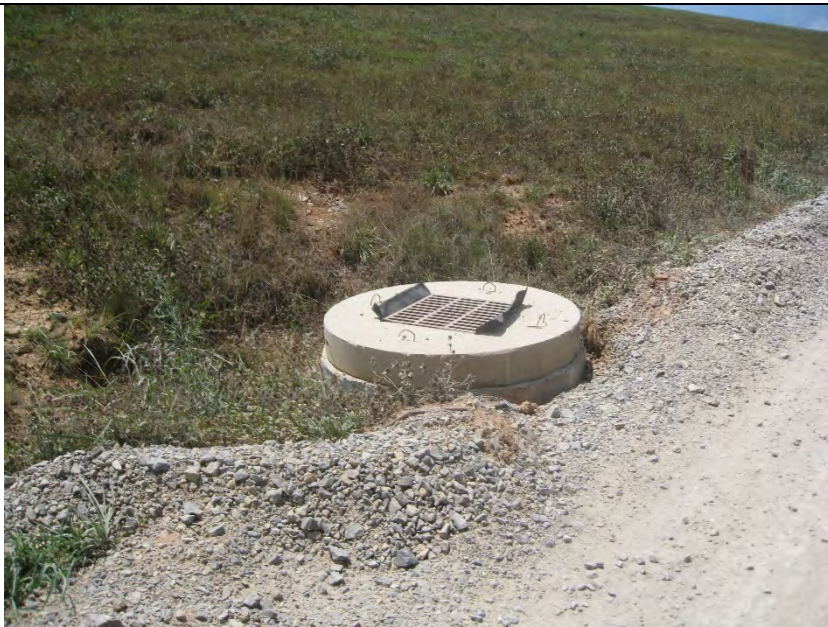
Photo 83  
Sta. 29+00 RT  
Proposed Haul Route  
Project 3

Inlet structures along haul road.

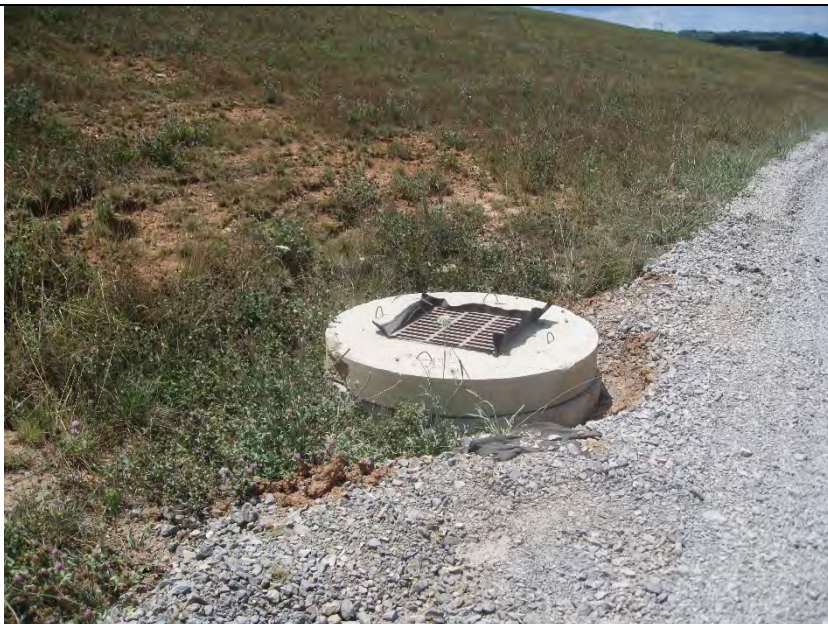
Photo 84  
Sta. 25+50 RT  
Proposed Haul Route  
Project 3

Inlet structures along haul road.

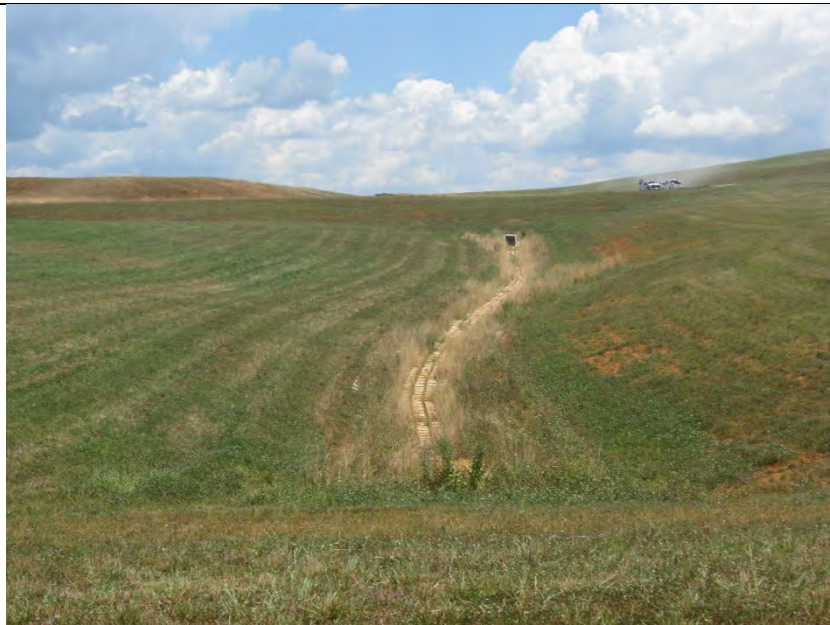
Photo 85  
Sta. 297+01  
(RW 5L-23R)  
Project 2

North Lateral Endwall 104.

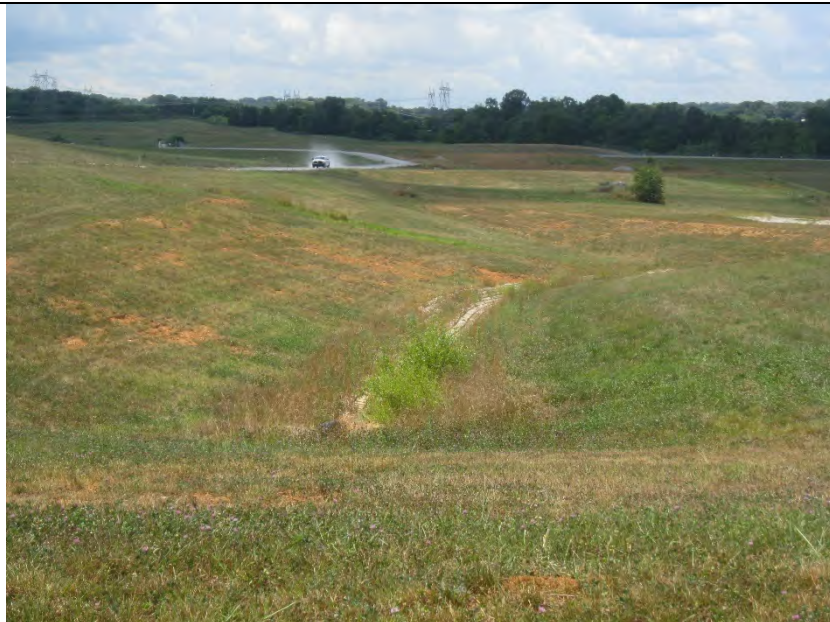
Photo 86  
Sta. 295+10  
(RW 5L-23R)  
Project 2

North Lateral Endwall 106.

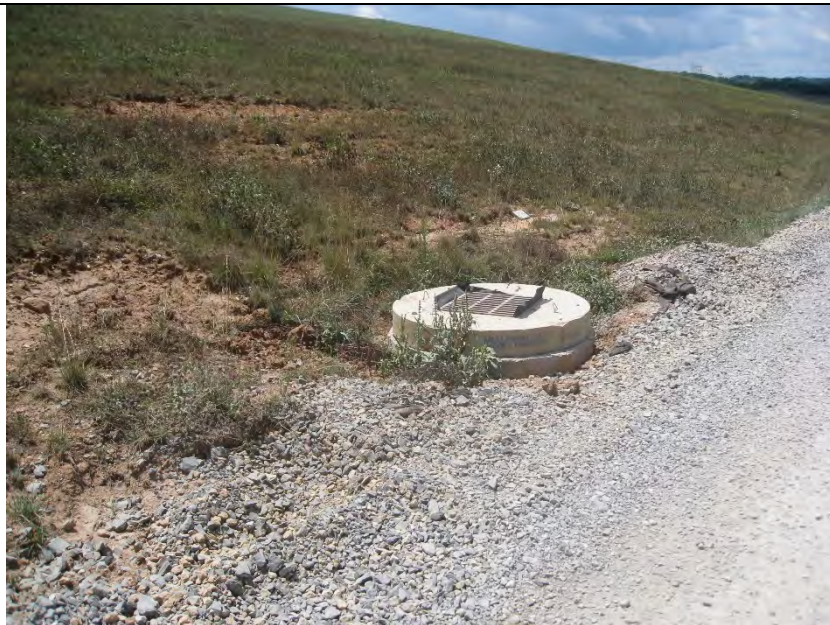
Photo 87  
Sta. 22+00 RT  
Proposed Haul Route  
Project 3

Inlet structures along haul road.

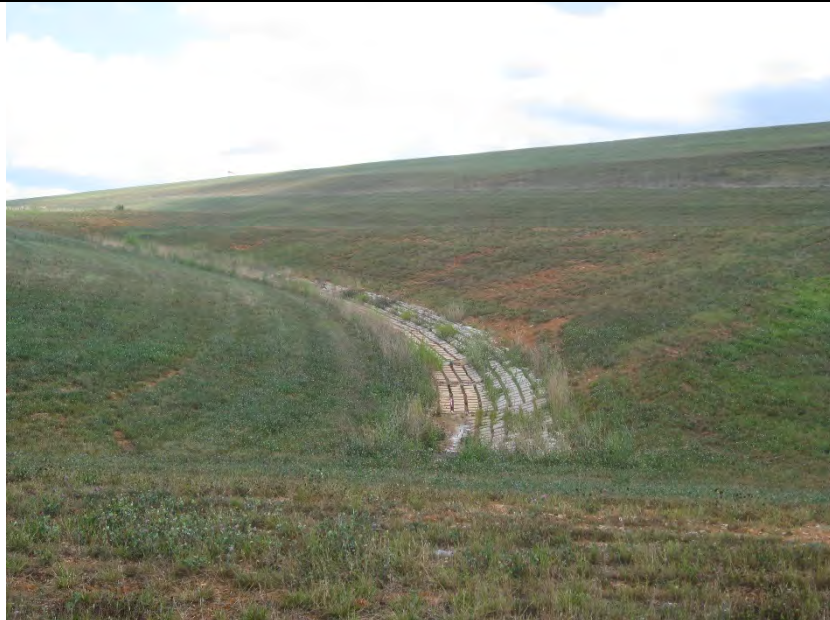
Photo 88  
Sta. 292+08  
(RW 5L-23R)  
Project 2

North Lateral Endwall 108.

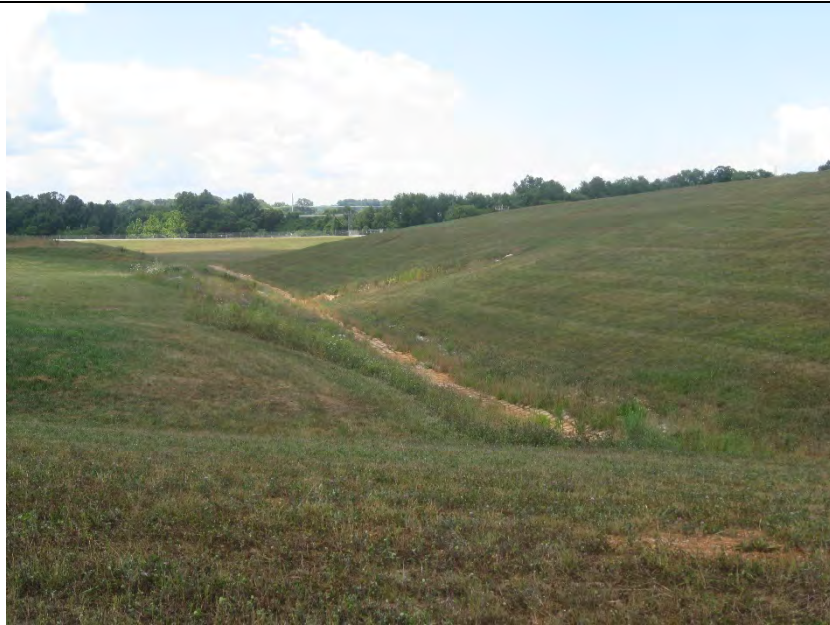
Photo 89  
Sta. 290+50 LT  
(RW 5L-23R)  
Project 2

North Lateral Endwall 110.

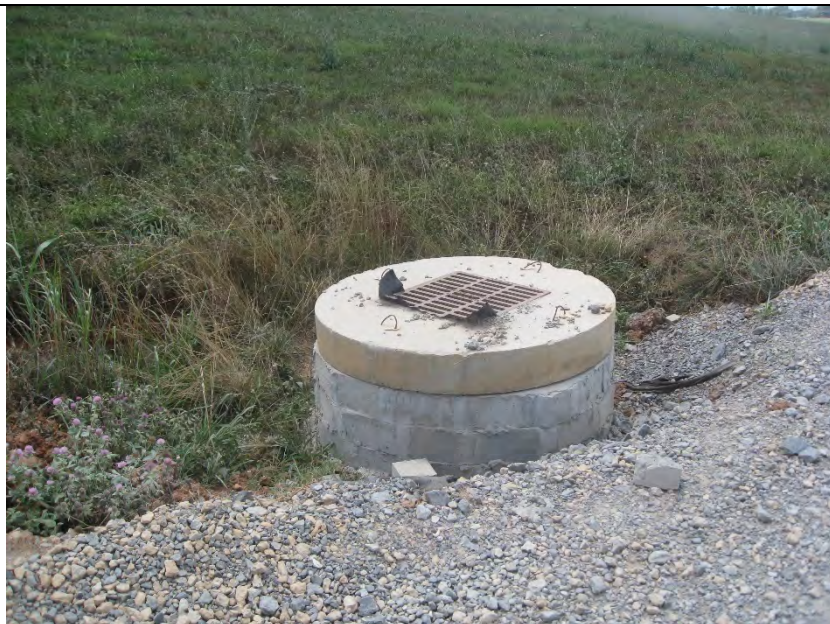
Photo 90  
Sta. 15+50 RT  
Proposed Haul Route  
Project 3

Inlet structures along haul road.

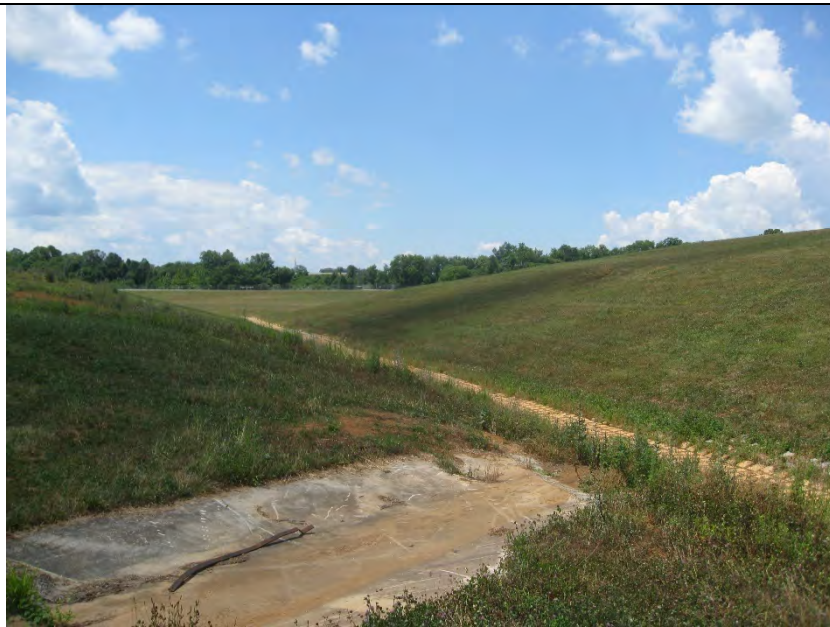
Photo 91  
Sta. 282+45 to 288+26 LT  
(RW 5L-23R)  
Project 2

North Lateral Ditch.

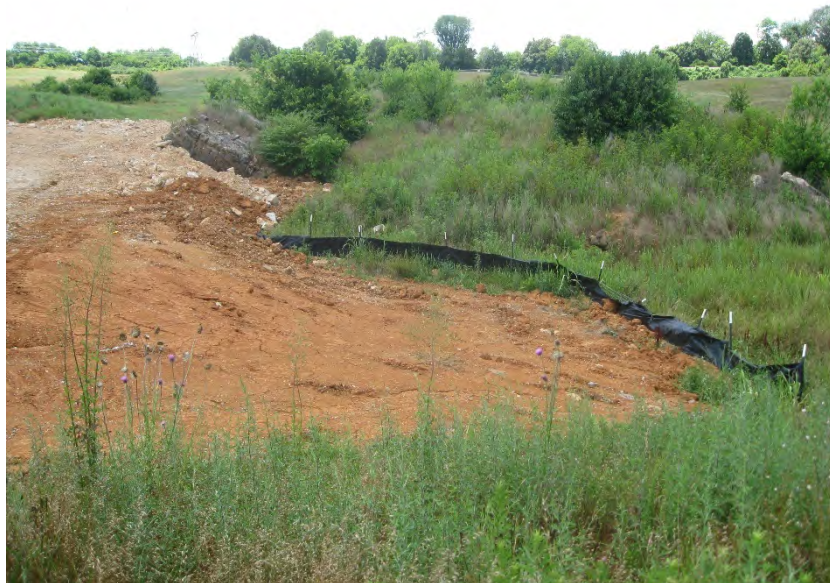
Photo 94  
(Repair TWY Lighting)

Fill area adjacent to Liberty Street from Taxiway shoulder removal.

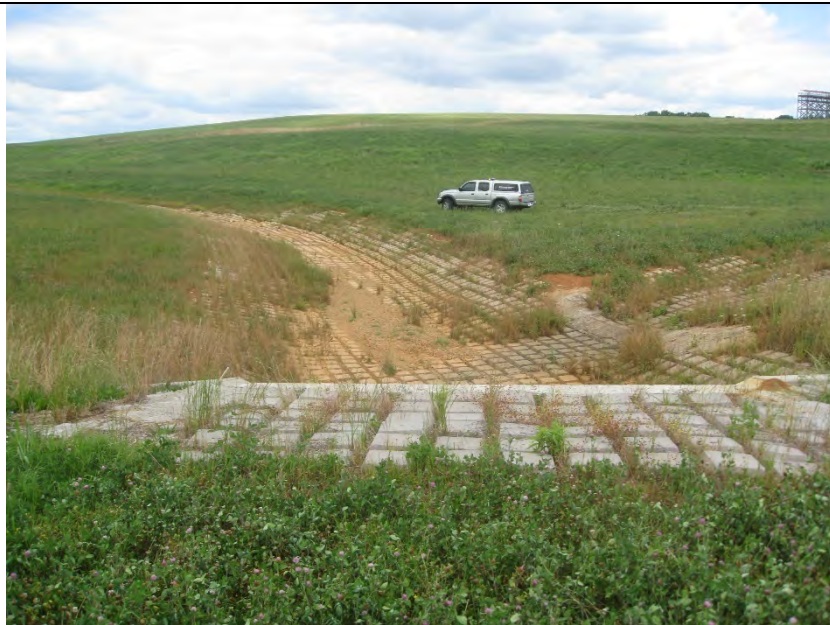
Photo 1  
Sta. 111+56 RT  
(Line LB)  
NLET 01  
Project 2

North Lateral End Treatment 01 (Outfall A).

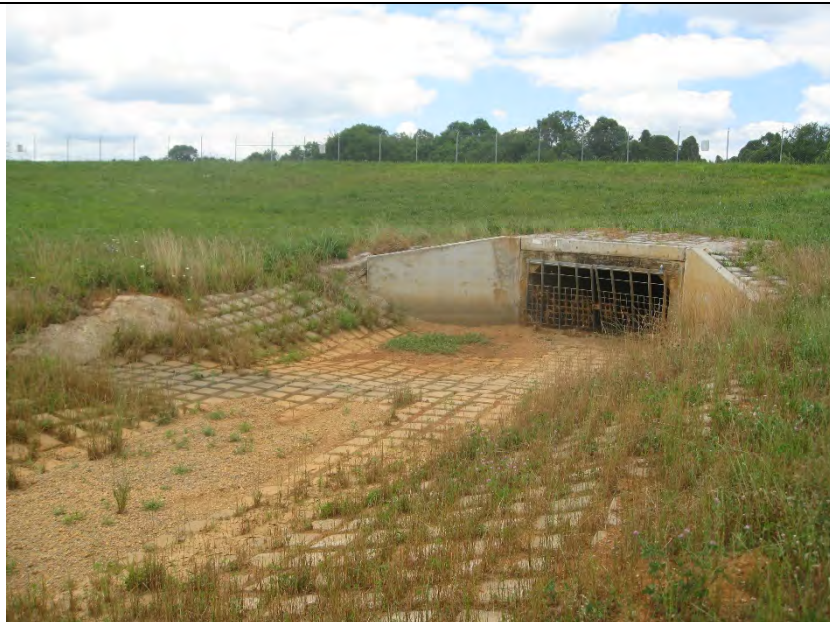
Photo 2  
Sta. 111+56 RT  
(Line LB)  
NLET 01  
Project 2

North Lateral End Treatment 01 (Outfall A).

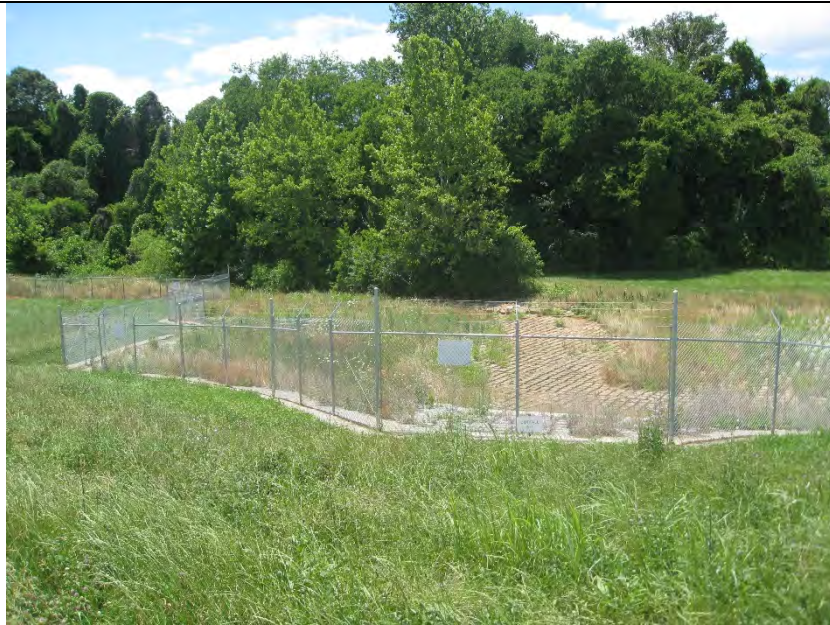
Photo 3  
Sta. 111+82 LT  
(Line LB)  
NLET 02  
Project 2

Main outfall to Lackey Creek. This section of the site was inaccessible at time of inspection.

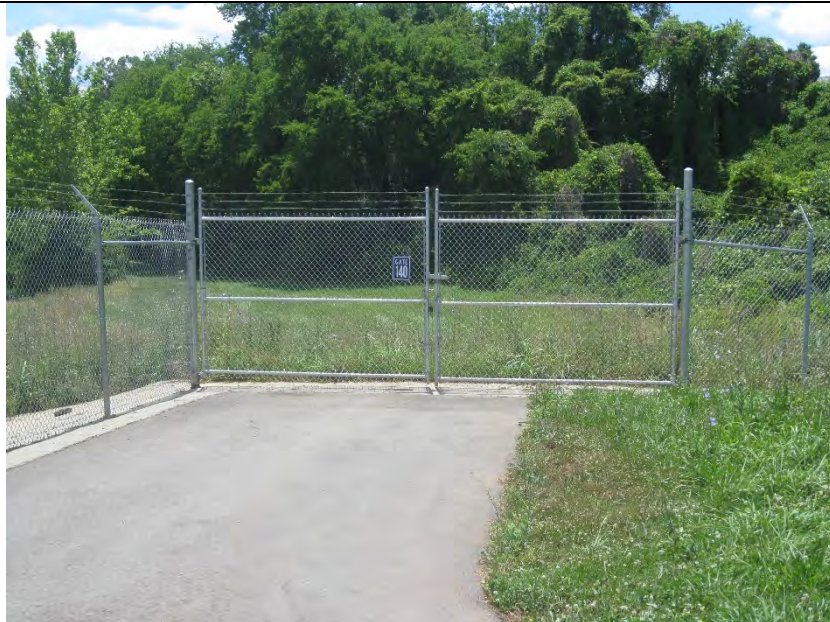
Photo 4  
Sta. 111+82 LT  
(Line LB)  
NLET 02  
Project 2

Main outfall to Lackey Creek was inaccessible at time of inspection.

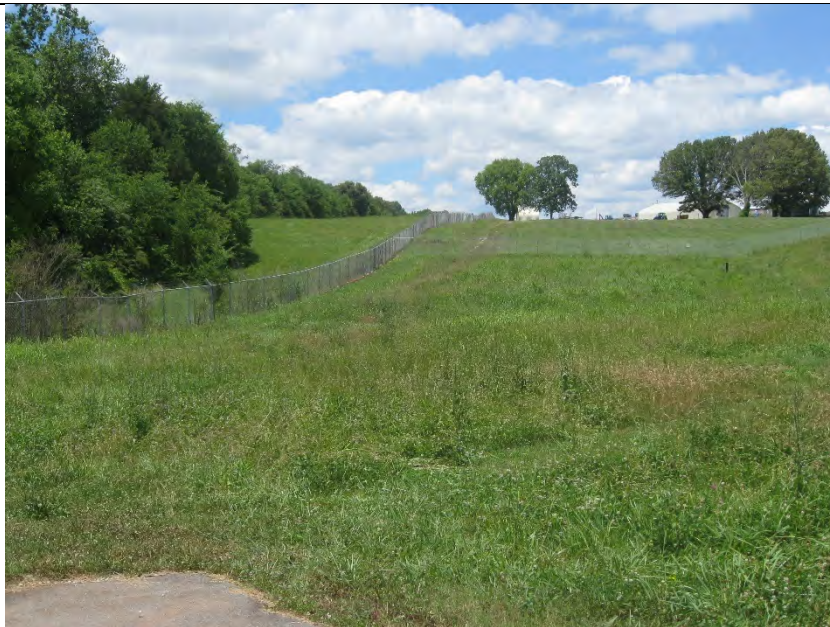
Photo 5  
Sta. 115+28 to Sta. 121+45  
(Line LB)  
Project 2

Grass established at ditch line along Liberty Street.

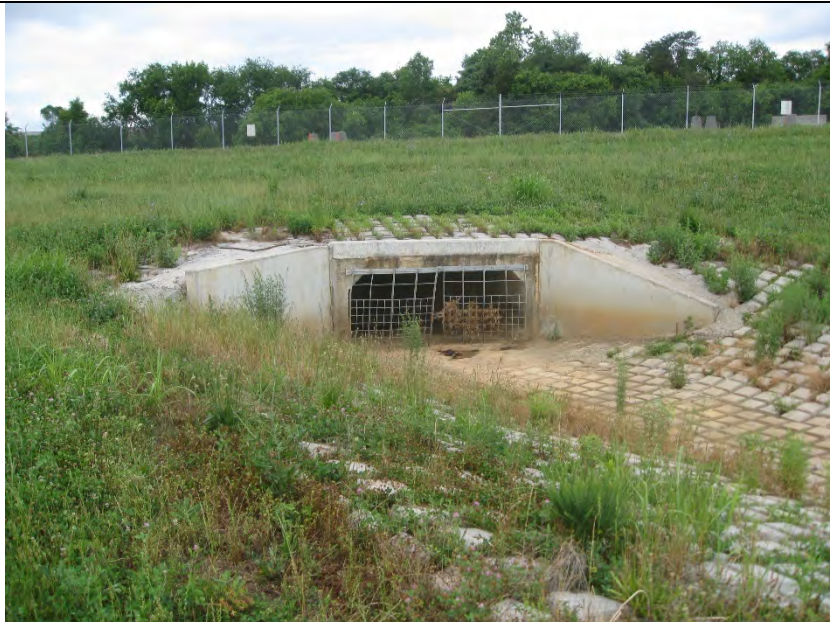
Photo 6  
Sta. 117+00  
(Line LB)  
Project 2

Guard Lateral Ditch (Outfall B).

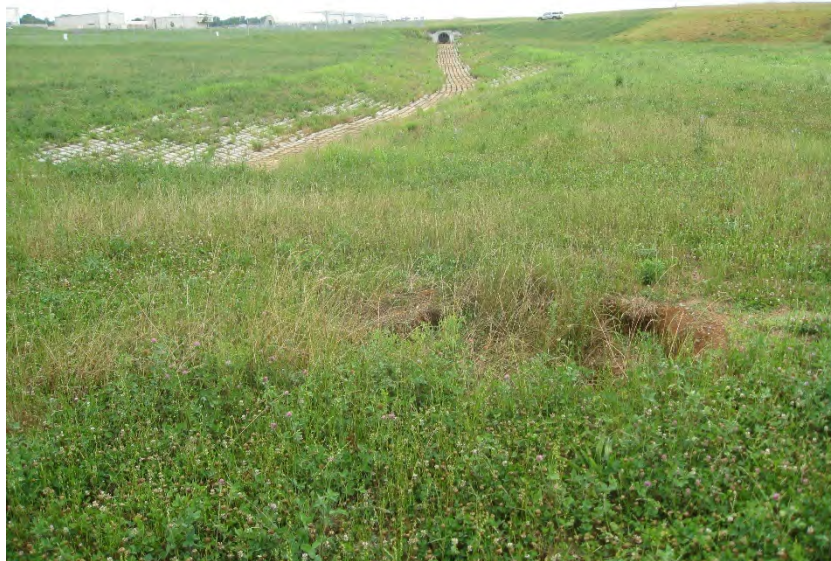
Photo 7  
Sta. 117+00  
(Line LB)  
Project 2

Above the Guard Lateral Ditch (Outfall B).  
Construction fall out present. Recommend coordinating remediation with CHA.

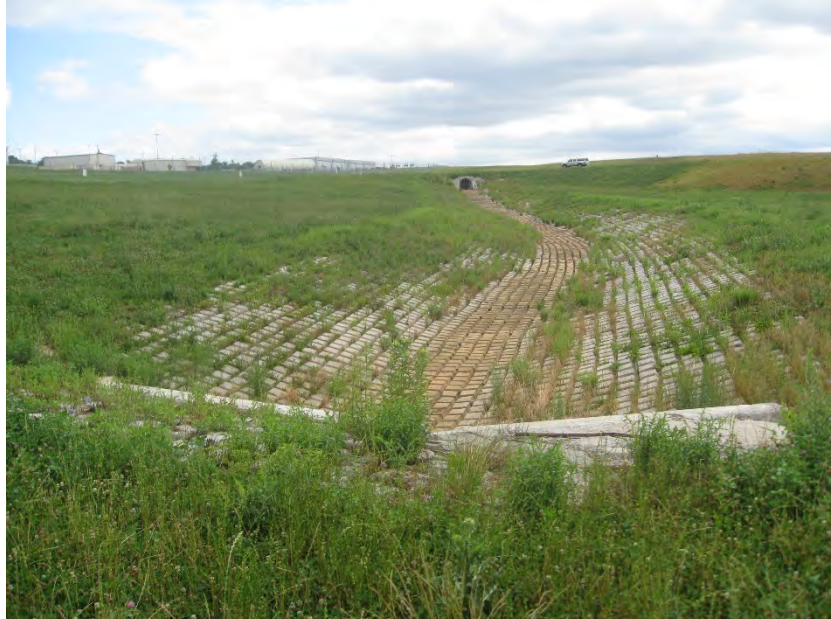
Photo 8  
Sta. 117+00  
(Line LB)  
Project 2

Guard Lateral Ditch (Outfall B).

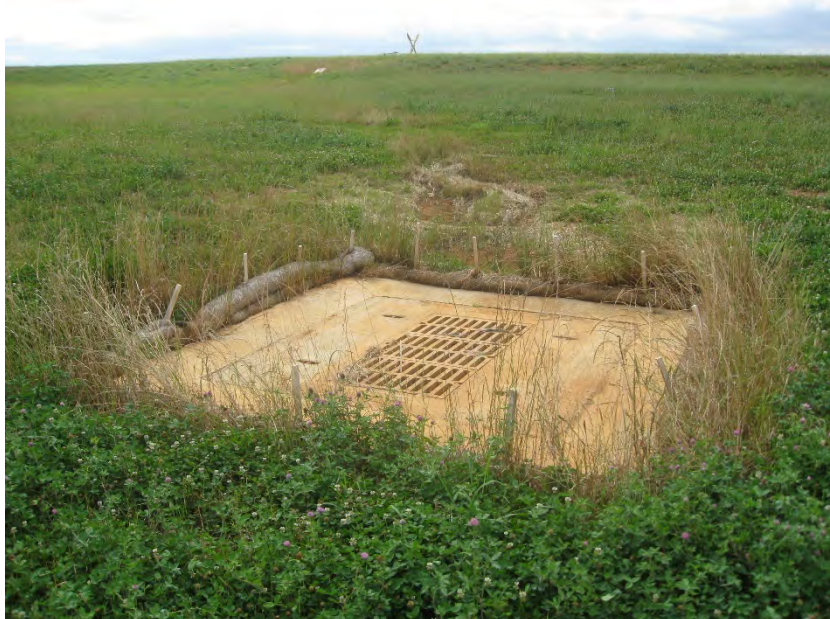
Photo 12  
Sta. 291+51 LT  
(RW 5L-23R)  
Structure 120  
Project 3

Structure 120.

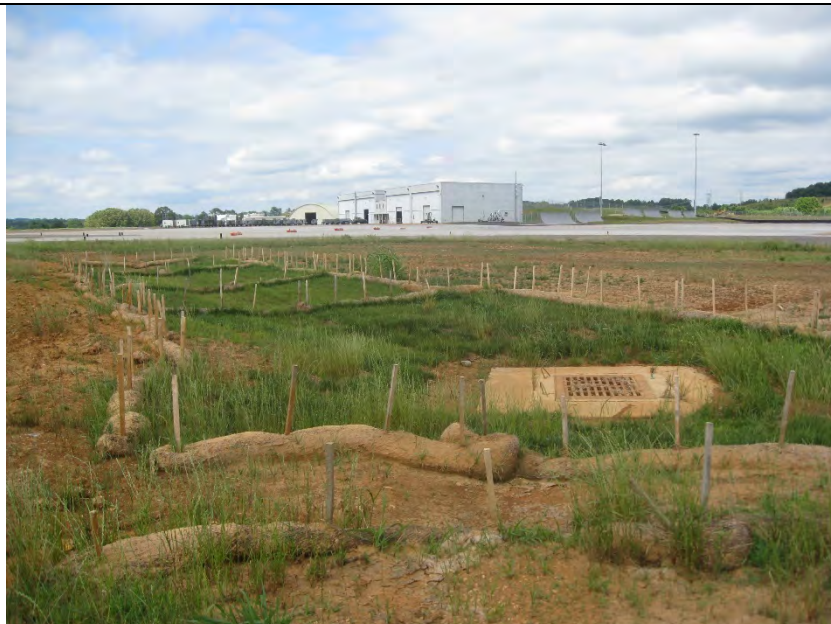
Photo 15  
Sta. 302+54 LT  
(RW 5L-23R)  
Structure 114  
Project 3

Structure 114.  
Bare areas recently stabilized.

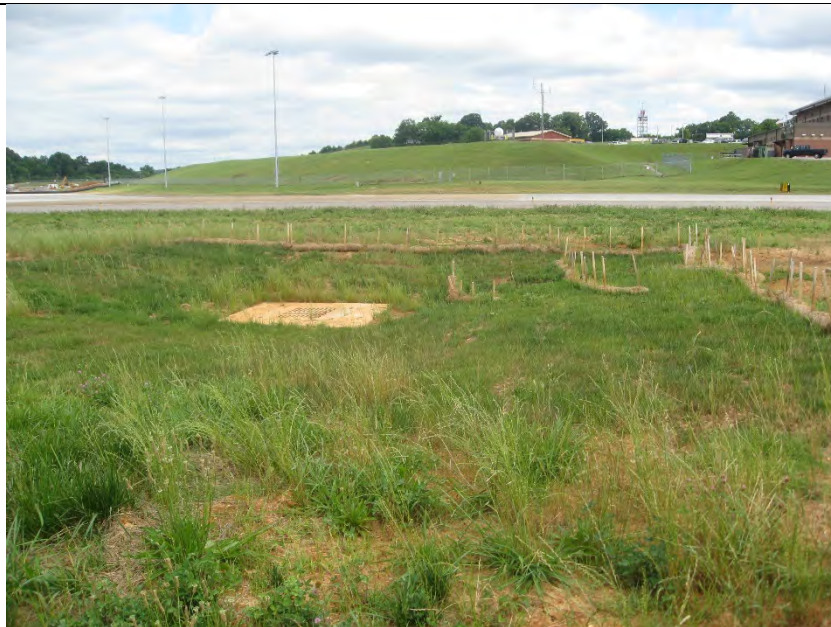
Photo 16  
Sta. 303+36 LT  
(RW 5L-23R)  
Structure 12  
Project 3

Structure 12.  
Bare areas recently stabilized.

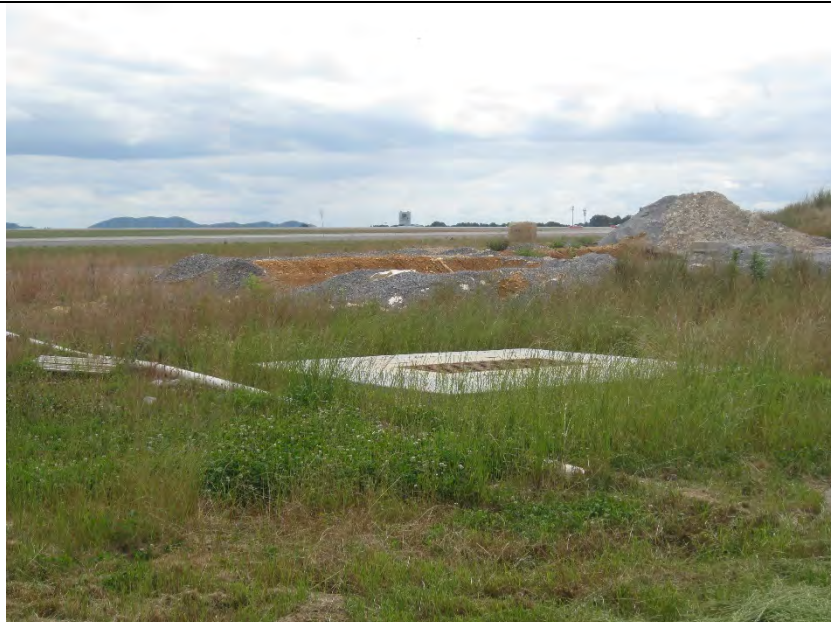
Photo 17  
Sta. 310+04 LT  
(RW 5L-23R)  
Structure 10  
Project 3

Structure 10.  
Bare areas recently stabilized.

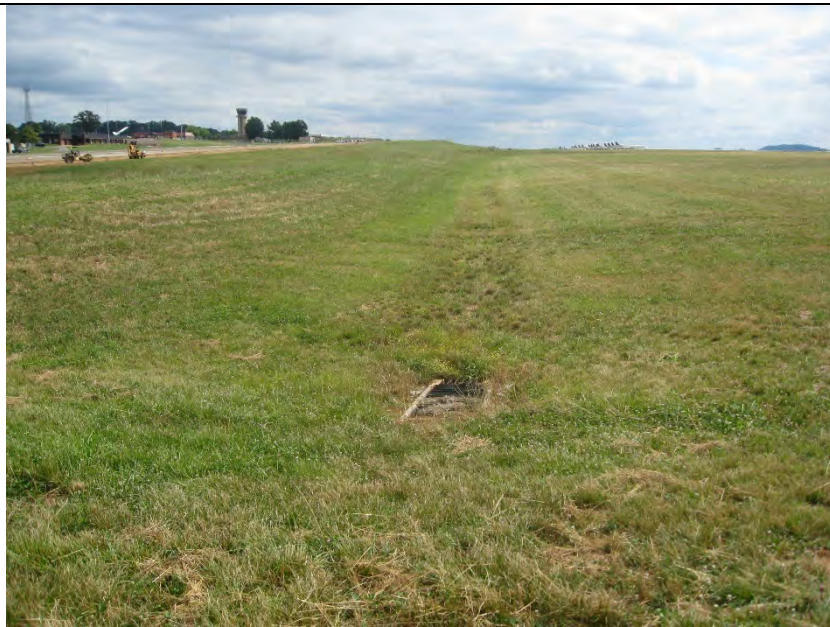
Photo 20  
Sta. 314+48 LT  
(RW 5L-23R)  
ES Endwall 108  
Project 3

Enhanced Swale Endwall 108.  
Recommend stabilizing remaining bare areas.
