**QUALITY ASSURANCE  
MONTHLY SITE  
ASSESSMENT REPORT**

Airfield Modernization Program  
Runway 5L-23R Reconstruction  
Project 2 / Project 3

## QUALITY ASSURANCE SITE ASSESSMENT

## **AIRFIELD MODERNIZATION PROGRAM RUNWAY 5L-23R RECONSTRUCTION**

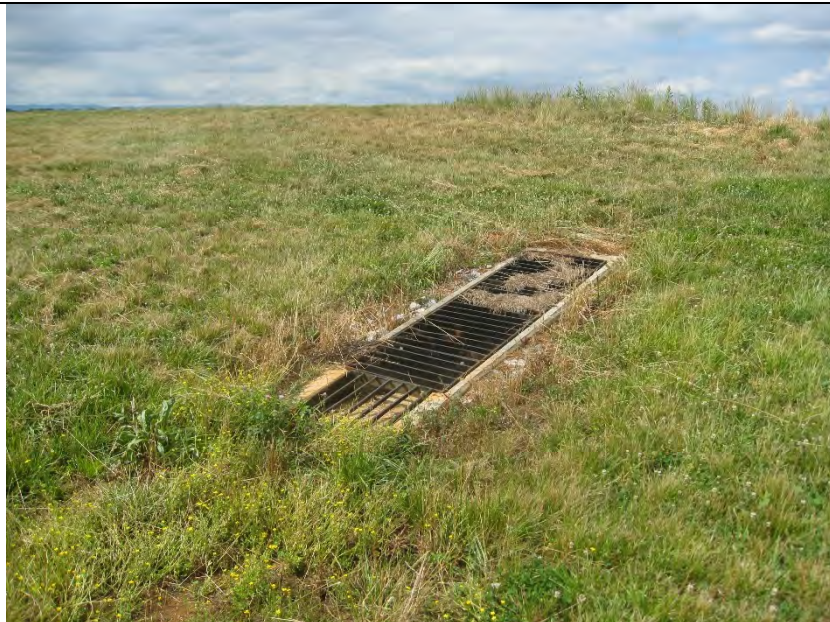
Photo 21  
Sta. 324+86 LT  
(RW 5L-23R)  
ES Endwall 106  
Project 3

Enhanced Swale Endwall 106.

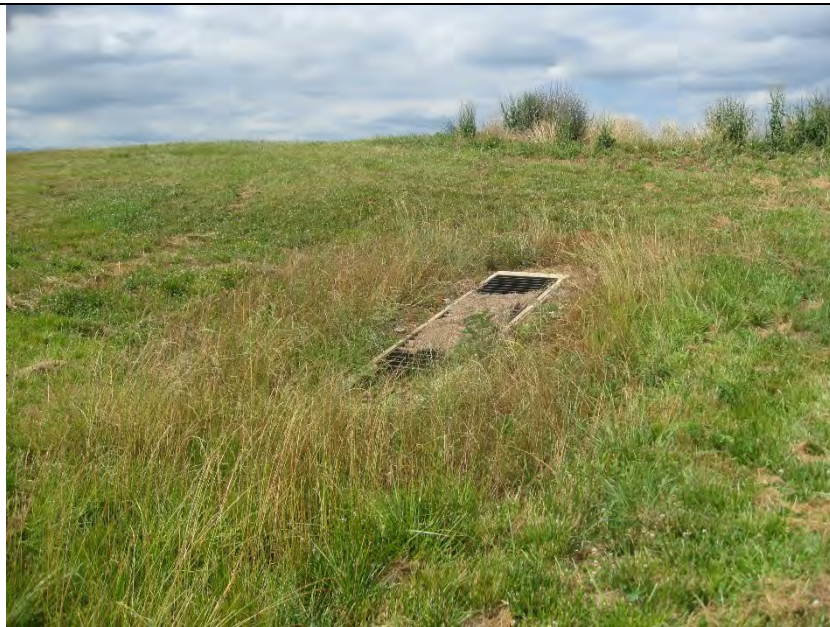
Photo 22  
Sta. 324+86 to Sta. 335+73 LT  
(RW 5L-23R)  
ES Endwall 106  
Project 3

Enhanced Swale Endwall 106.

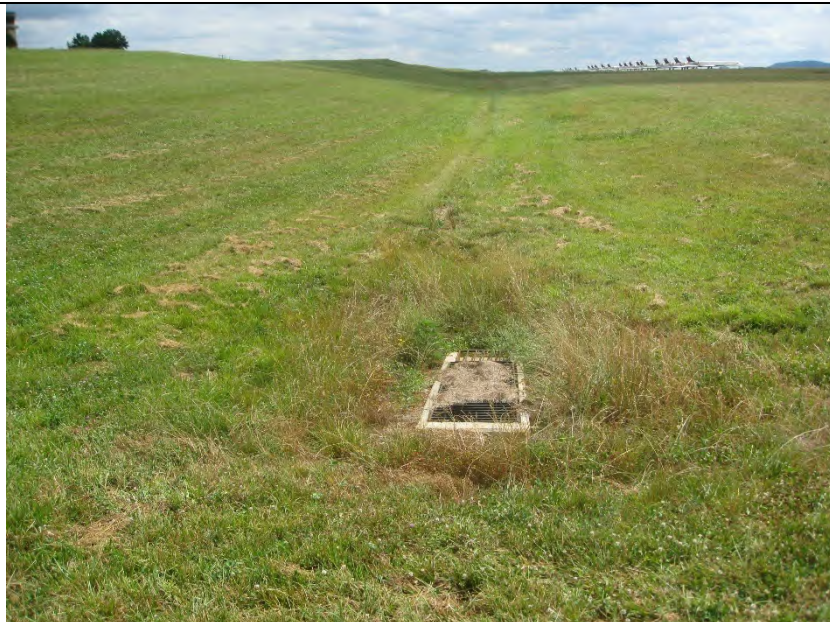
Photo 23  
Sta. 335+73 LT  
(RW 5L-23R)  
ES Endwall 104  
Project 3

Enhanced Swale Endwall 104.

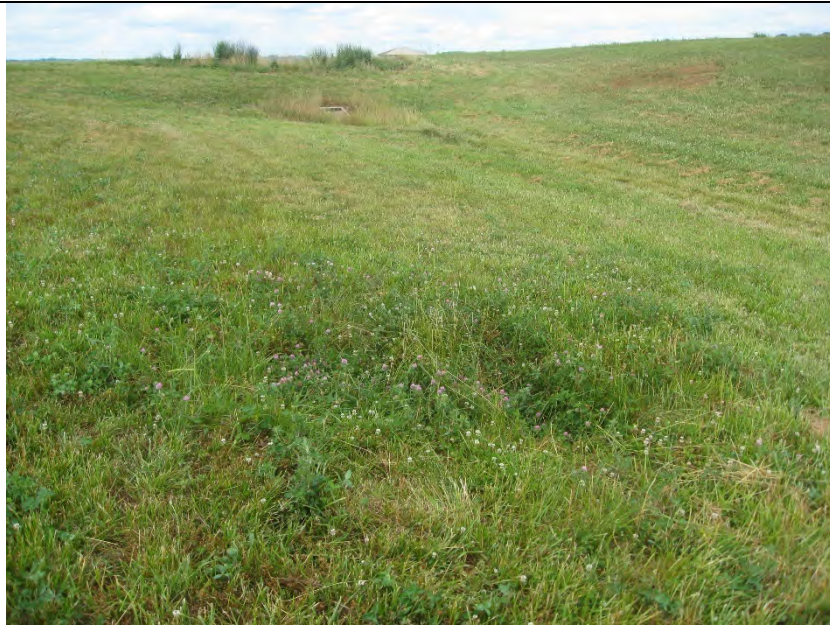
Photo 24  
Sta. 335+73 LT  
(RW 5L-23R)  
ES Endwall 104  
Project 3

Enhanced Swale Endwall 104.

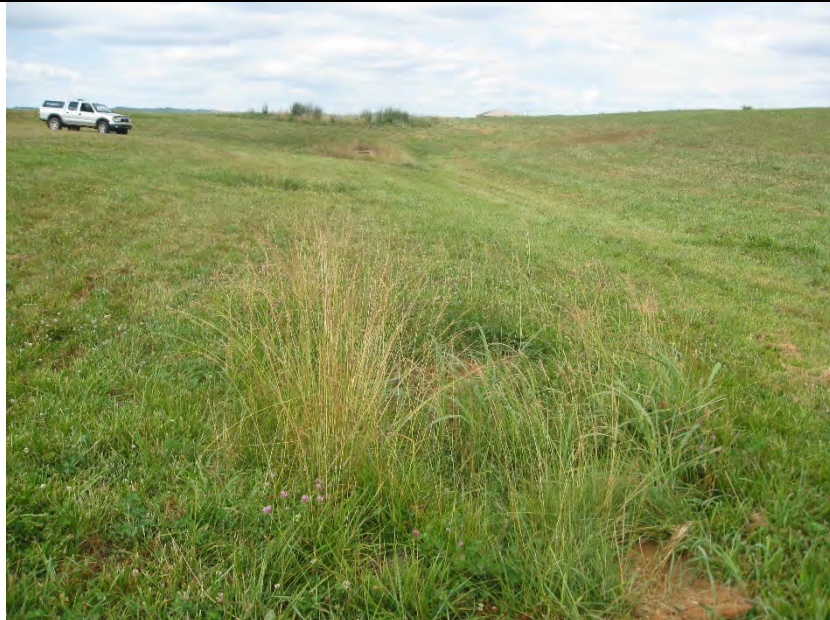
Photo 25  
Sta. 341+50 LT  
(RW 5L-23R)  
Between ES Endwall 104 and 102  
Project 3

Potential construction fallout on Storm Line 1 between ES Endwall 104 and 102.

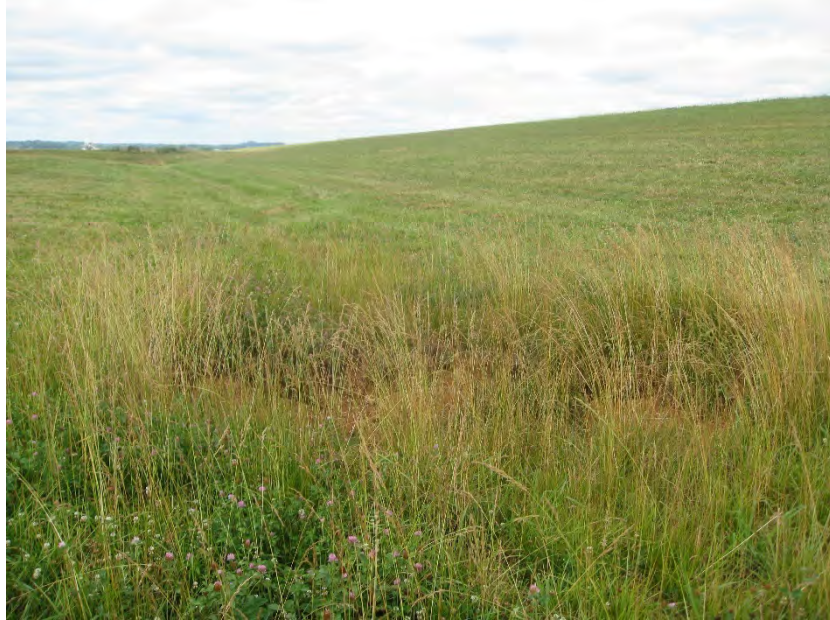
Photo 26  
Sta. 341+50 LT  
(RW 5L-23R)  
Between ES Endwall 104 and 102  
Project 3

First construction fallout on Storm Line 1 between ES Endwall 104 and 102.  
Coordinate remediation with CHA.

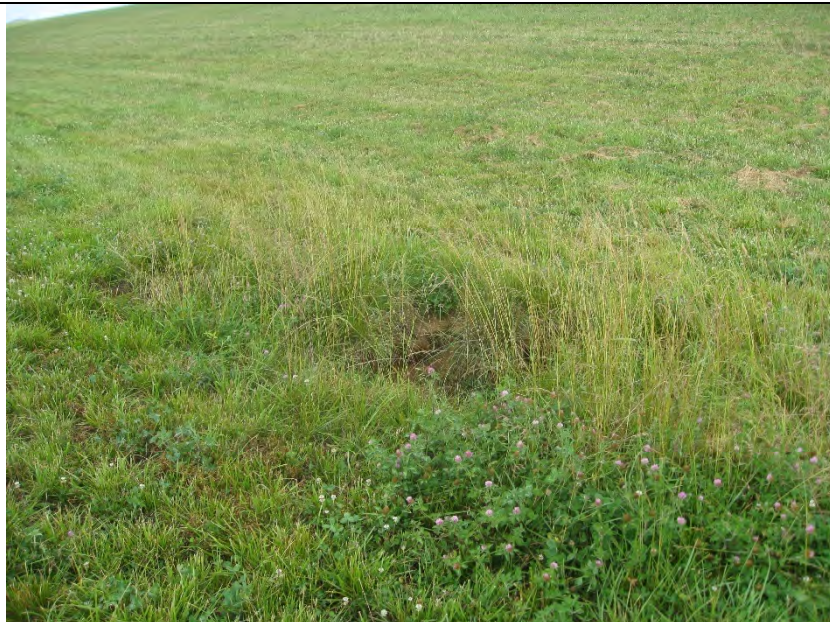
Photo 27  
Sta. 341+50 LT  
(RW 5L-23R)  
Between ES Endwall 104 and 102  
Project 3

Second construction fallout on Storm Line 1 between ES Endwall 104 and 102.  
Coordinate remediation with CHA.

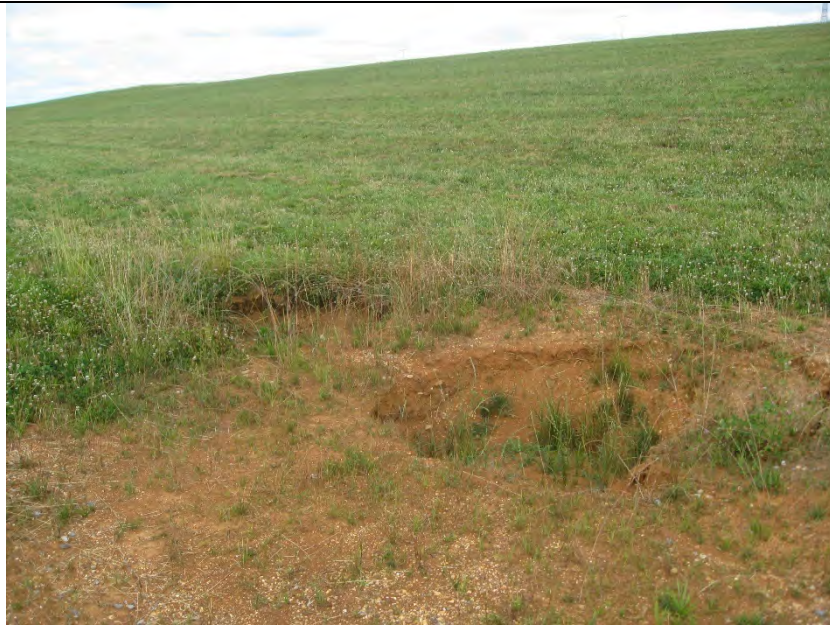
Photo 28  
Sta. 341+50 LT  
(RW 5L-23R)  
Between ES Endwall 104 and 102  
Project 3

Third construction fallout on Storm Line 1 between ES Endwall 104 and 102.  
Coordinate remediation with CHA.

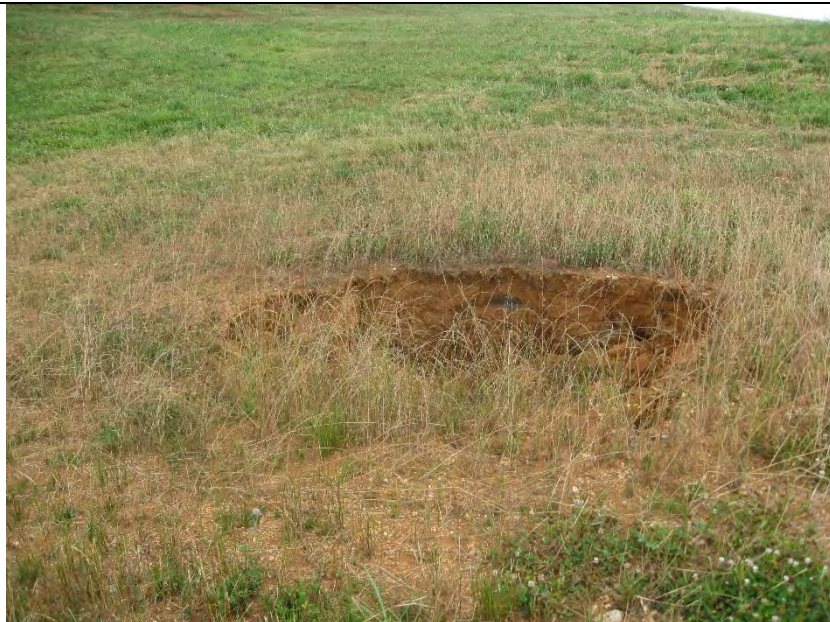
Photo 29  
Sta. 341+50 LT  
(RW 5L-23R)  
Between ES Endwall 104 and 102  
Project 3

Fourth construction fallout on Storm Line 1 between ES Endwall 104 and 102.  
Coordinate remediation with CHA.

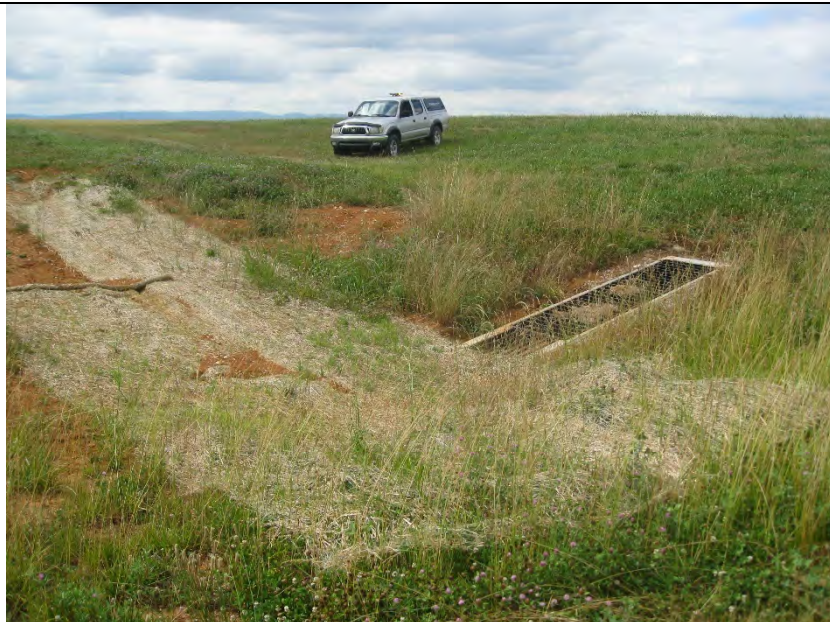
Photo 31  
Sta. 347+31 LT  
(RW 5L-23R)  
ES Endwall 102  
Project 3

Enhanced Swale Endwall 102.  
Recommend stabilizing remaining bare areas.

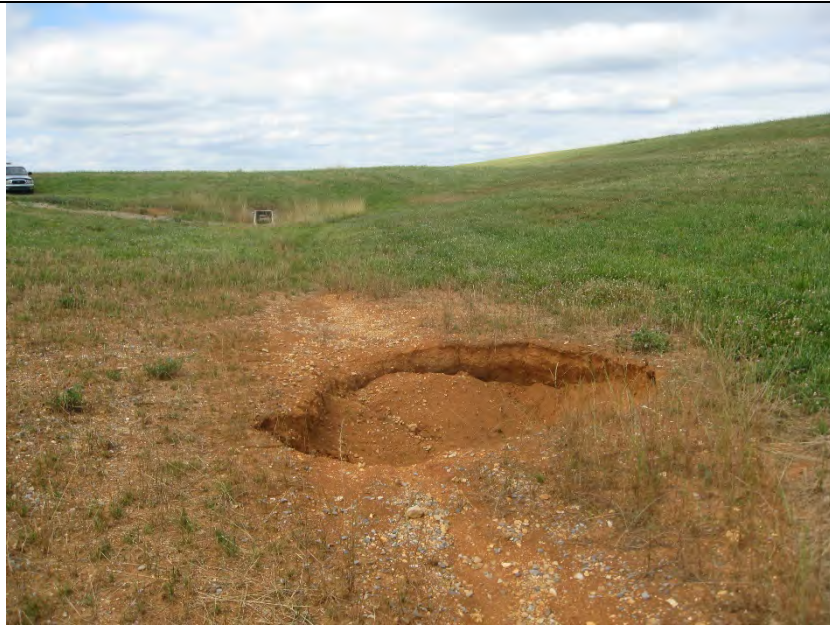
Photo 32  
Sta. 347+31 LT  
(RW 5L-23R)  
ES Endwall 102  
Project 3

Enhanced Swale Endwall 102.  
Recommend stabilizing remaining bare areas.

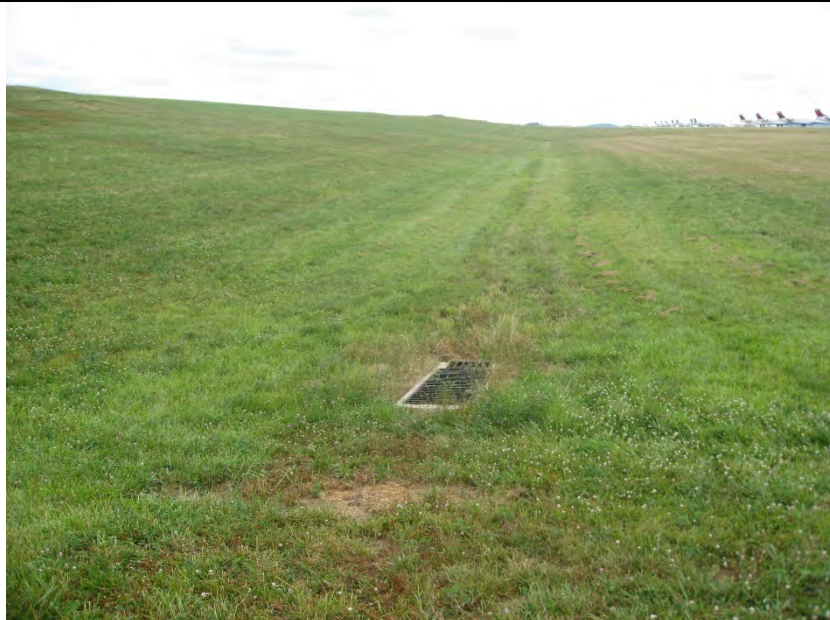
Photo 33  
Sta. 341+50 LT  
(RW 5L-23R)  
ES Endwall 102  
Project 3

Construction fallout on Storm Line 1 between ES Endwall 102 and 100.  
Coordinate remediation with CHA.

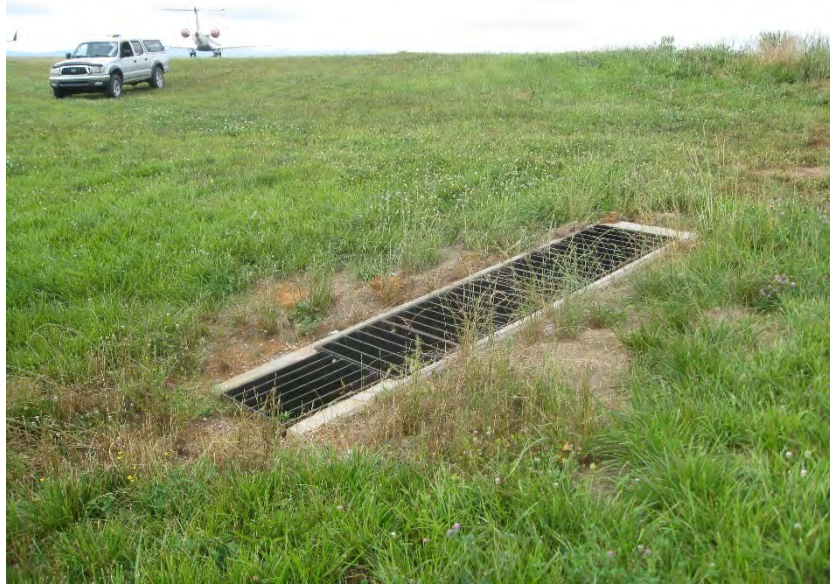
Photo 34  
Sta. 354+75 LT  
(RW 5L-23R)  
ES Endwall 100  
Project 2

Enhanced Swale Endwall 100.

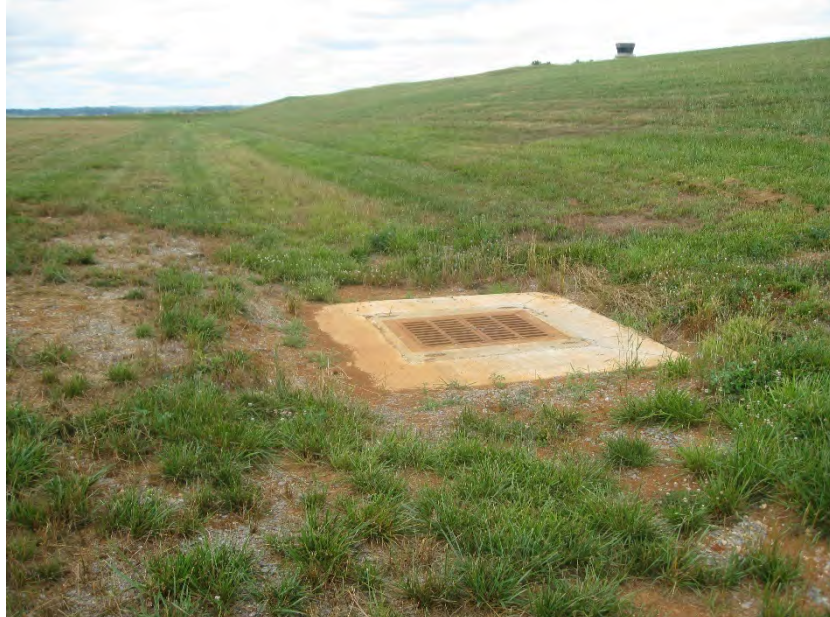
Photo 35  
Sta. 354+75 LT  
(RW 5L-23R)  
ES Endwall 100  
Project 3

Enhanced Swale Endwall 100.

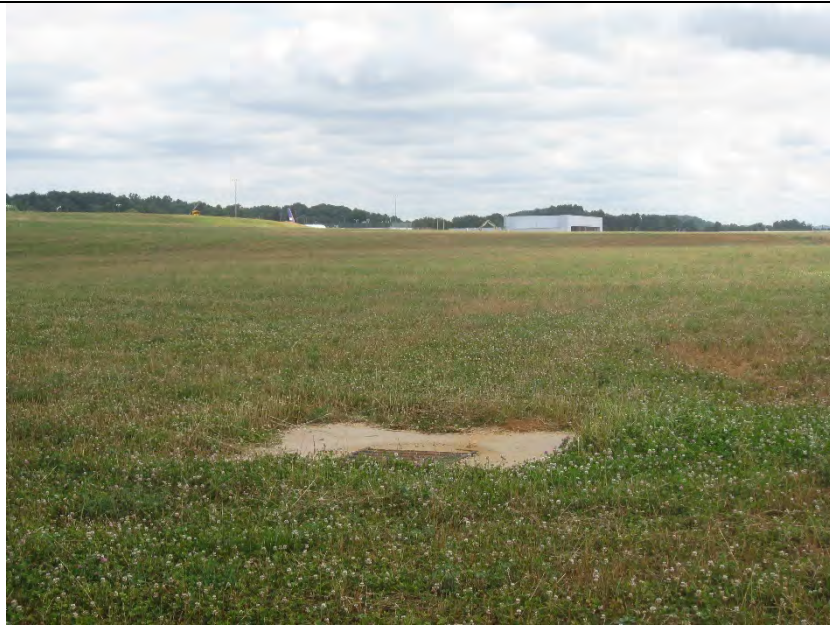
Photo 36  
Sta. 361+39 LT  
(RW 5L-23R)  
Structure 100  
Project 3

Structure 100.  
Recommend stabilizing remaining bare areas.

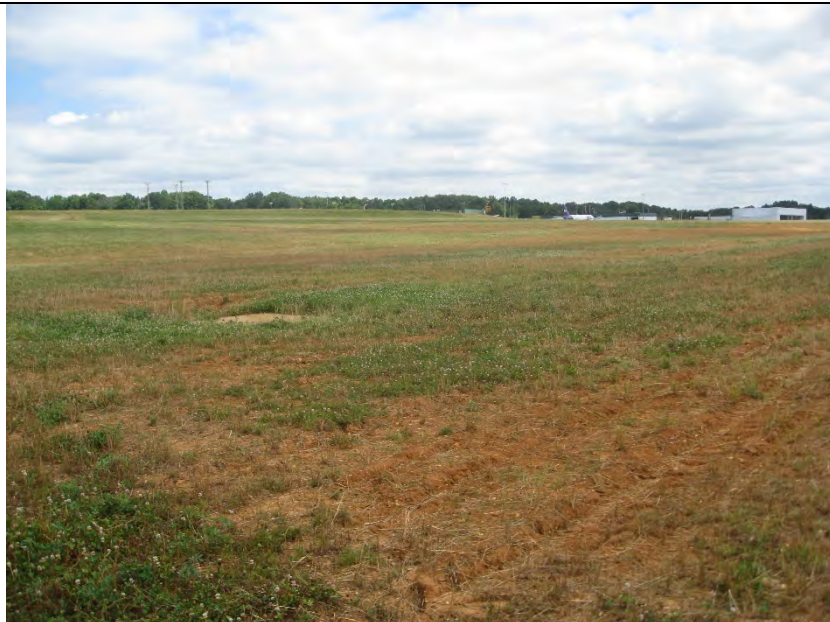
Photo 37  
Sta. 363+35 LT  
(RW 5L-23R)  
Existing Structure  
Project 2

Existing Structure.

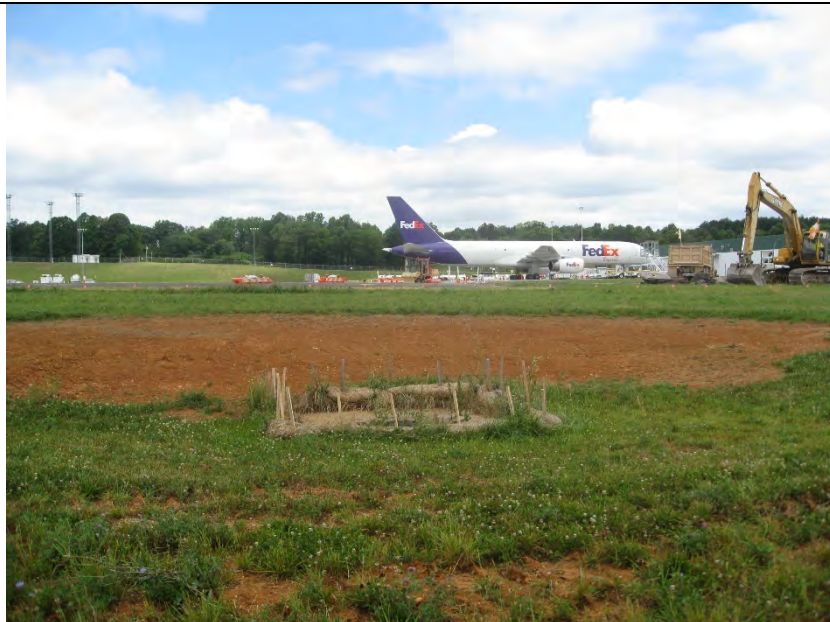
Photo 39  
Sta. 369+11 LT  
(RW 5L-23R)  
Existing Structure  
Project 2

Existing Structure.  
Recommend stabilizing bare areas.

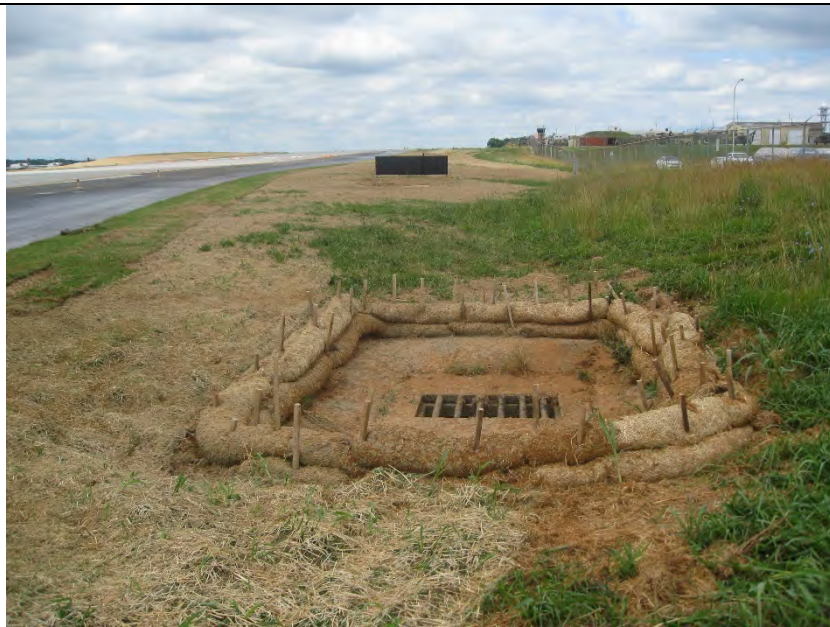
Photo 40  
Sta. 677+00 RT  
(RW 5L-23R)  
Existing Structure  
Project 4

Structure south of Taxiway "G".  
Slopes recently regraded.  
Recommend stabilizing bare areas.

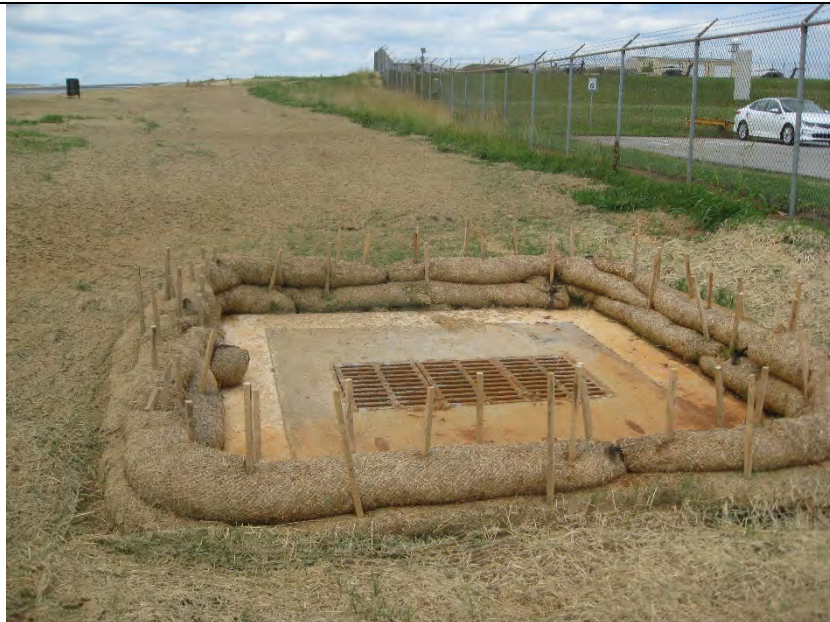
Photo 41  
Sta. 677+00 RT  
(RW 5L-23R)  
Project 4

Structure between Taxiway G and UPS Facility.

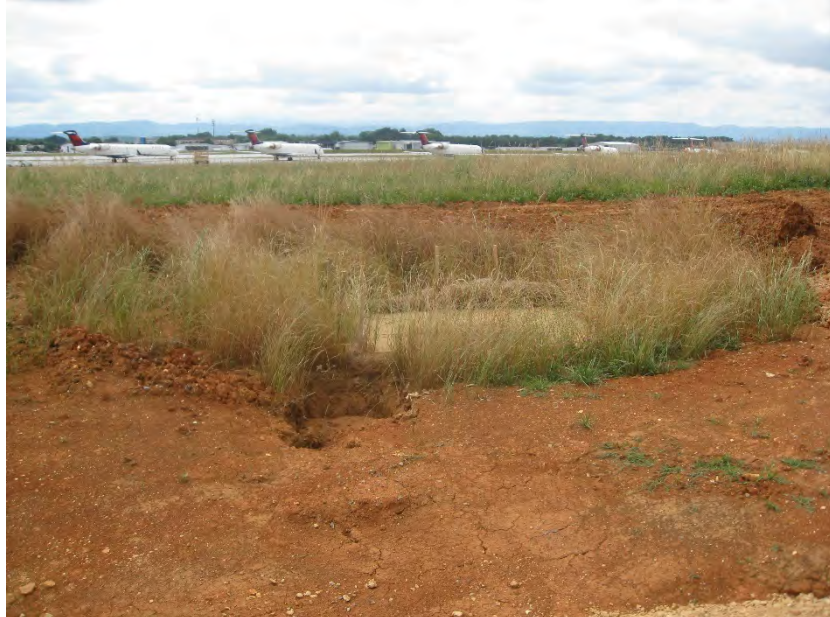
Photo 43  
(RW 5L-23R)  
Existing Structure  
Project 4

Existing structure south of Taxiway G  
Area recently regraded, recommend stabilizing bare areas.

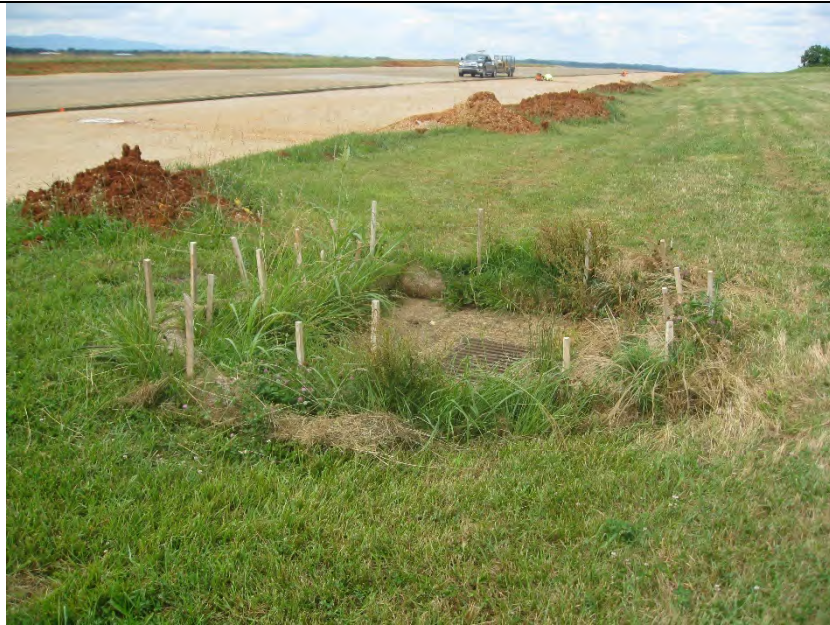
Photo 44  
(RW 5L-23R)  
Existing Structure  
Project 4

Existing structure south of Taxiway G.

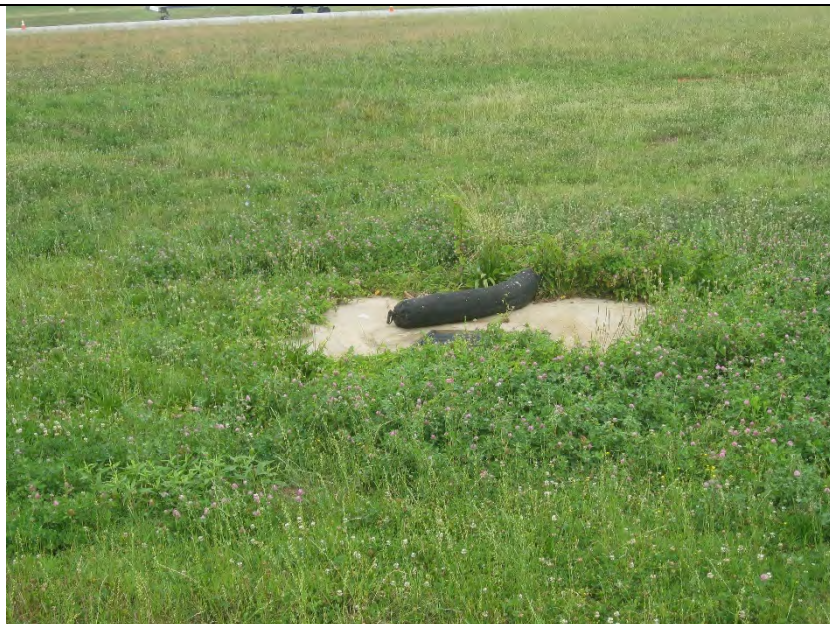
Photo 45  
(RW 5L-23R)  
Existing Structure  
Project 4

Existing structure north of Taxiway G.

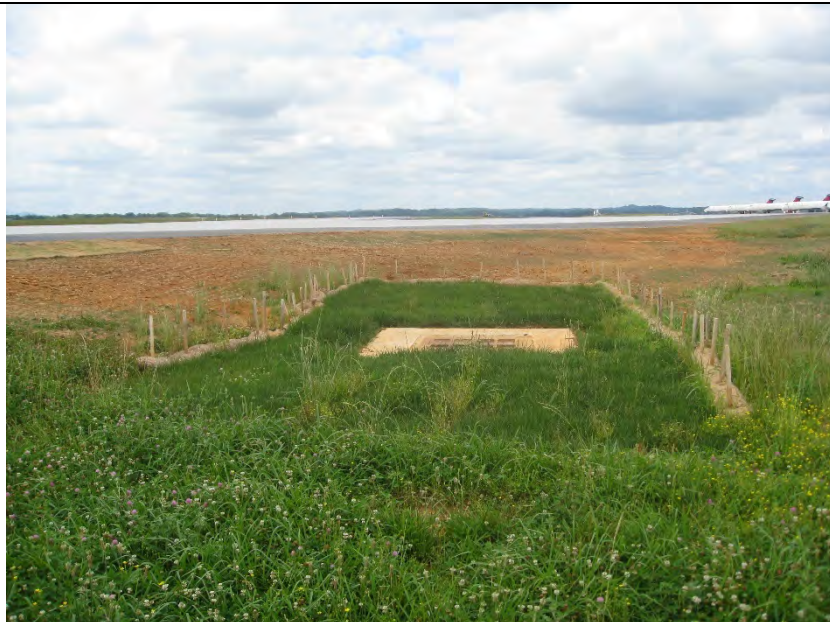
Photo 47  
Sta. 366+89 RT  
(RW 5L-23R)  
Outfall C  
Project 4

Recommend removing filter fabric from this structure to allow sampling for DMR.  
(Outfall C).

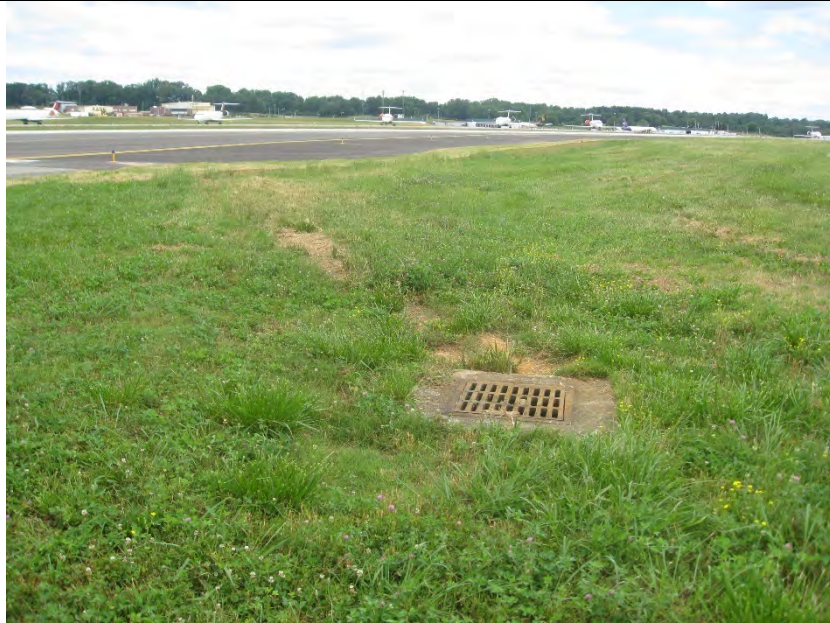
Photo 48  
Sta. 365+69 RT  
(RW 5L-23R)  
Structure 300  
Project 4

Structure 300.  
Recommend stabilizing bare areas.

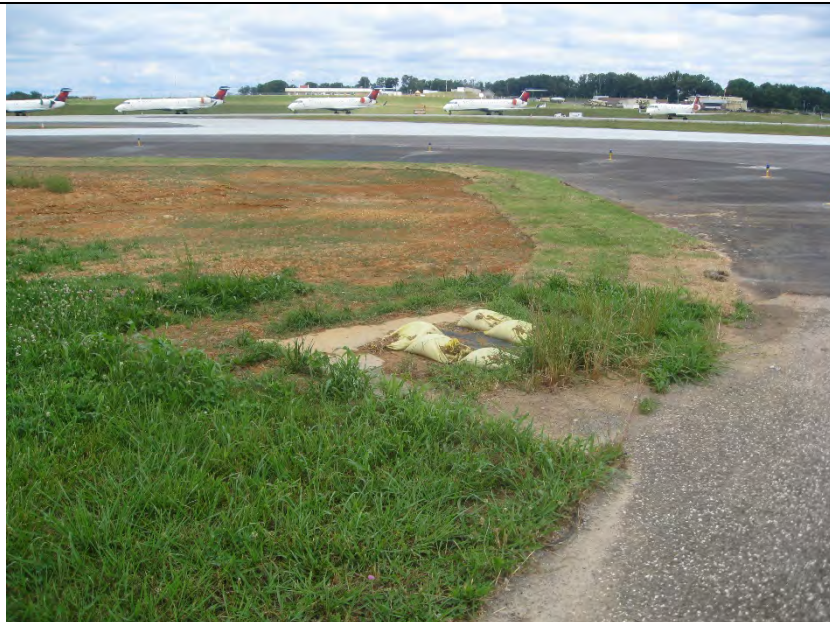
Photo 49  
(RW 5L-23R)  
TWY Y Tie-in  
Project 4

Existing structure north of Taxiway Y.

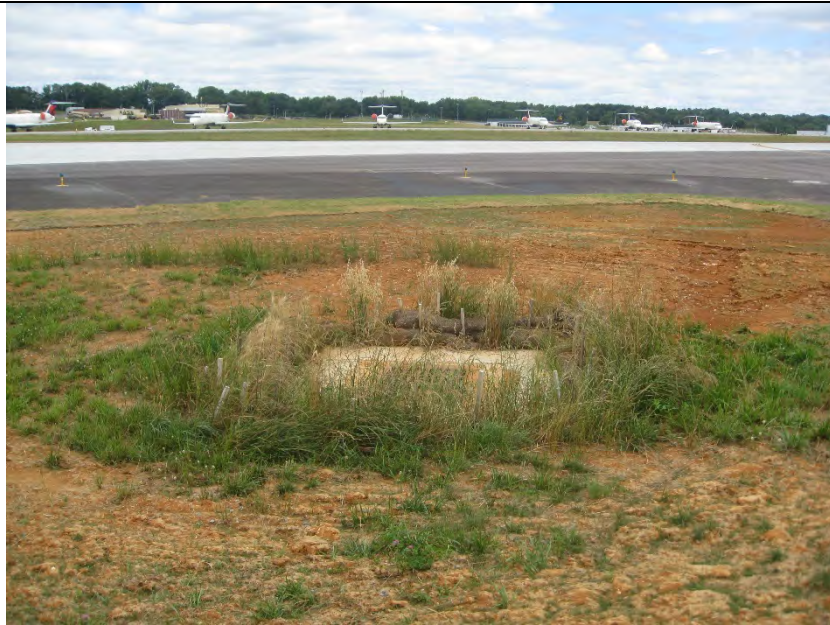
Photo 50  
(RW 5L-23R)  
TWY Y Tie-in  
Project 4

Existing structure south of Taxiway Y.  
Sod recently installed

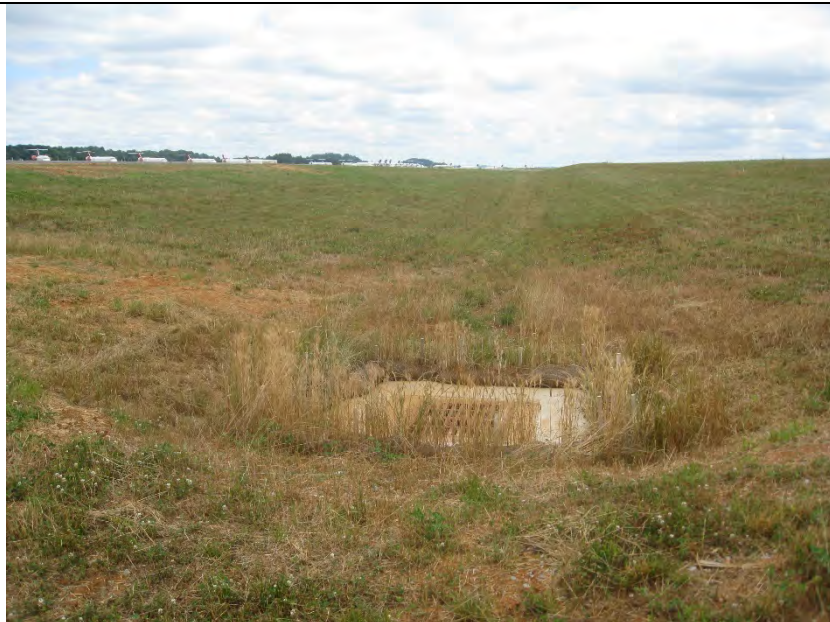
Photo 51  
Sta. 362+02 LT  
(RW 5L-23R)  
Structure 400  
Project 4

Structure 400.  
Sod recently installed on shoulder.

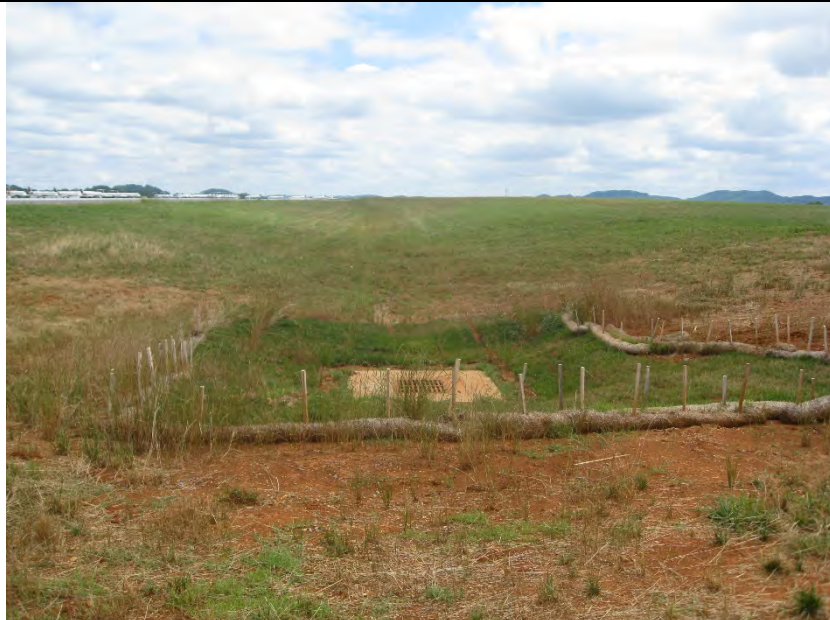
Photo 53  
Taxiway "B"  
Project 4

Taxiway "B"  
Shoulders recently stabilized.

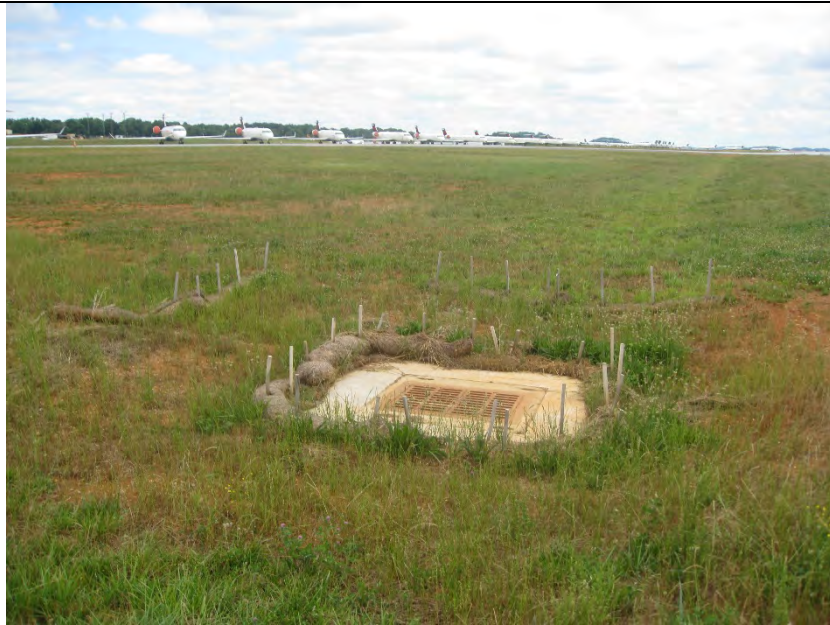
Photo 54  
Sta. 347+26 RT  
(RW 5L-23R)  
Structure 22  
Project 4

Structure 22.  
Sediment tubes recently relocated to edge of sod. Recommend stabilizing bare areas.

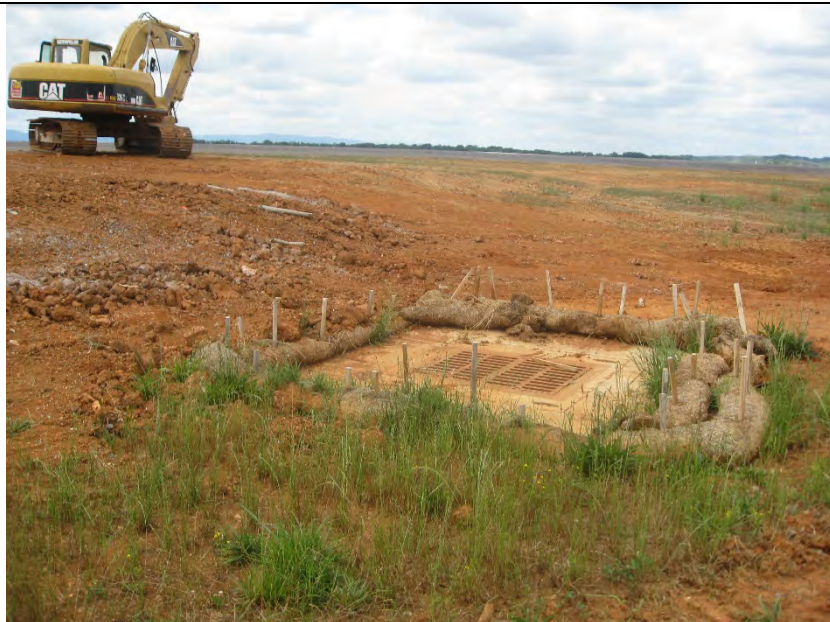
Photo 55  
Sta. 353+56 RT  
(RW 5L-23R)  
Structure 200  
Project 4

Structure 200.

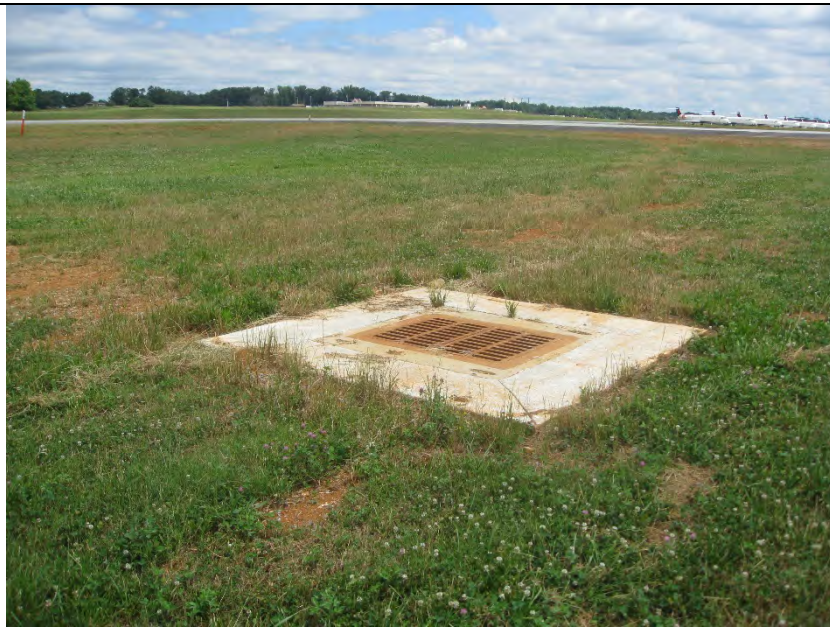
Photo 56  
Sta. 347+26 RT  
(RW 5L-23R)  
Structure 202  
Project 4

Structure 202.

Construction activities recently taken place.  
Area appears to be at grade.

Recommend replacing sediment tubes and stabilizing bare areas.

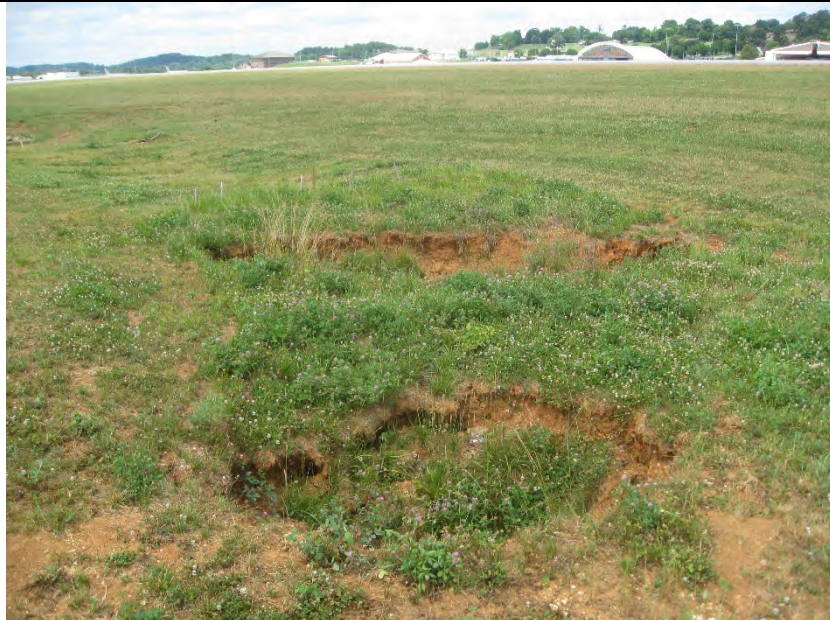
Photo 57  
Sta. 341+86 RT  
(RW 5L-23R)  
Structure 204  
Project 4

Structure 204.

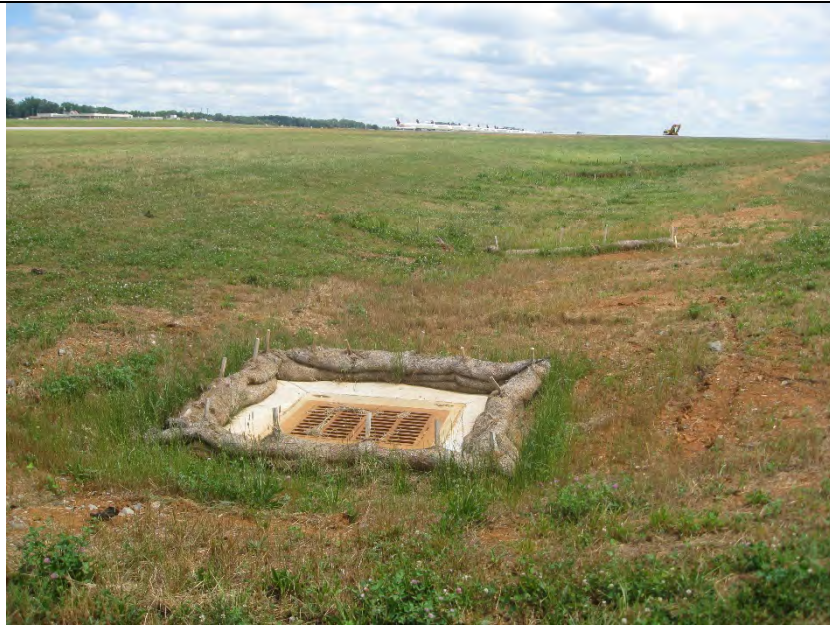
Photo 58  
Sta. 341+86 RT  
(RW 5L-23R)  
Project 4

Construction fallout on Storm Line 2 between structures 204 and 206.  
Recommend coordinating remediation with CHA.

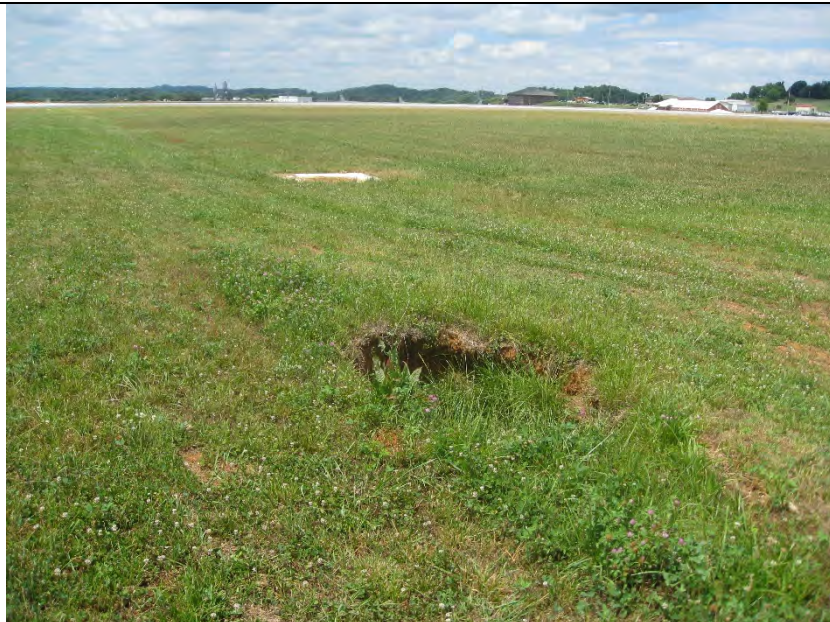
Photo 59  
Sta. 338+02 RT  
(RW 5L-23R)  
Structure 206  
Project 4

Structure 206.

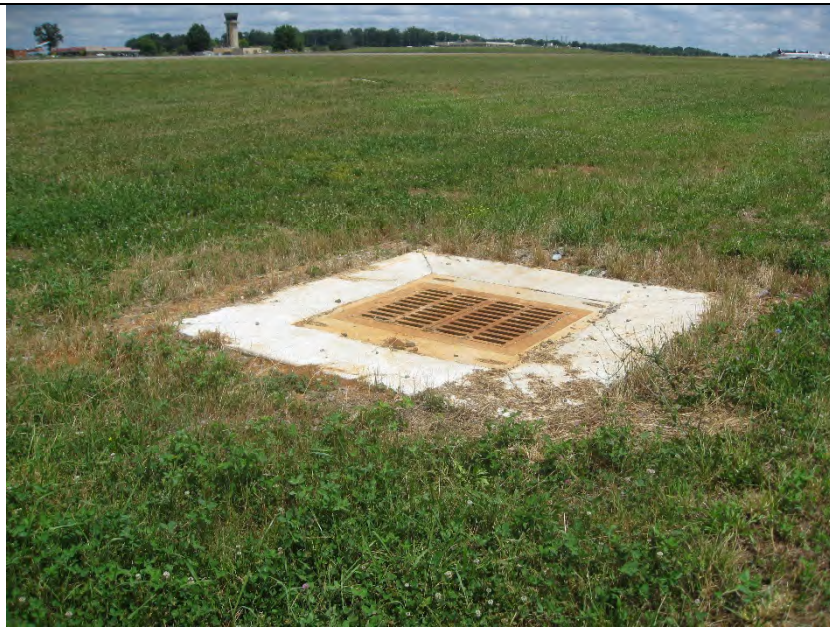
Photo 60  
(RW 5L-23R)  
Project 4

Construction fallout on Storm Line 2 between structures 206 and 208.  
Recommend coordinating remediation with CHA.

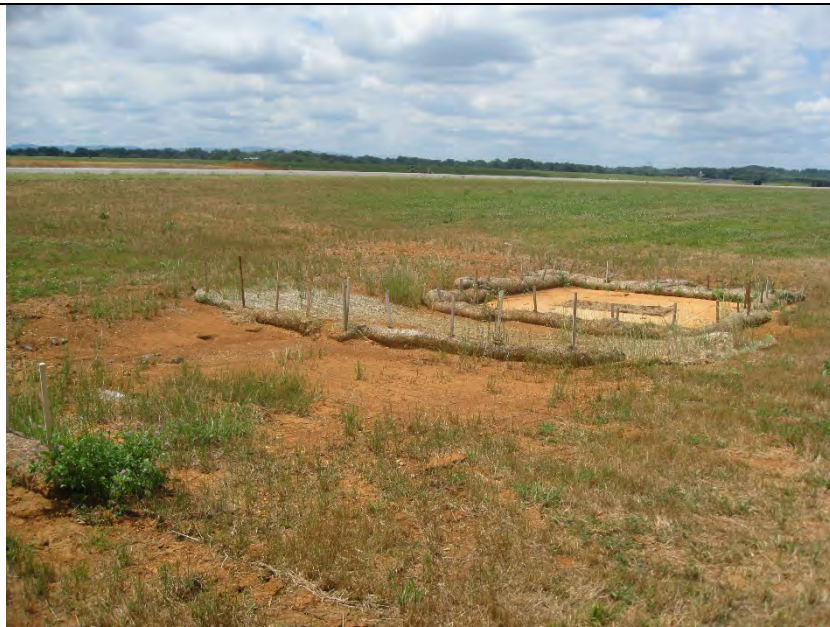
Photo 62  
Sta. 329+86 RT  
(RW 5L-23R)  
Structure 210  
Project 3

Structure 210.  
Recommend stabilizing bare areas above sediment tubes.

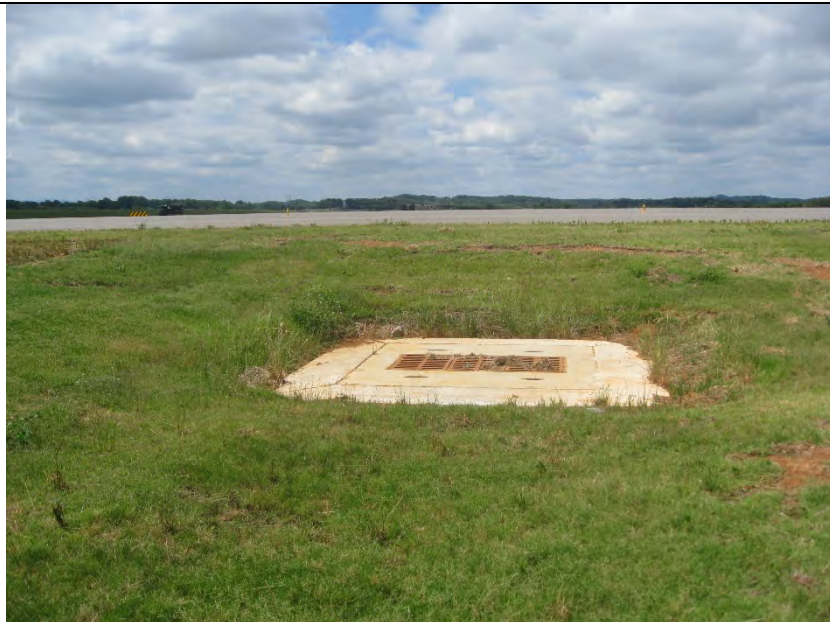
Photo 63  
Sta. 321+73 RT  
(RW 5L-23R)  
Structure 212  
Project 3

Structure 212.  
Sediment removed from top of structure.  
Erosion blanket recently installed.

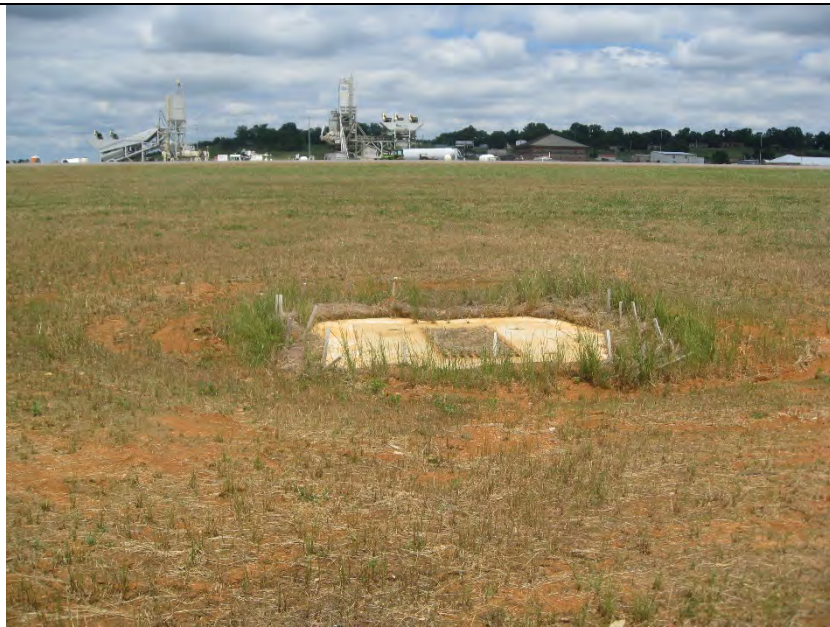
Photo 64  
Sta. 314+32 RT  
(RW 5L-23R)  
Structure 214  
Project 3

Structure 214.

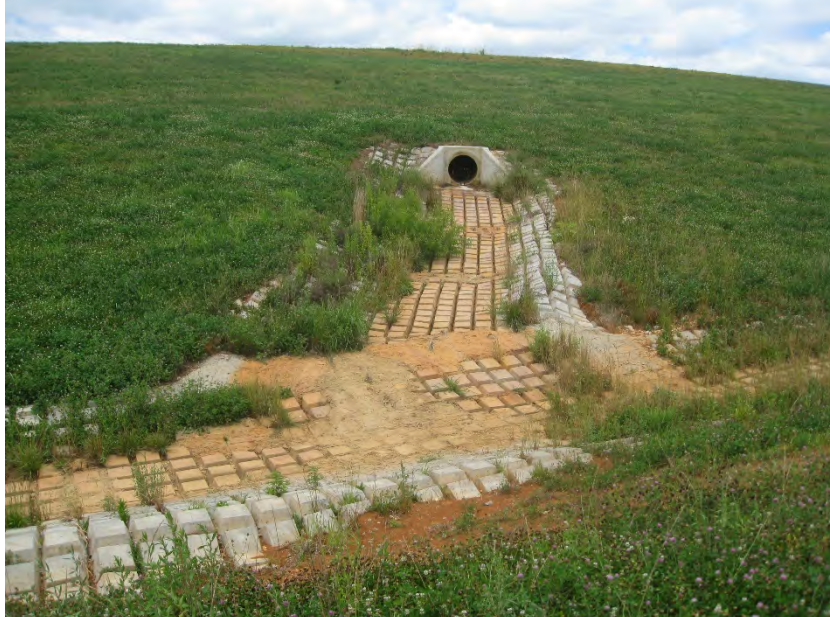
Photo 67  
Sta. 296+83 RT  
(RW 5L-23R)  
Structure 220  
Project 2

Structure 220.  
Recommend stabilizing remaining bare areas.

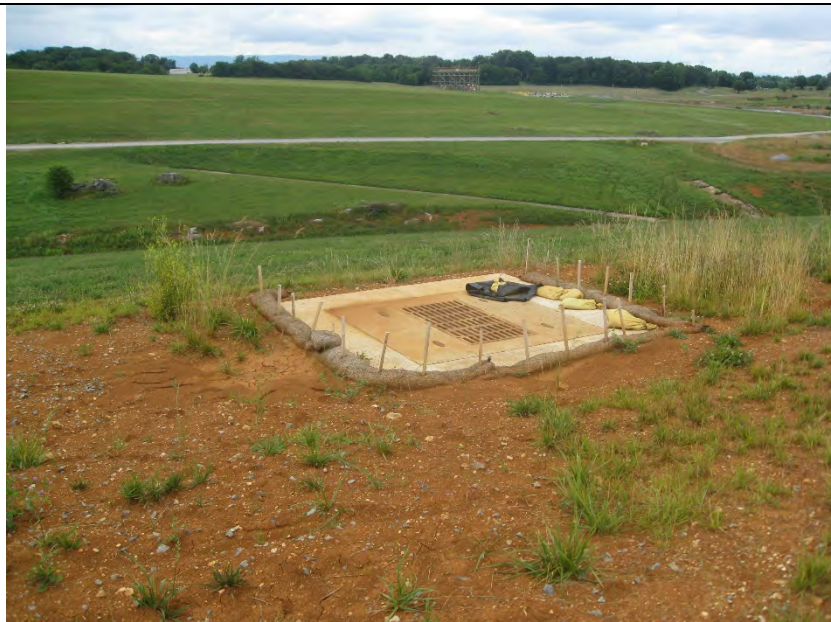
Photo 69  
Sta. 290+26 RT  
(RW 5L-23R)  
Structure 600 Ditch  
Project 2

Structure 600 Ditch.  
Ditch recently regraded and sod applied.  
Recommend stabilizing remaining bare areas.

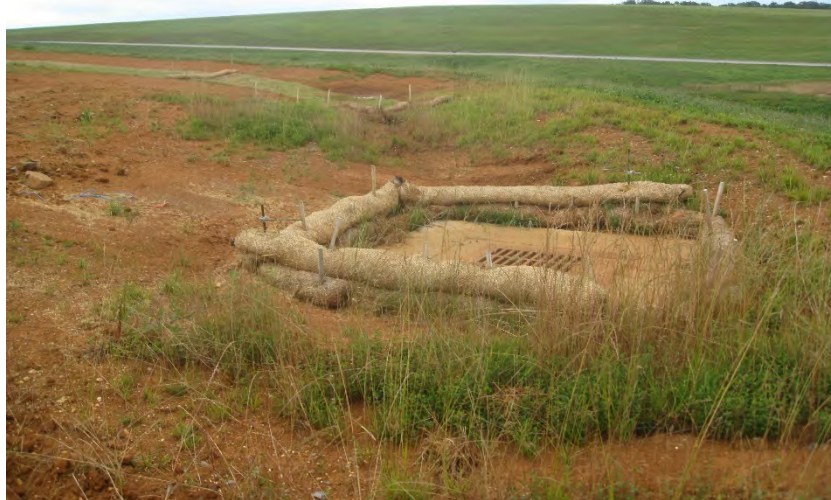
Photo 72  
Sta. 290+26 RT  
(RW 5L-23R)  
Structure 600 Ditch  
Project 2

Structure 600 ditch.  
Recommend stabilizing bare areas.

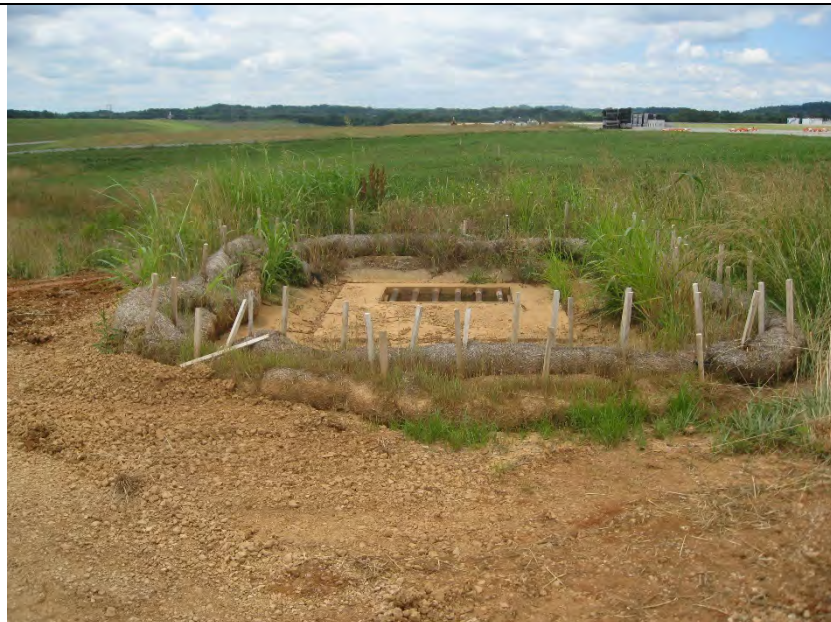
Photo 73  
Sta. 284+59  
(RW 5L-23R)  
Structure 600  
Project 3

Structure 600.  
Recommend stabilizing bare areas.
