**QUALITY ASSURANCE  
MONTHLY SITE  
ASSESSMENT REPORT**

Airfield Modernization Program  
Runway 5L-23R Reconstruction  
Project 2 / Project 3

## QUALITY ASSURANCE SITE ASSESSMENT

## **AIRFIELD MODERNIZATION PROGRAM RUNWAY 5L-23R RECONSTRUCTION**

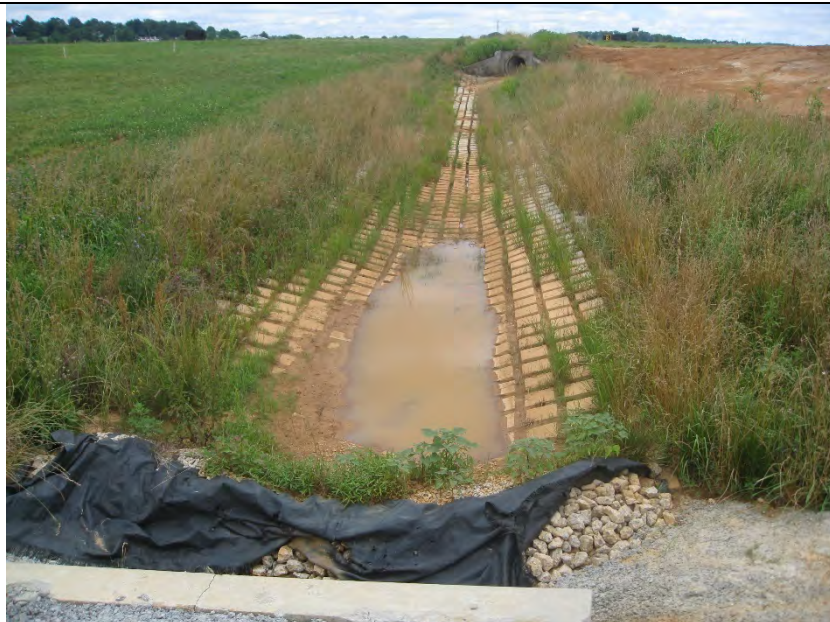
Photo 77  
(RW 5L-23R)  
Project 3

Grading operations recently taken place at existing crushing operations area.  
Recommend adding silt fence on contour and stabilizing bare areas.

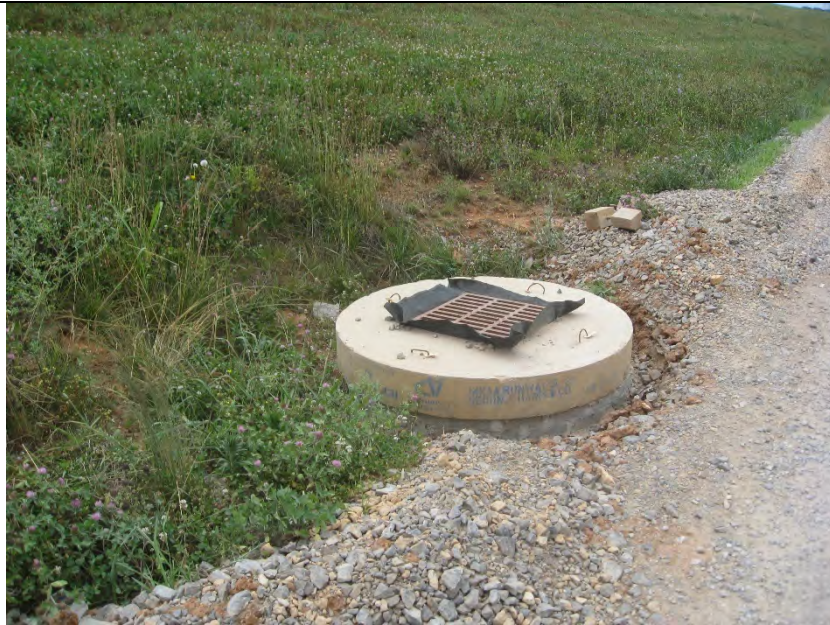
Photo 80  
Sta. 37+25 RT  
Proposed Haul Route  
Project 3

Inlet structures along haul road.  
Structures undergoing reconstruction into traditional man holes at time of inspection.

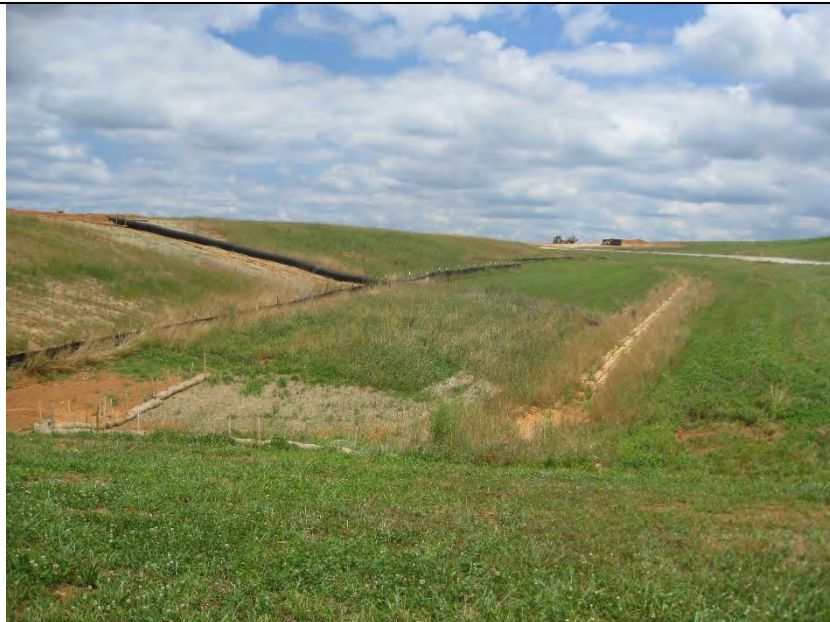
Photo 83  
Sta. 302+54  
(RW 5L-23R)  
Project 2

Soil stockpile area next to haul road at Taxiway B.  
Additional sediment tubes recently installed.  
Recommend stabilizing bare areas.

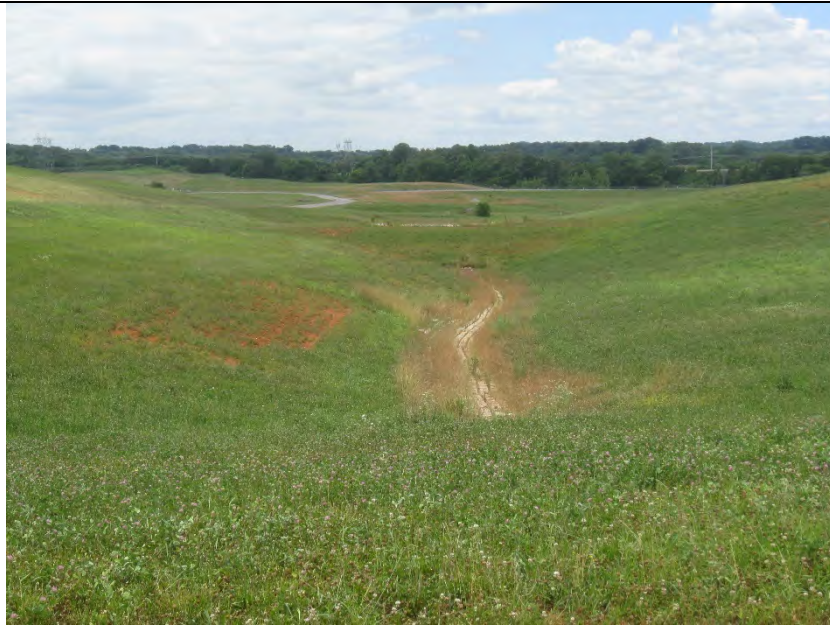
Photo 84  
Sta. 302+54 to Sta. 313+50  
(RW 5L-23R)  
Project 2

North Lateral Endwall 100.  
Erosion control blanket and sediment tubes recently added.  
Recommend stabilizing bare areas.

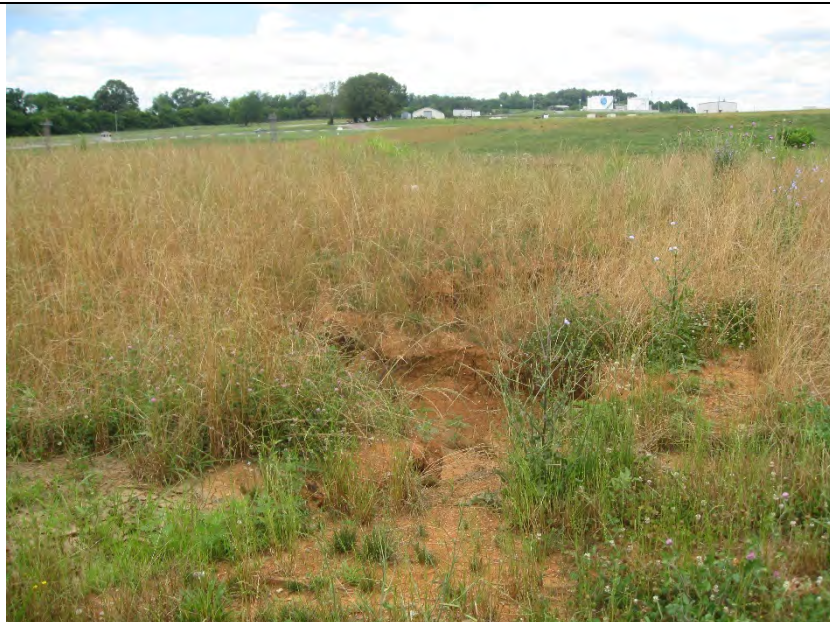
Photo 95  
Sta. 284+00 LT  
(RW 5L-23R)  
Project 2

Existing vault at old Liberty street.  
Construction fallout present. Recommend coordinating with CHA on remediation.

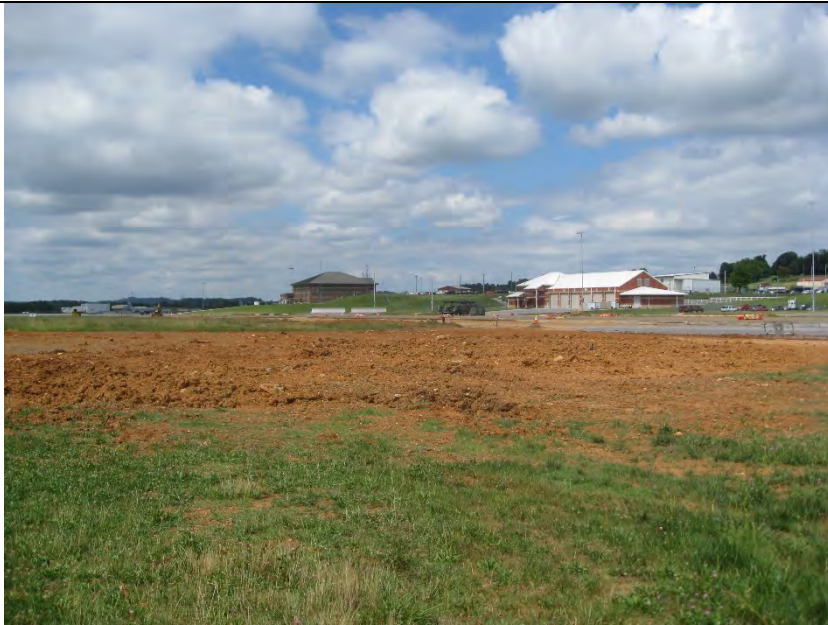
Photo 98  
(Repair TWY Lighting)  
Sheet EC2.1.7

Existing structure at Upper Apron.  
Base stone recently installed. Area appears to be stable.  
Recommend continuing to monitor for possible sediment migration and/or color contrasted water entering apron storm structures.

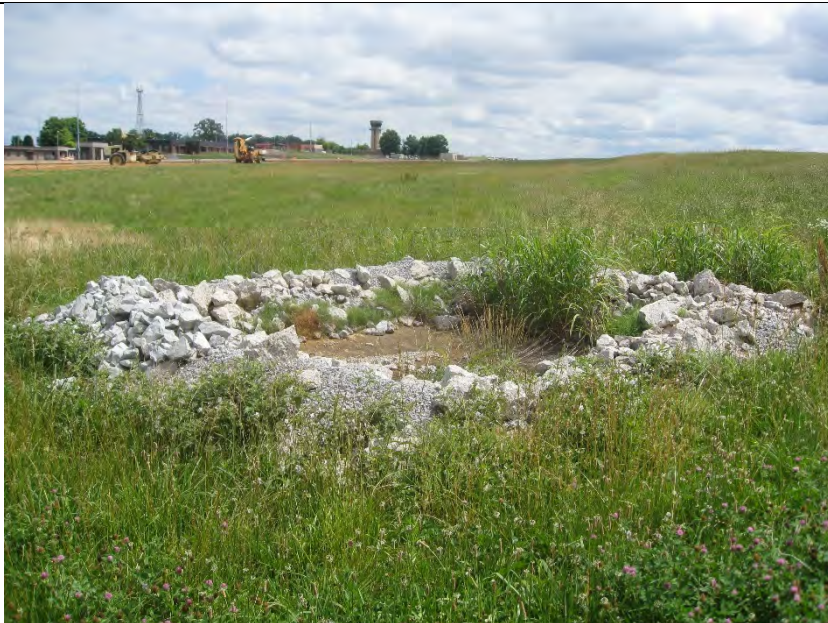
Photo 99  
(Repair TWY Lighting)  
Sheet EC2.1.6

Existing remaining Taxiway G4 recently demolished.  
Trench drain recently demolished.

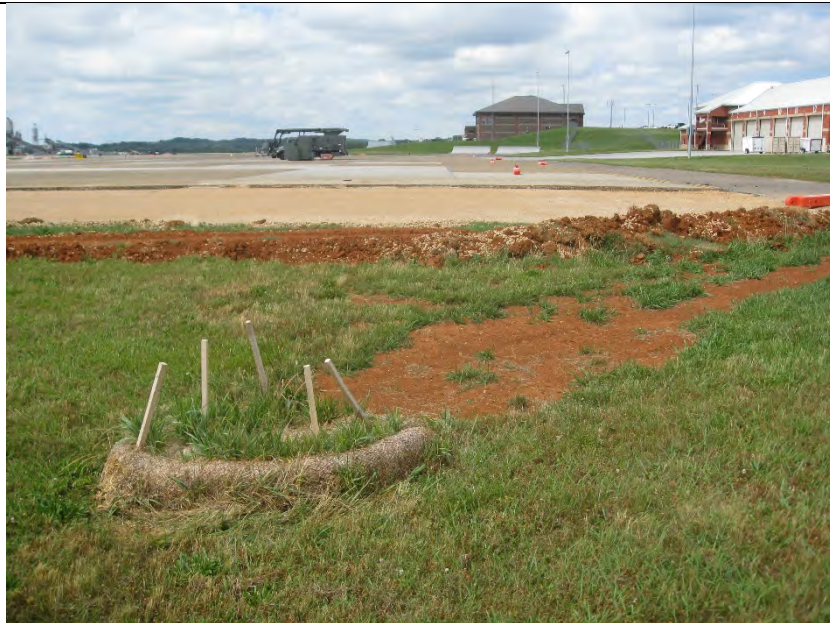
Photo 101  
(Repair TWY Lighting)  
Sheet EC2.1.5

Existing structure at Upper Apron.  
Newly installed underdrain recently backfilled and sediment tubes reinstalled.
