**QUALITY ASSURANCE
MONTHLY SITE
ASSESSMENT REPORT**

Airfield Modernization Program
Runway 5L-23R Reconstruction
Project 2 / Project 3

NPDES TN0081868 (Individual)
NPDES TNR134734 (General)

AIRFIELD MODERNIZATION PROGRAM RUNWAY 5L-23R RECONSTRUCTION

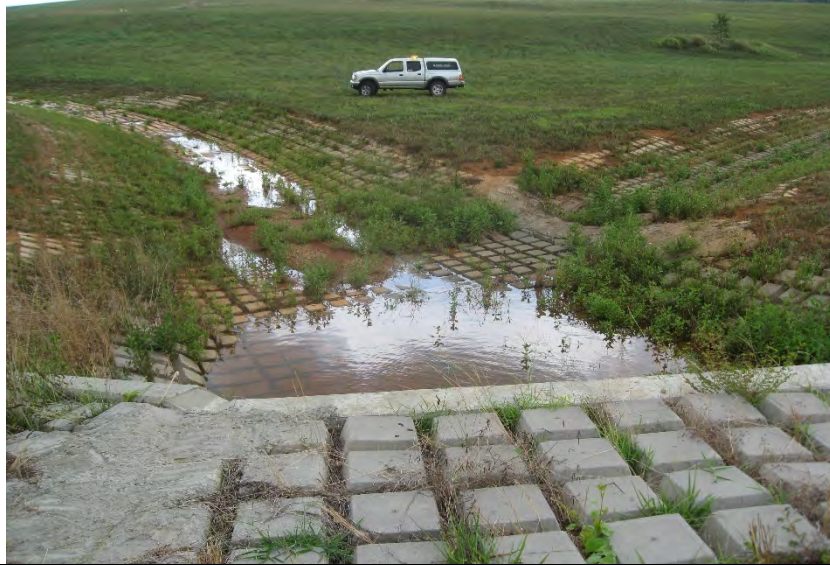
Photo 1
Sta. 111+56 RT
(Line LB)
NLET 01
Project 2

North Lateral End Treatment 01 (Outfall A).
Clear flow observed.

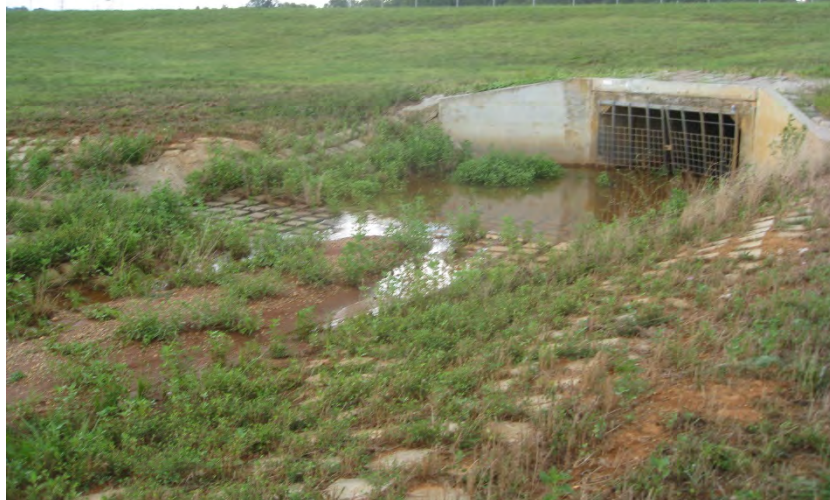
Photo 2
Sta. 111+56 RT
(Line LB)
NLET 01
Project 2

North Lateral End Treatment 01 (Outfall A).
Clear flow observed.

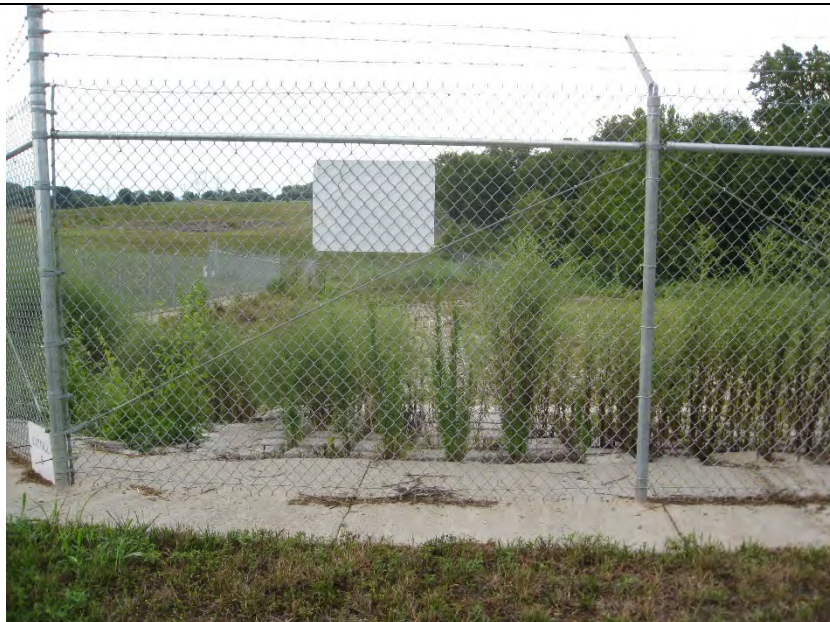
Photo 4
Sta. 114+00
(Line LB)
Project 2

Guard Lateral End Treatment 02.
This section of the site was inaccessible at time of inspection.

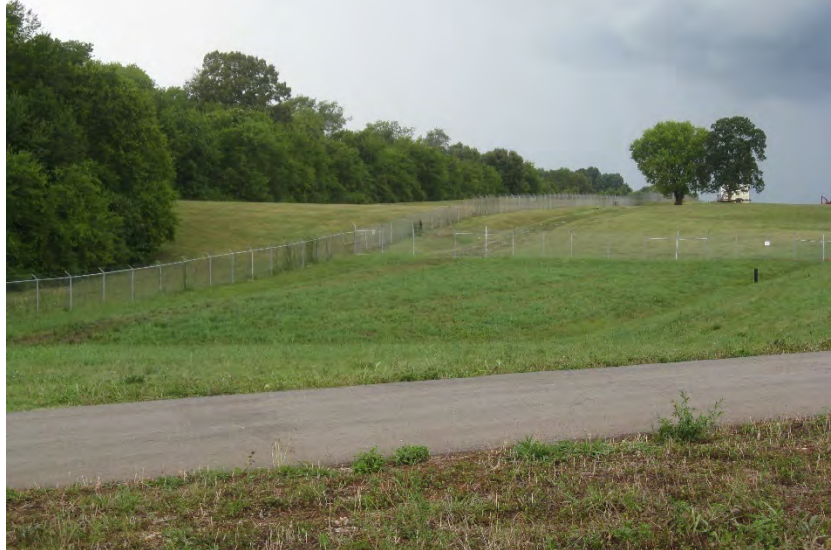
Photo 5
Sta. 115+28 to Sta. 121+45
(Line LB)
Project 2

Grass established at ditch line along Liberty Street.

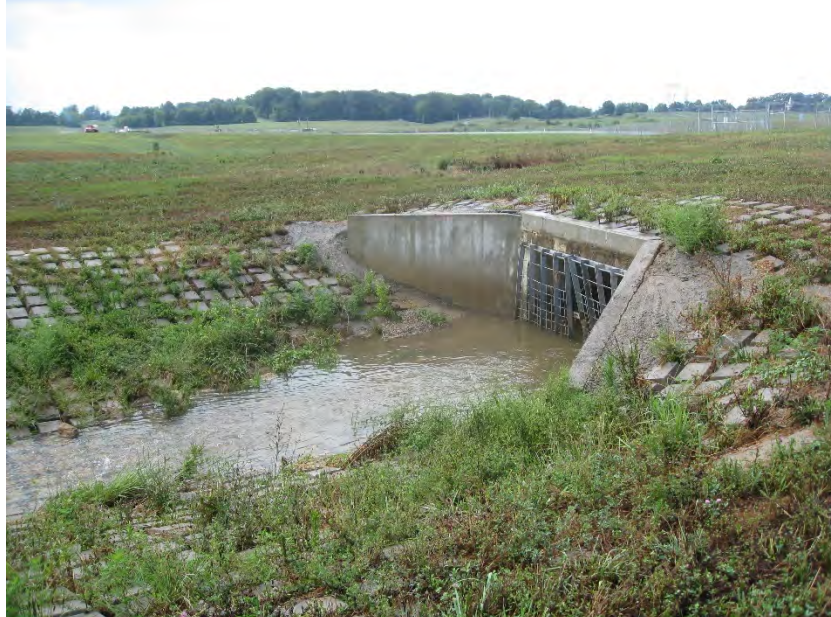
Photo 6
Sta. 117+00
(Line LB)
Project 2

Guard Lateral Ditch (Outfall B).
Clear flow observed.

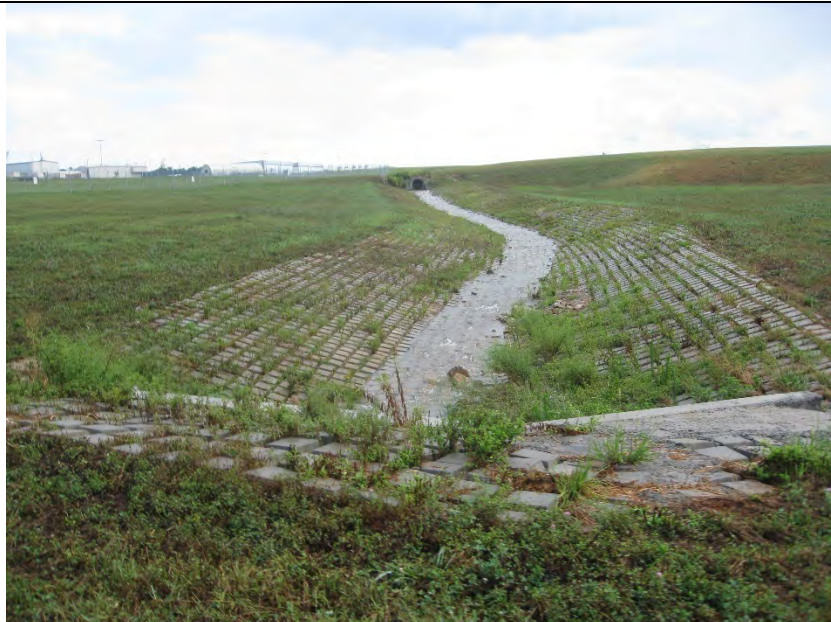
Photo 8
Sta. 117+00
(Line LB)
Project 2

Guard Lateral Ditch (Outfall B).
Clear flow observed.

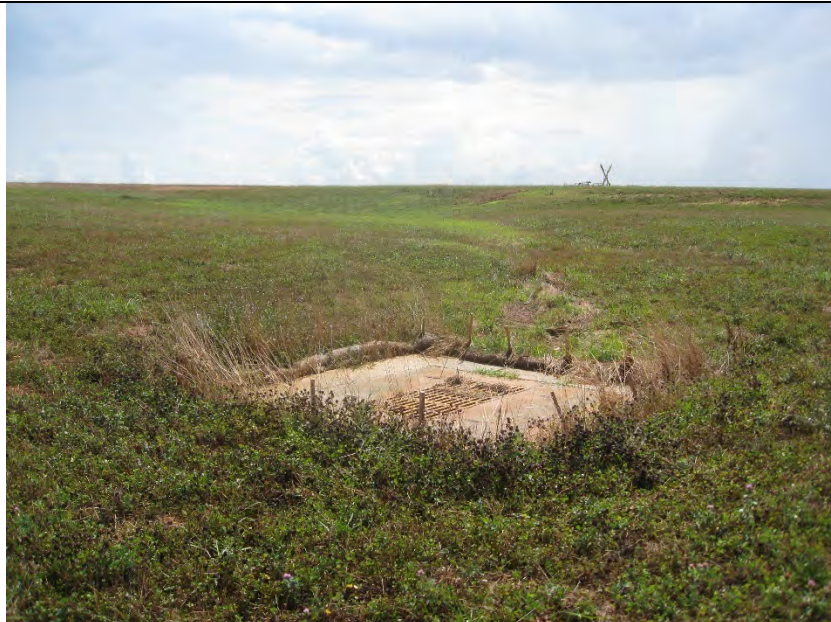
Photo 12
Sta. 291+51 LT
(RW 5L-23R)
Structure 120
Project 3

Structure 120.

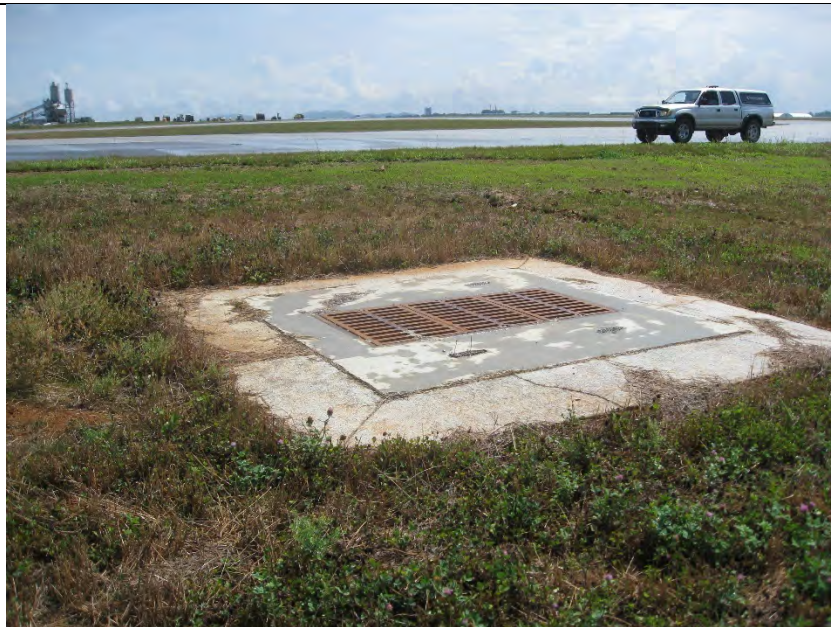
Photo 13
Sta. 294+31 LT
(RW 5L-23R)
Structure 118
Project 3

Structure 118.

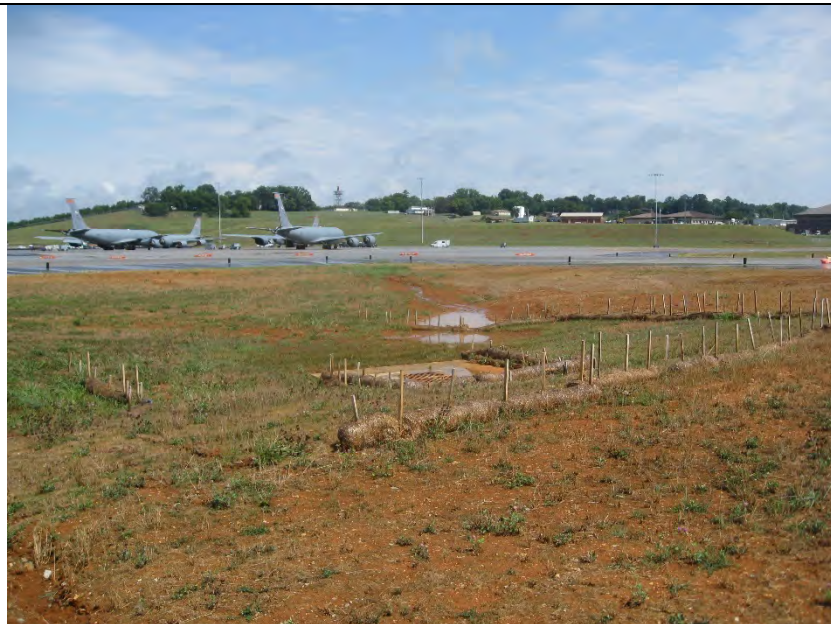
Photo 14
Sta. 298+71 LT
(RW 5L-23R)
Structure 116
Project 3

Structure 116.
Recommend stabilizing bare areas and repairing rills (see photos #15 and #16 below).

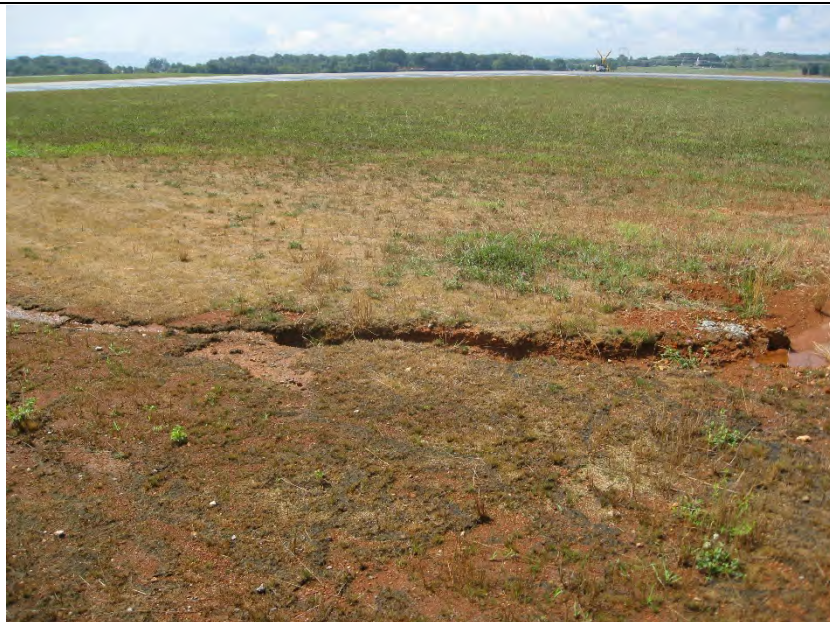
Photo 16
Sta. 298+71 LT
(RW 5L-23R)
Structure 116
Project 3

Above Structure 116 on Taxiway G2.
Recommend repairing rills and stabilizing bare areas.

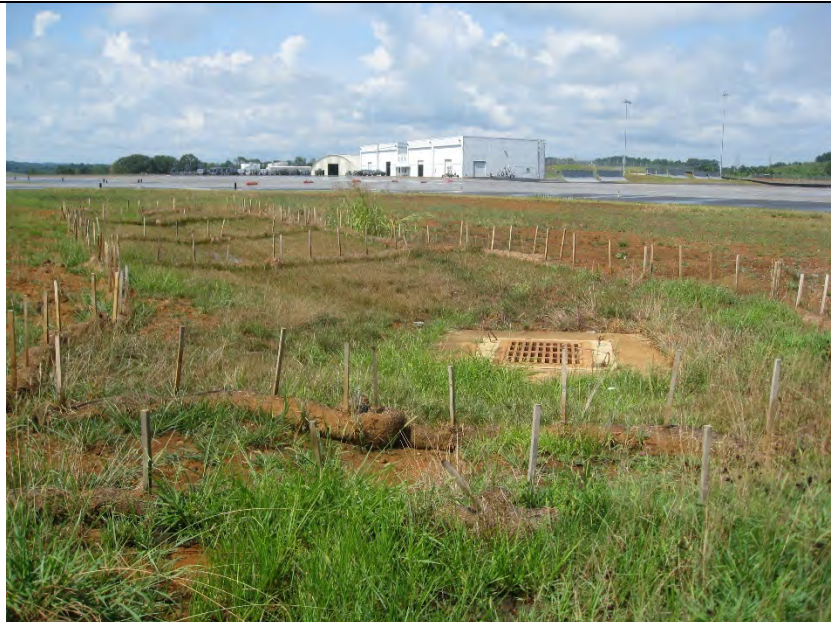
Photo 18
Sta. 303+36 LT
(RW 5L-23R)
Structure 12
Project 3

Structure 12.

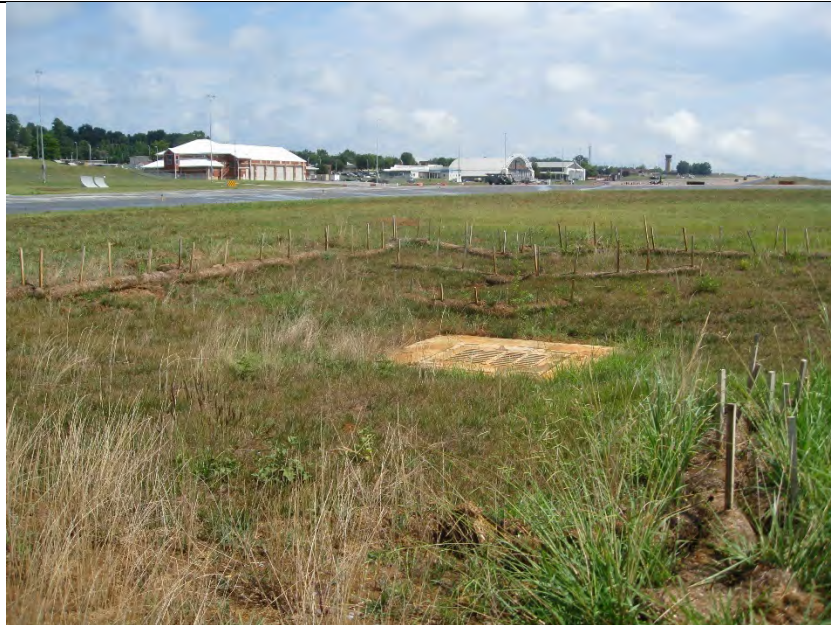
Photo 19
Sta. 310+04 LT
(RW 5L-23R)
Structure 10
Project 3

Structure 10.
Bare areas recently stabilized.

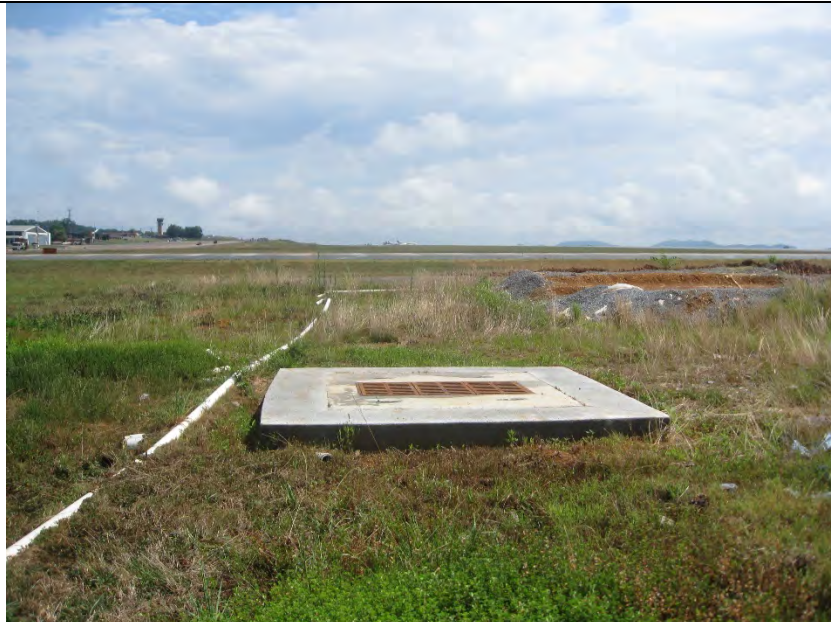
Photo 20
Sta. 310+00 LT
(RW 5L-23R)
Project 3

Structure 112 and Concrete Washout Area.

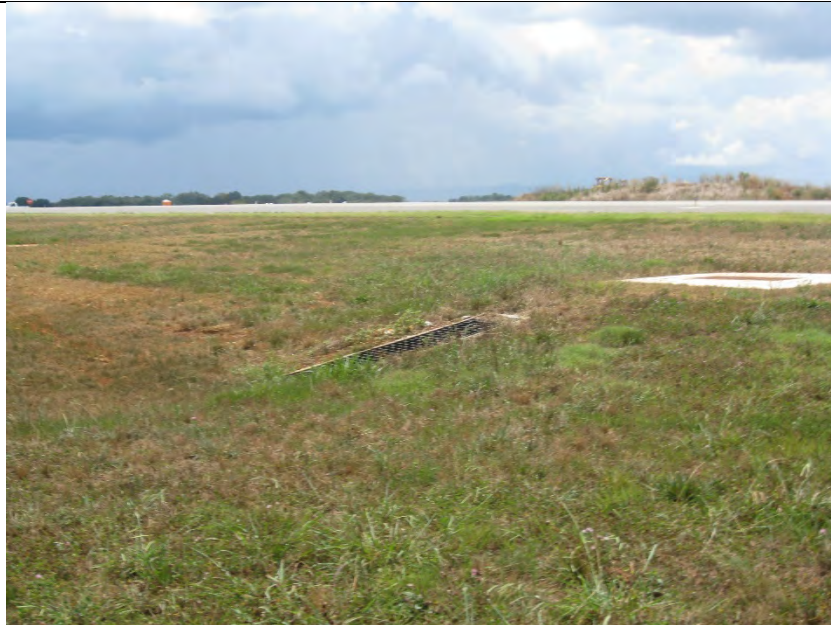
Photo 21
Sta. 314+48 LT
(RW 5L-23R)
ES Endwall 108
Project 3

Enhanced Swale Endwall 108.
Recommend stabilizing remaining bare areas.

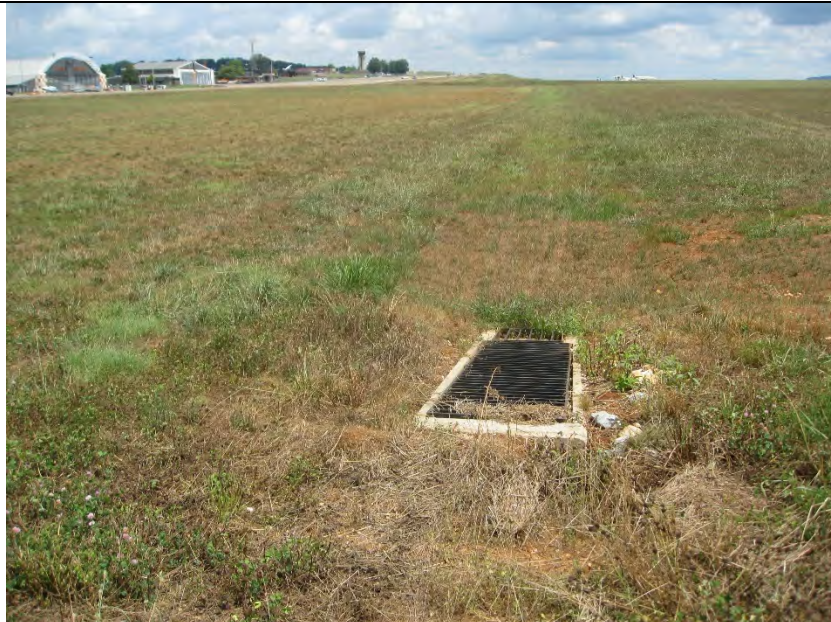
Photo 22
Sta. 314+48 LT
(RW 5L-23R)
ES Endwall 108
Project 3

Enhanced Swale Endwall 108.
Recommend stabilizing remaining bare areas.

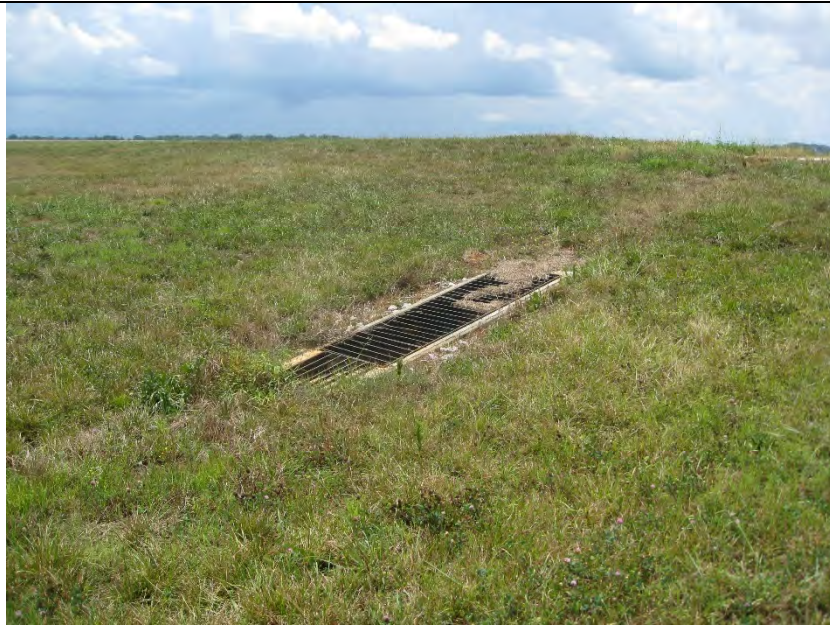
Photo 23
Sta. 324+86 LT
(RW 5L-23R)
ES Endwall 106
Project 3

Enhanced Swale Endwall 106.

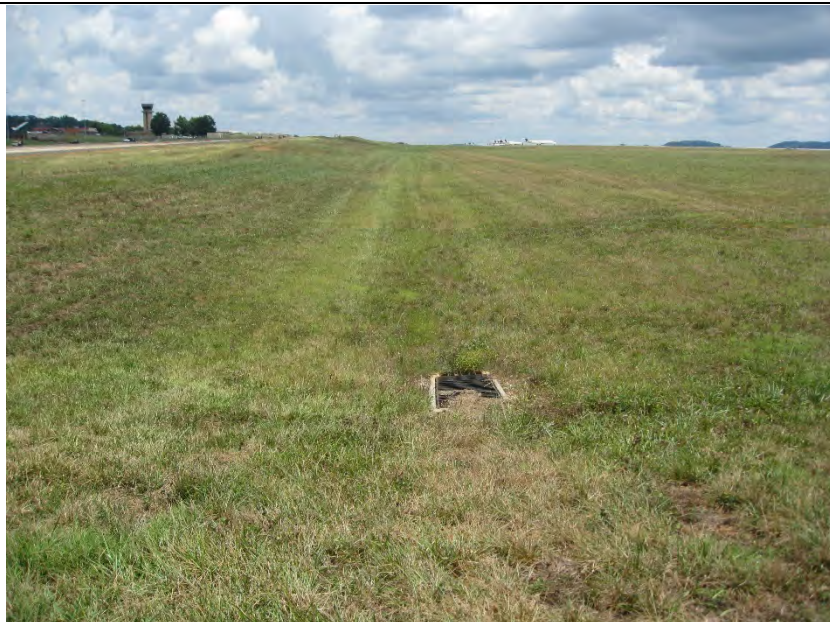
Photo 24
Sta. 324+86 to Sta. 335+73 LT
(RW 5L-23R)
ES Endwall 106
Project 3

Enhanced Swale Endwall 106.

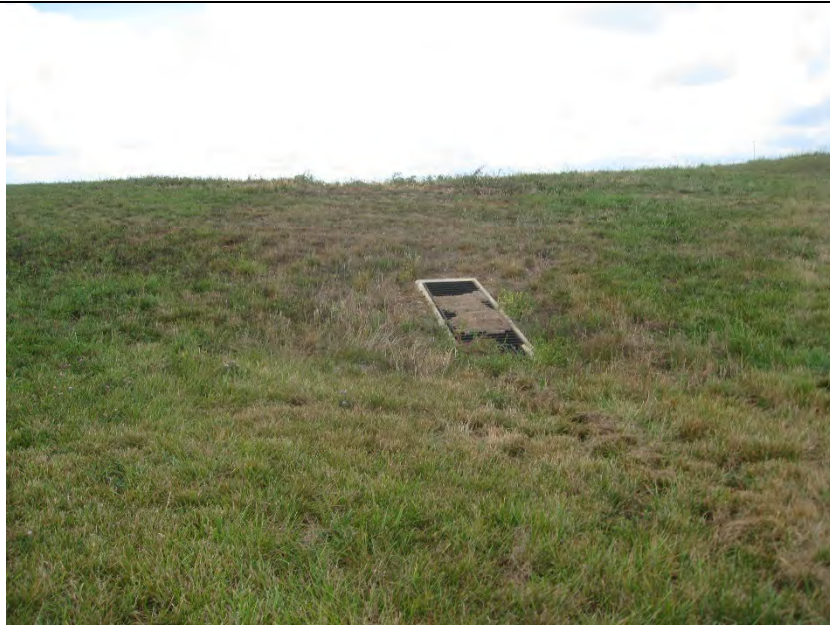
Photo 25
Sta. 335+73 LT
(RW 5L-23R)
ES Endwall 104
Project 3

Enhanced Swale Endwall 104.

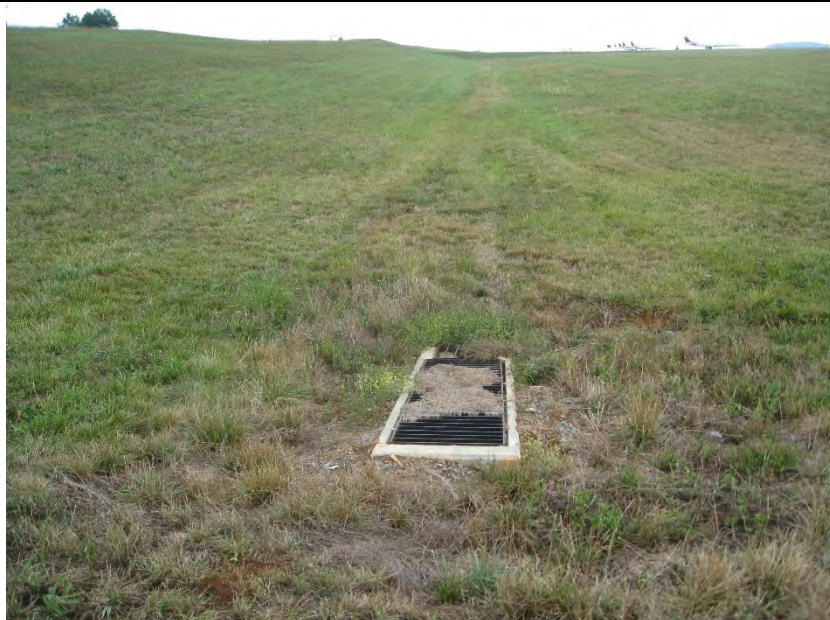
Photo 26
Sta. 335+73 LT
(RW 5L-23R)
ES Endwall 104
Project 3

Enhanced Swale Endwall 104.

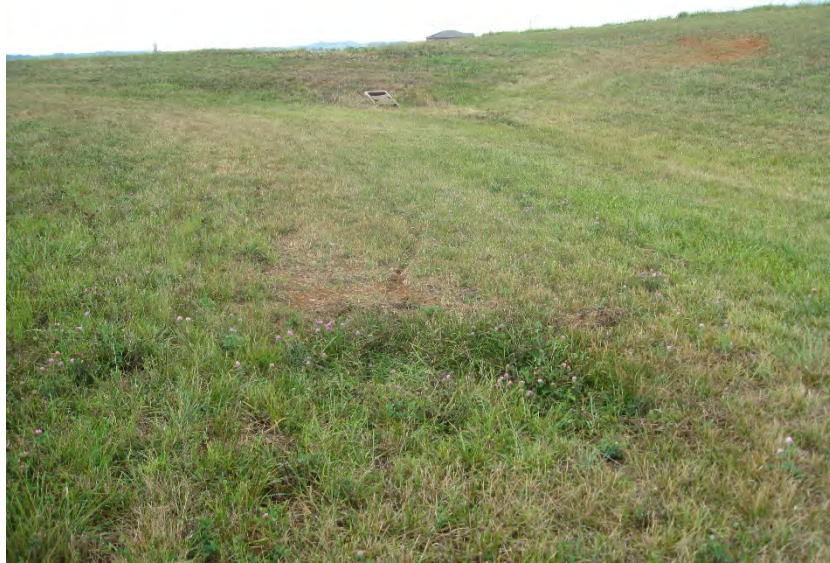
Photo 27
 Sta. 341+50 LT
 (RW 5L-23R)
 Between ES Endwall 104 and 102
 Project 3

First potential construction fallout on Storm Line 1 between ES Endwall 104 and 102.

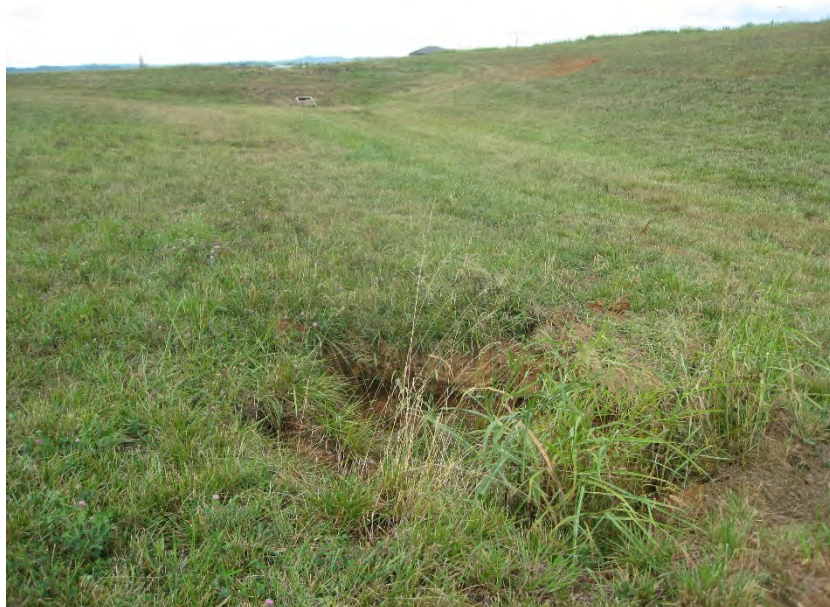
Photo 28
 Sta. 341+50 LT
 (RW 5L-23R)
 Between ES Endwall 104 and 102
 Project 3

Second construction fallout on Storm Line 1 between ES Endwall 104 and 102.
 Coordinate remediation with CHA.

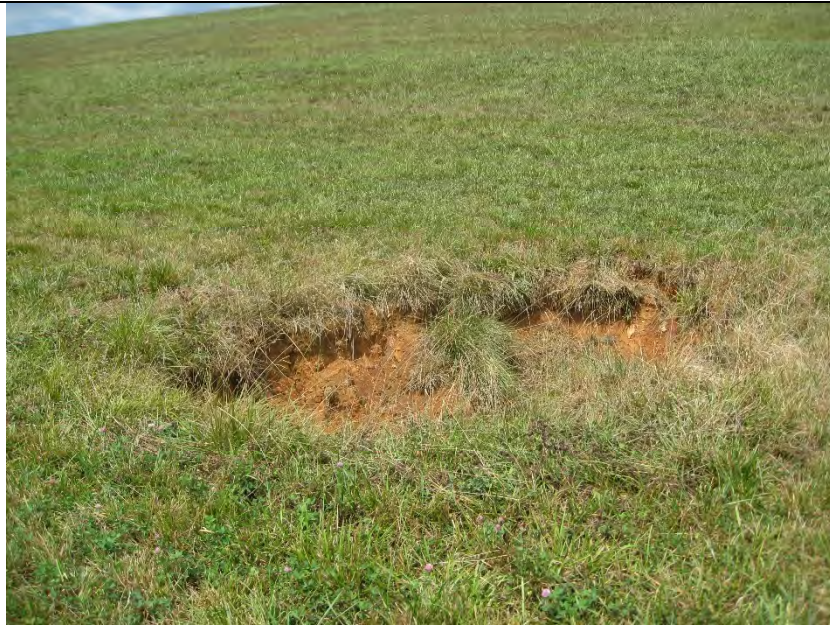
Photo 29
Sta. 341+50 LT
(RW 5L-23R)
Between ES Endwall 104 and 102
Project 3

Third construction fallout on Storm Line 1 between ES Endwall 104 and 102.
Coordinate remediation with CHA.

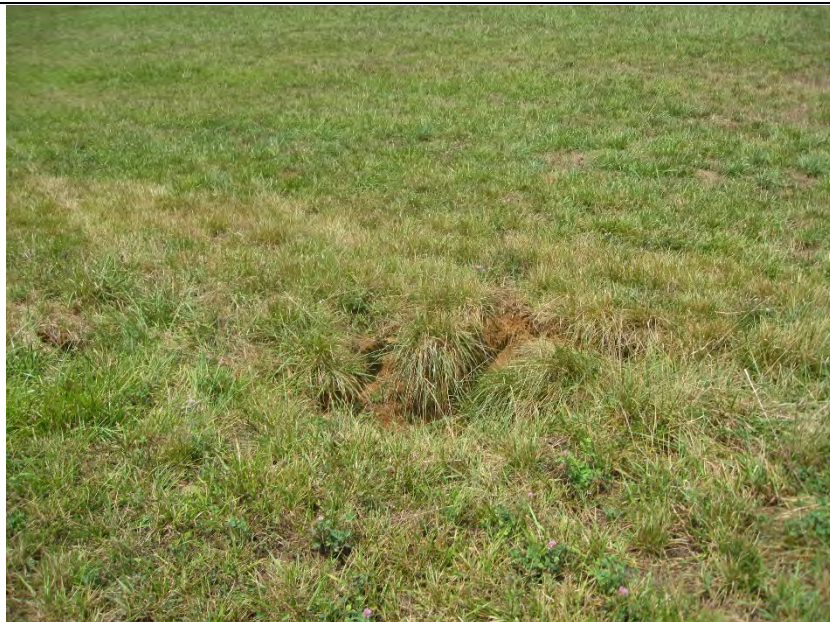
Photo 30
Sta. 341+50 LT
(RW 5L-23R)
Between ES Endwall 104 and 102
Project 3

Fourth construction fallout on Storm Line 1 between ES Endwall 104 and 102.
Coordinate remediation with CHA.

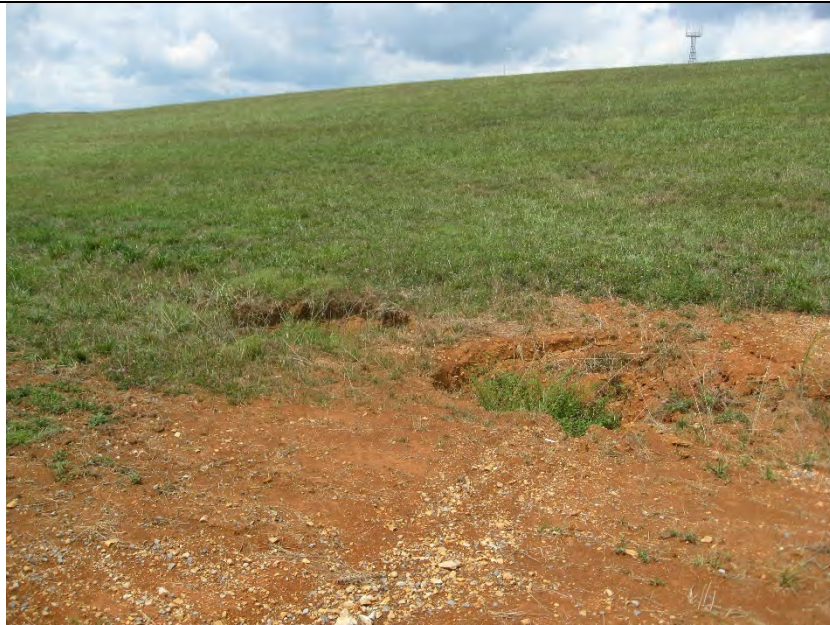
Photo 31
Sta. 341+50 LT
(RW 5L-23R)
Between ES Endwall 104 and 102
Project 3

Fifth construction fallout on Storm Line 1 between ES Endwall 104 and 102.
Coordinate remediation with CHA.

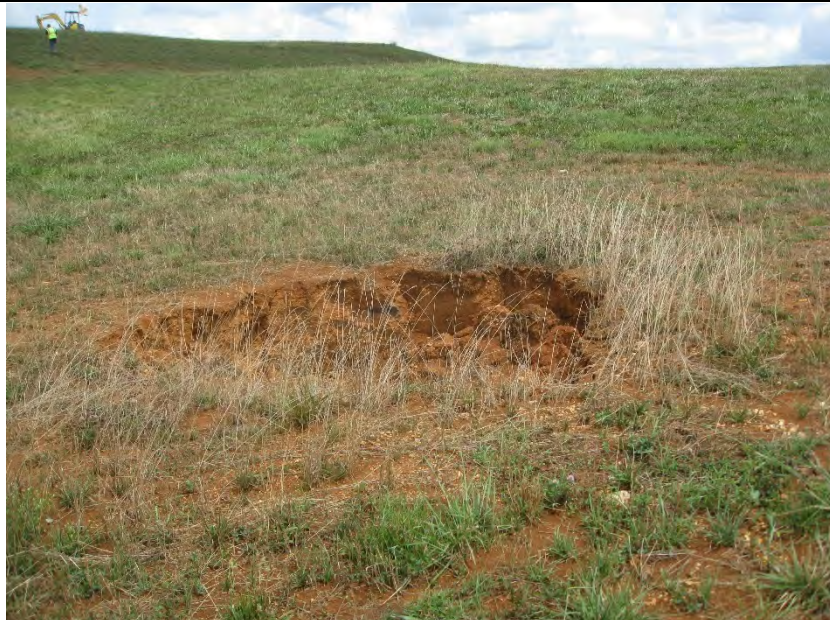
Photo 32
Sta. 341+50 LT
(RW 5L-23R)
Between ES Endwall 104 and 102
Project 3

Sixth construction fallout on Storm Line 1 between ES Endwall 104 and 102.
Coordinate remediation with CHA.

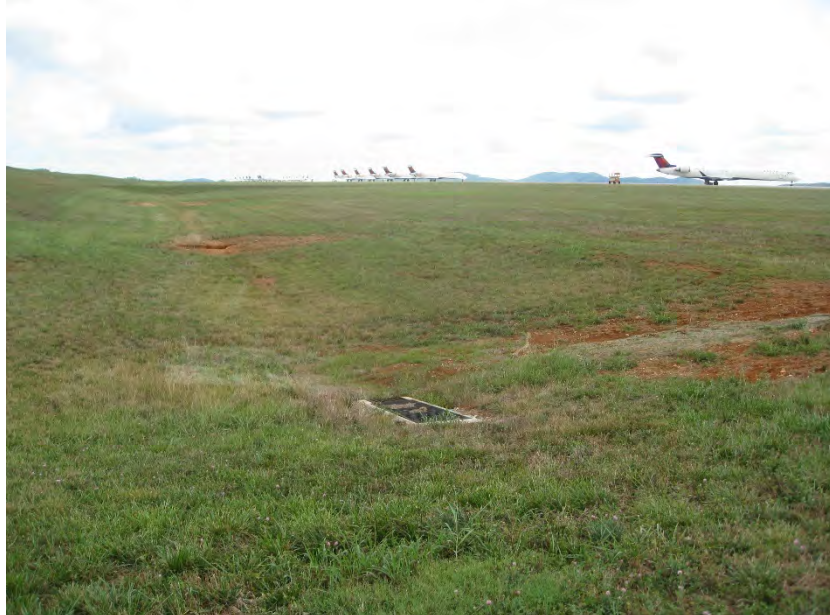
Photo 34
Sta. 347+31 LT
(RW 5L-23R)
ES Endwall 102
Project 3

Enhanced Swale Endwall 102.
Recommend stabilizing remaining bare areas.

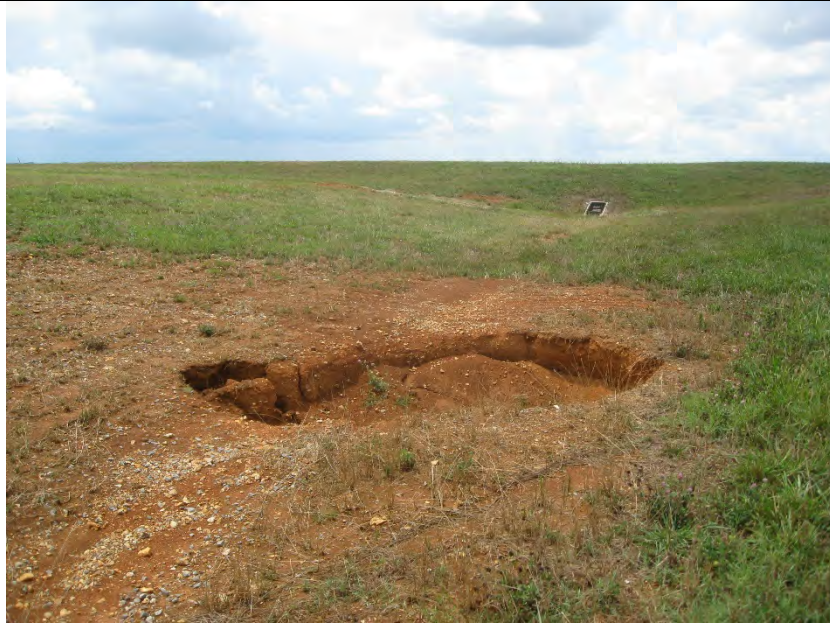
Photo 35
Sta. 341+50 LT
(RW 5L-23R)
ES Endwall 102
Project 3

Seventh construction fallout on Storm Line 1 between ES Endwall 102 and 100.
Coordinate remediation with CHA.

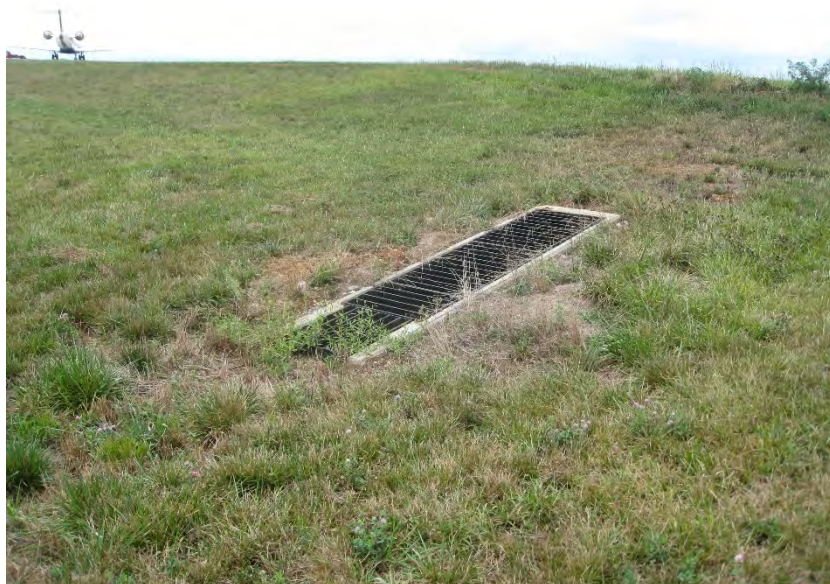
Photo 36
Sta. 354+75 LT
(RW 5L-23R)
ES Endwall 100
Project 2

Enhanced Swale Endwall 100.

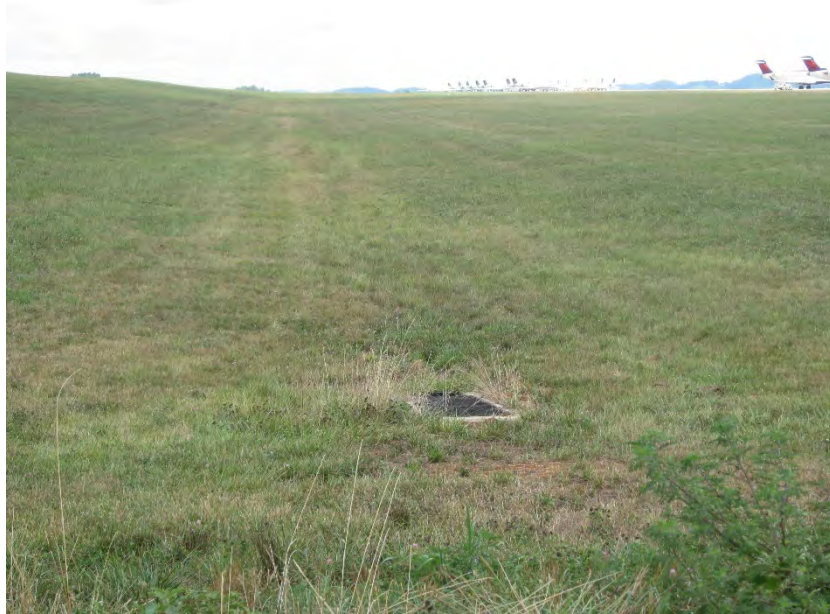
Photo 37
Sta. 354+75 LT
(RW 5L-23R)
ES Endwall 100
Project 3

Enhanced Swale Endwall 100.

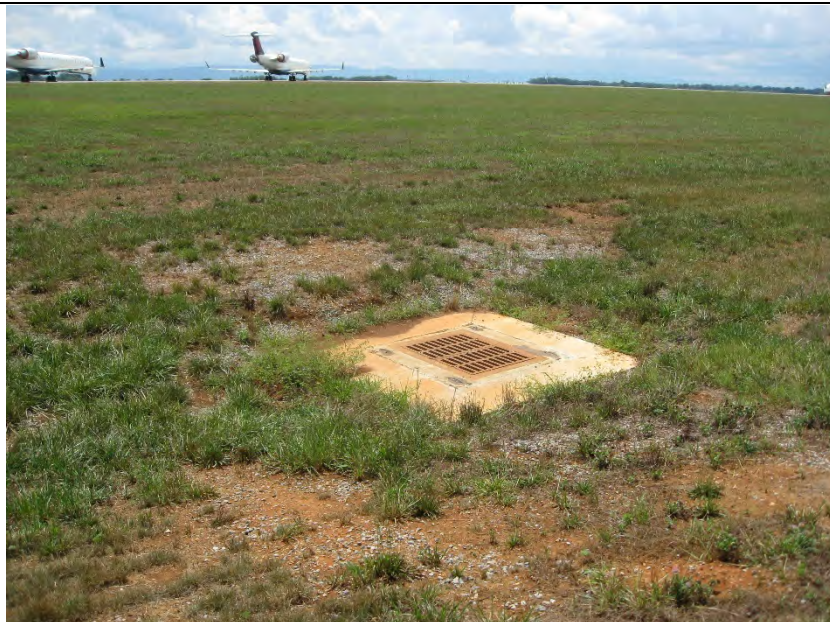
Photo 38
Sta. 361+39 LT
(RW 5L-23R)
Structure 100
Project 3

Structure 100.
Recommend stabilizing remaining bare areas.

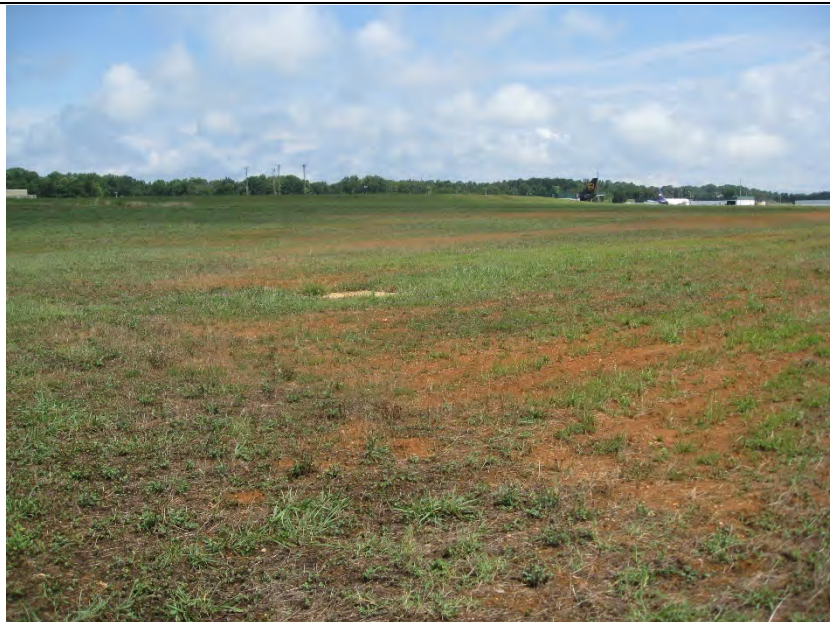
Photo 40
Sta. 366+25 LT
(RW 5L-23R)
Existing Structure
Project 2

Existing Structure.
Recommend stabilizing bare areas.

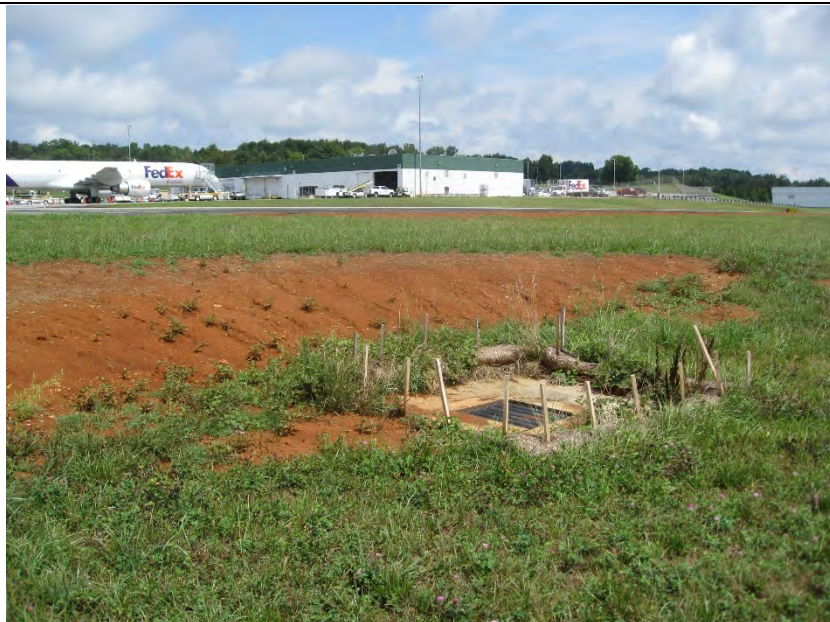
Photo 42
Sta. 677+00 RT
(RW 5L-23R)
Existing Structure
Project 4

Structure south of Taxiway "G".
Slopes started to rill after previous storm events. Sediment has migrated to structure.
Recommend repairing rills, removing accumulated sediment, and replacing sediment tubes.
Recommend stabilizing bare areas.

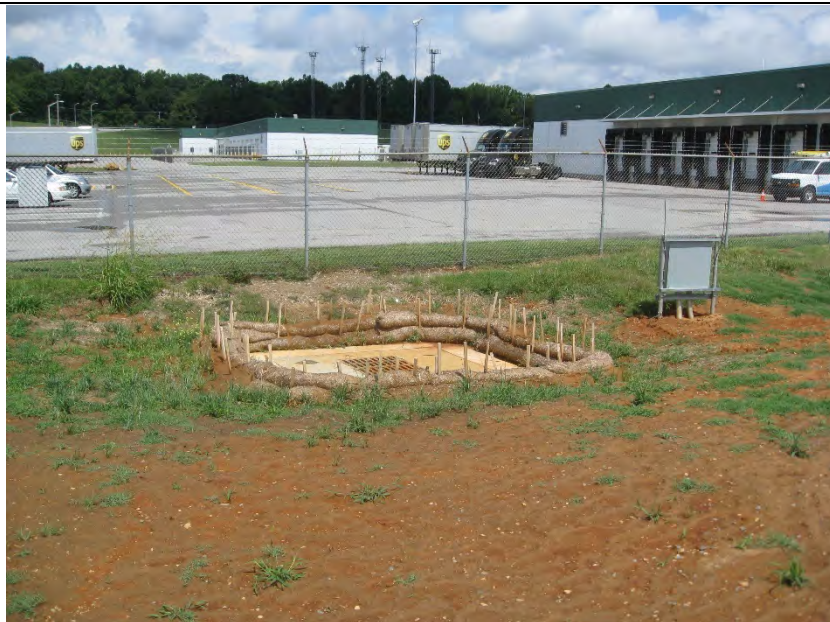
Photo 44
Sta. 676+00 RT
(RW 5L-23R)
Project 4

Storm structure adjacent to UPS.

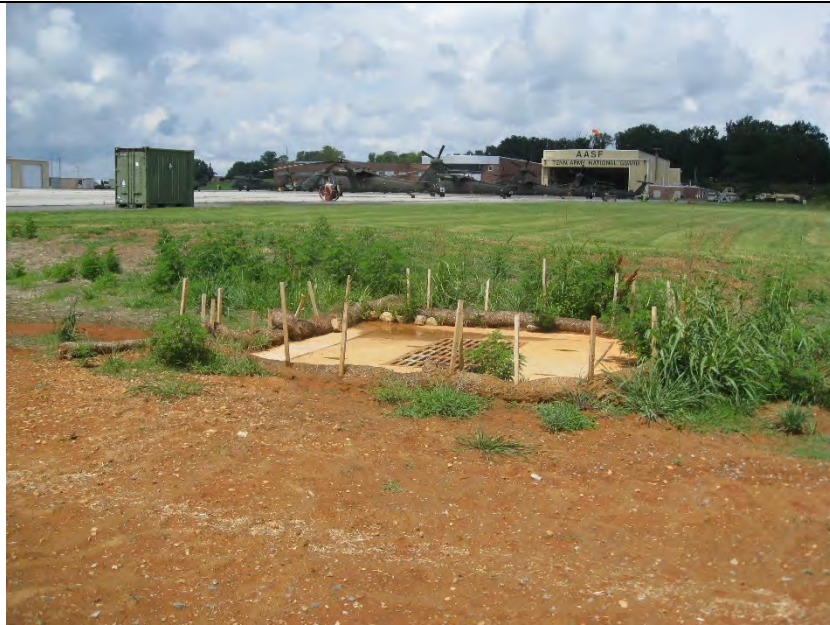
Photo 45
New structure
Project 4

New storm structure installed north of Taxiway G.

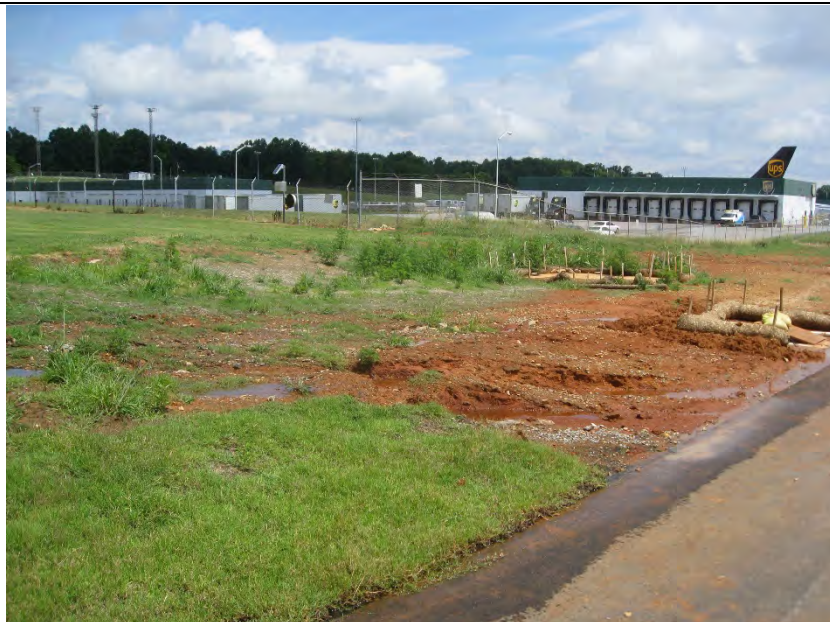
Photo 46
New structure
Project 4

Above new structure north of Taxiway G.
Erosion of shoulder has occurred and continues to erode.
Area to be regraded and stabilized per discussion at Progress Meeting on 07/30/2020.

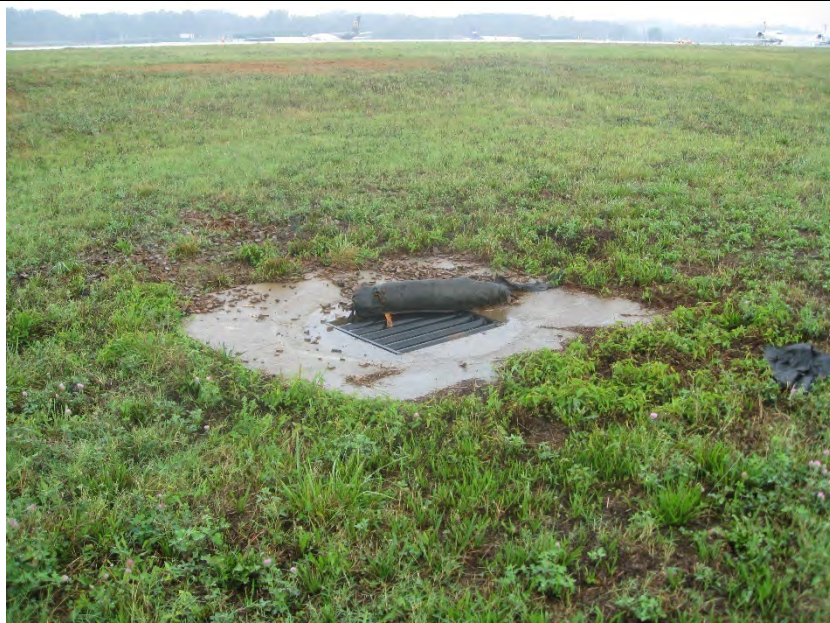
Photo 47
Sta. 366+89 RT
(RW 5L-23R)
Existing Structure
Project 4

Existing Structure adjacent to Outfall C.

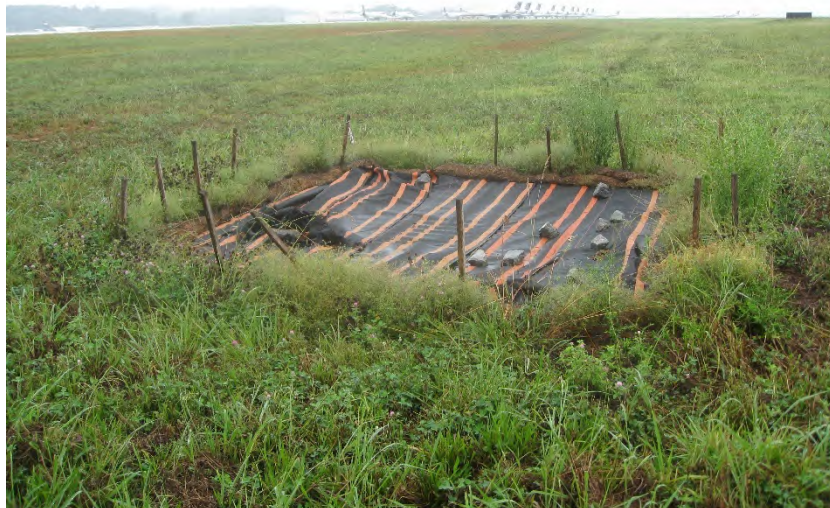
Photo 48
Sta. 366+89 RT
(RW 5L-23R)
Outfall C
Project 4

Recommend removing filter fabric from this structure to allow sampling for DMR.
(Outfall C).

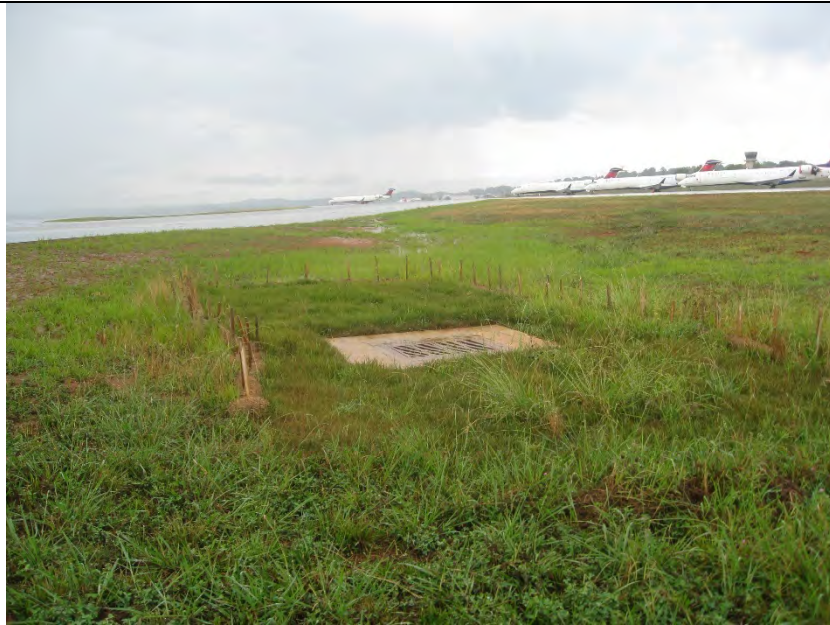
Photo 49
Sta. 365+69 RT
(RW 5L-23R)
Structure 300
Project 4

Structure 300

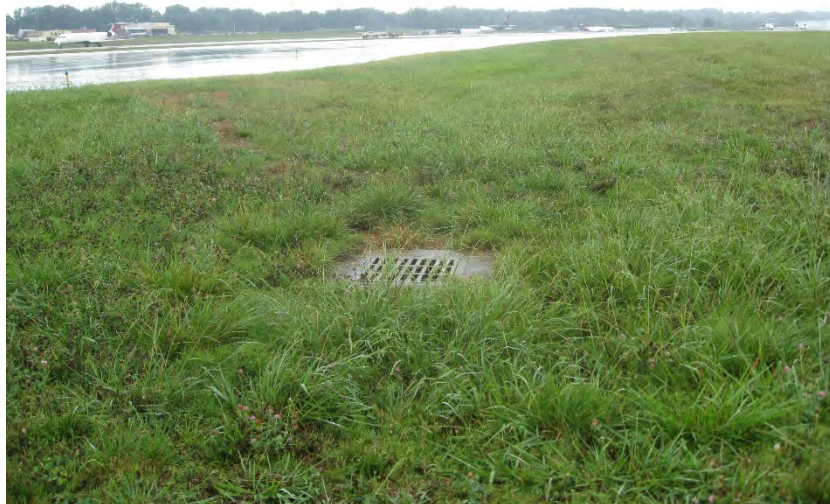
Photo 50
(RW 5L-23R)
TWY Y Tie-in
Project 4

Existing structure north of Taxiway Y.

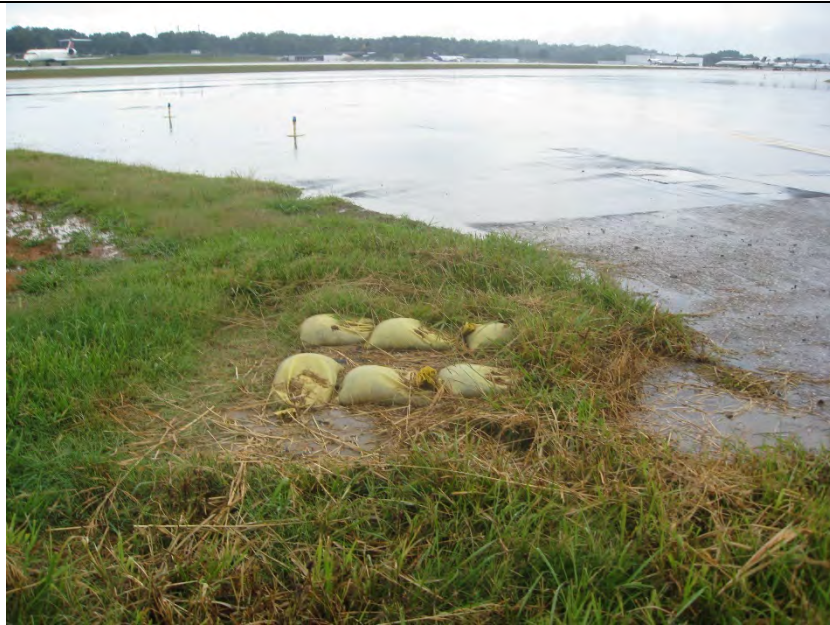
Photo 51
(RW 5L-23R)
TWY Y Tie-in
Project 4

Existing structure south of Taxiway Y.
Recommend removing inlet protection.

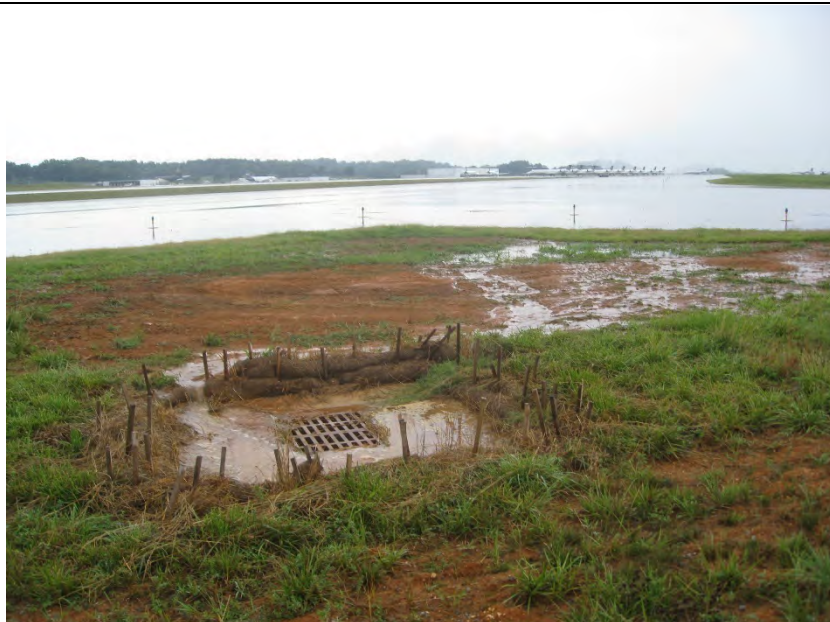
Photo 52
Sta. 362+02 LT
(RW 5L-23R)
Structure 400
Project 4

Structure 400.
Bare areas recently stabilized.

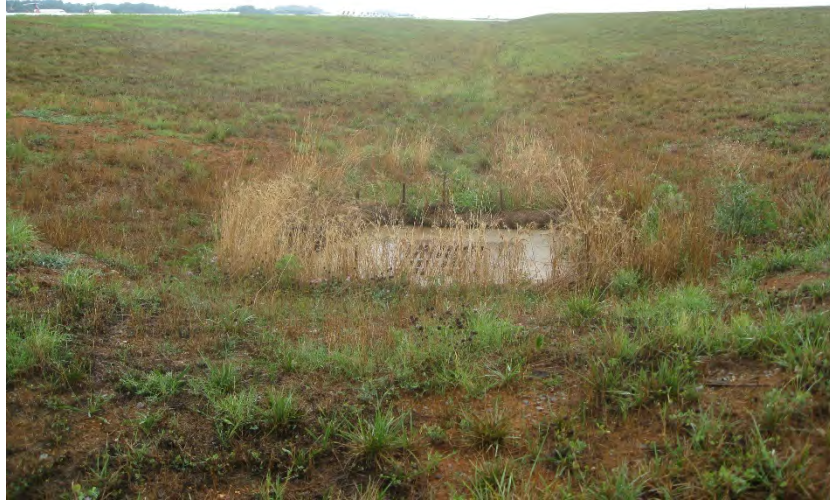
Photo 53
Sta. 353+56 RT
(RW 5L-23R)
Structure 20
Project 4

Structure 20.

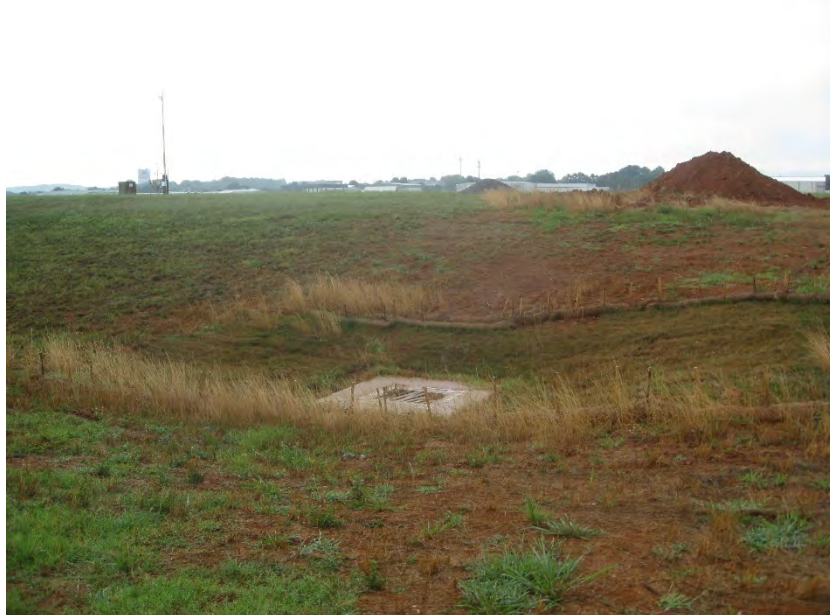
Photo 54
Sta. 347+26 RT
(RW 5L-23R)
Structure 22
Project 4

Structure 22.
Recommend stabilizing bare areas.
