**QUALITY ASSURANCE
MONTHLY SITE
ASSESSMENT REPORT**

Airfield Modernization Program
Runway 5L-23R Reconstruction
Project 2 / Project 3

NPDES TN0081868 (Individual)
NPDES TNR134734 (General)

AIRFIELD MODERNIZATION PROGRAM RUNWAY 5L-23R RECONSTRUCTION

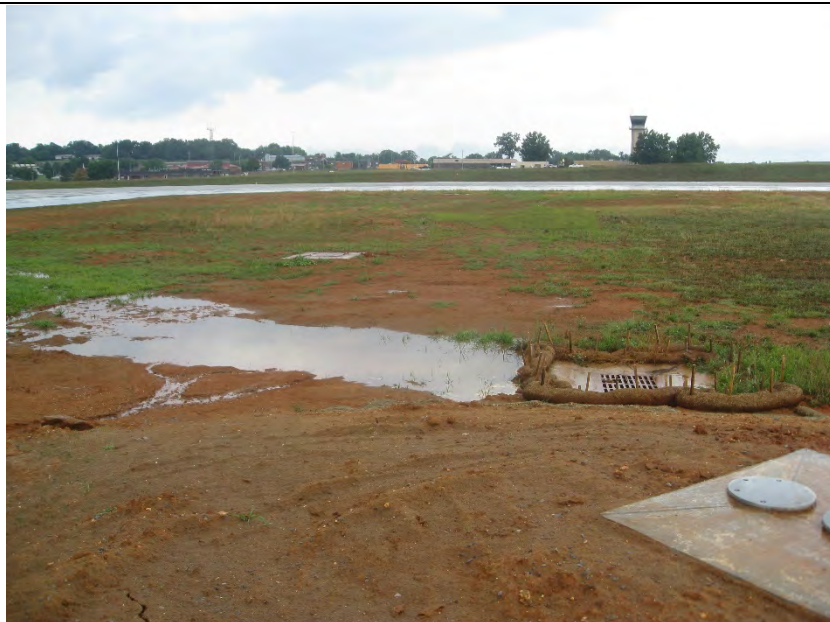
Photo 56
Sta. 347+26 RT
(RW 5L-23R)
Structure 202
Project 4

Structure 202.

Rills and sediment migration occurred after recent storm events.

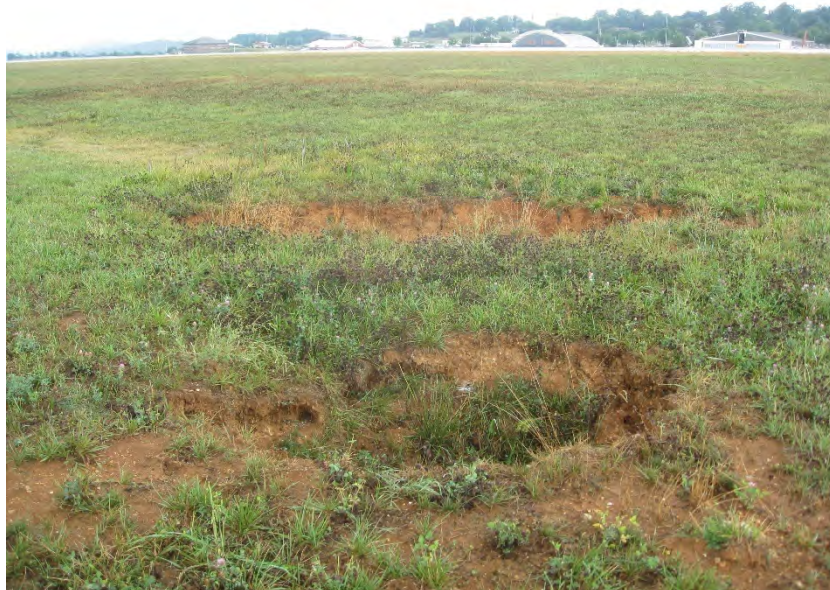
Photo 58
Sta. 341+86 RT
(RW 5L-23R)
Project 4

Construction fallout on Storm Line 2 between structures 204 and 206.
Recommend coordinating remediation with CHA.

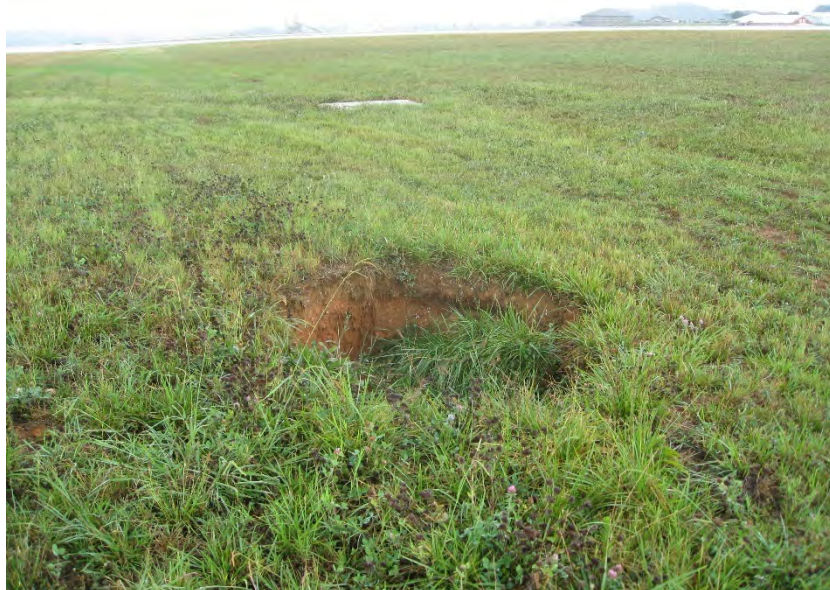
Photo 60
(RW 5L-23R)
Project 4

Construction fallout on Storm Line 2 between structures 206 and 208.
Recommend coordinating remediation with CHA.

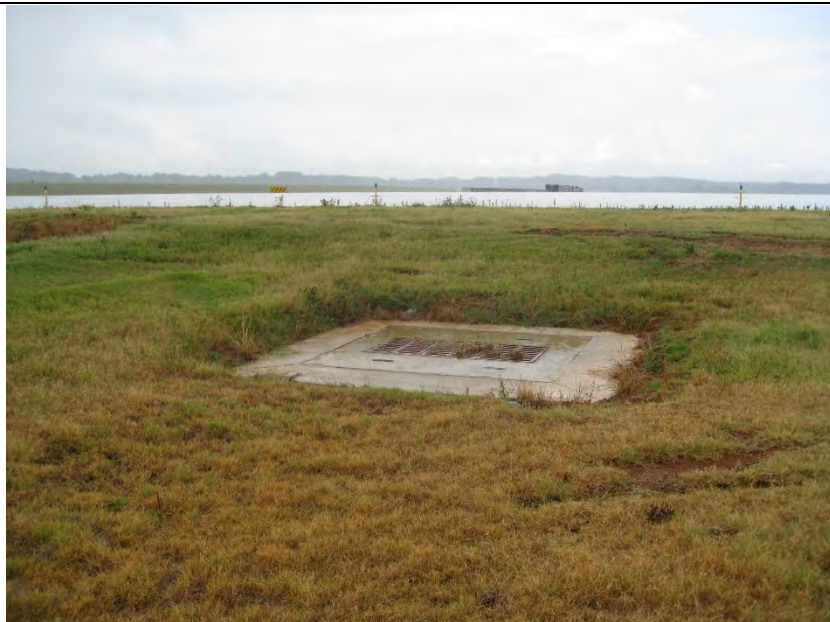
Photo 64
Sta. 314+32 RT
(RW 5L-23R)
Structure 214
Project 3

Structure 214.

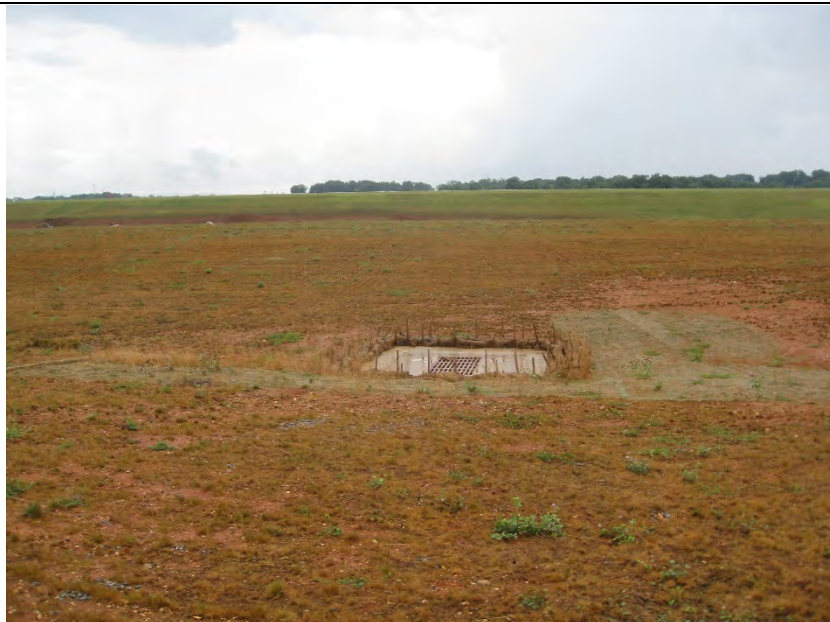
Photo 68
Sta. 296+83 RT
(RW 5L-23R)
Structure 220
Project 2

Structure 220.
Recommend stabilizing remaining bare areas.

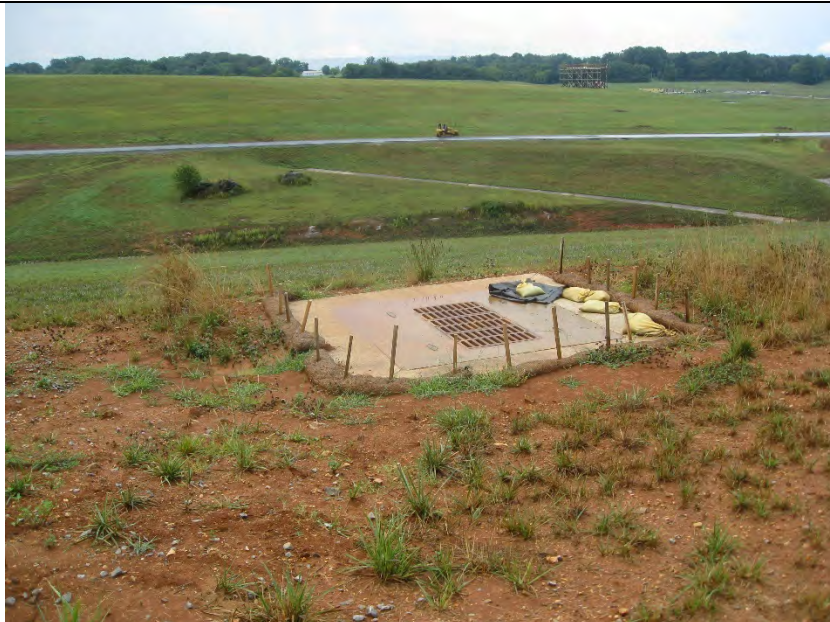
Photo 72
Sta. 290+26 RT
(RW 5L-23R)
Structure 222
Project 2

Structure 222.
Recommend removing inlet protection.
Recommend stabilizing bare areas.

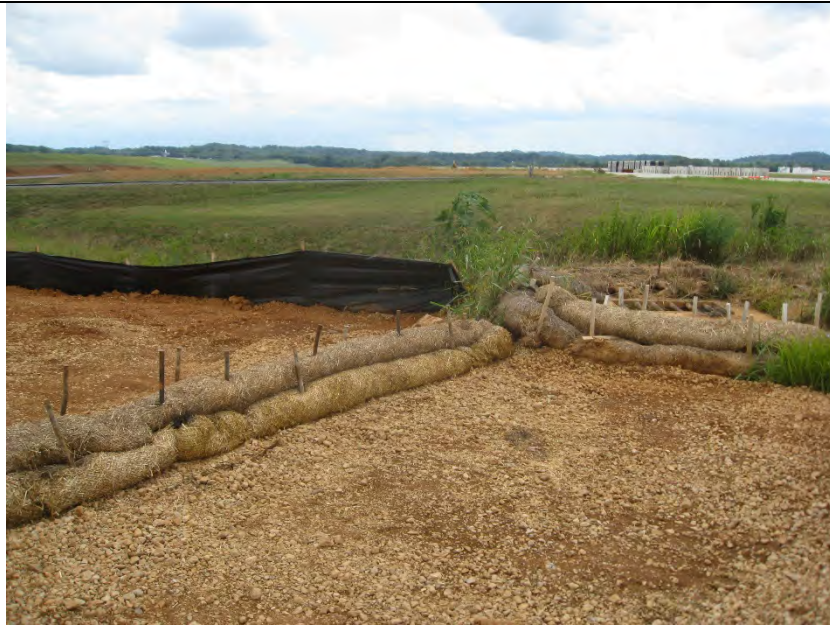
Photo 75
(RW 5L-23R)
Project 3

Area above Haul Road Culvert Inlet (stone stockpile area).
Sediment tubes recently installed to divert runoff into existing storm structure.

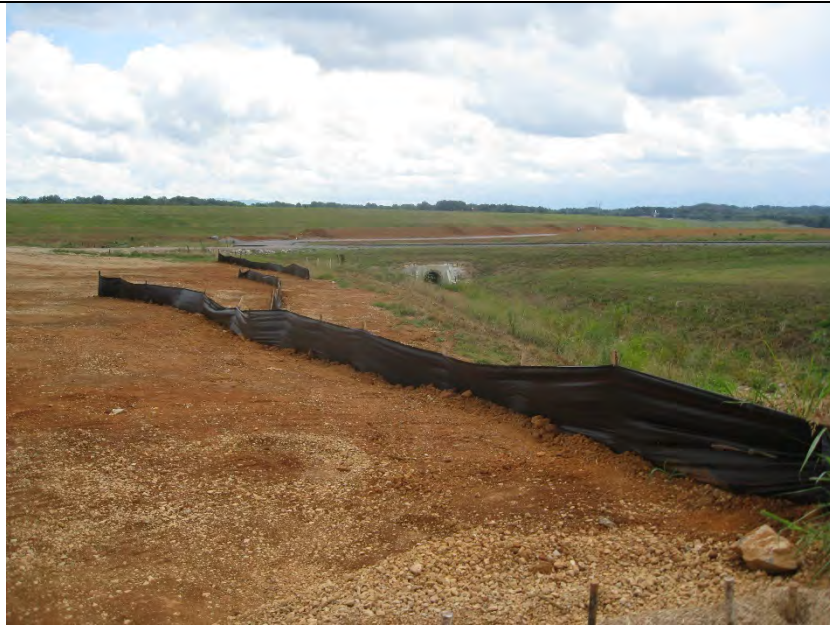
Photo 80
Sta. 39+00 CL
Proposed Haul Route
Project 3

Inlet side of 54" haul route crossing culvert.

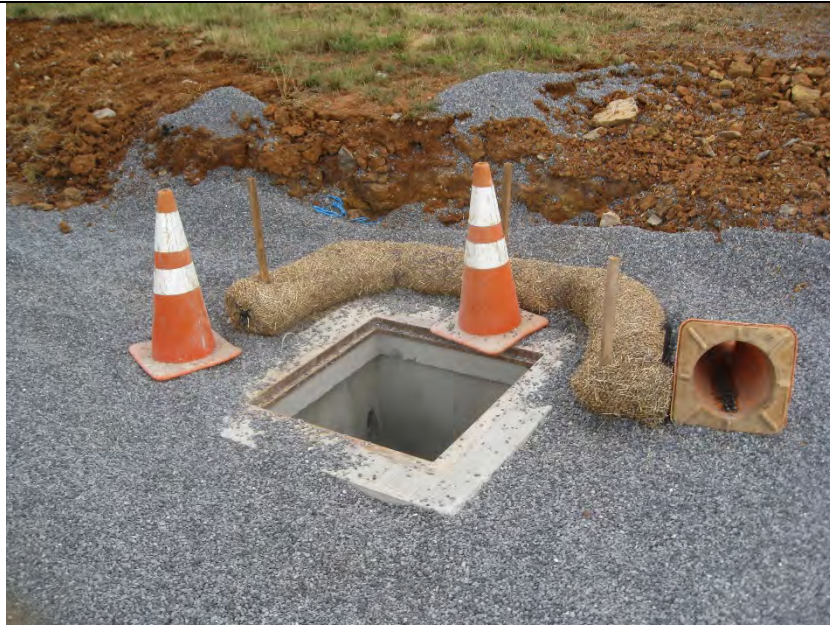
Photo 83
Sta. 37+25 RT
Proposed Haul Route
Project 3

New storm structure installed along haul road.
Recommend installing grate and filter fabric or extend sediment tube around structure.

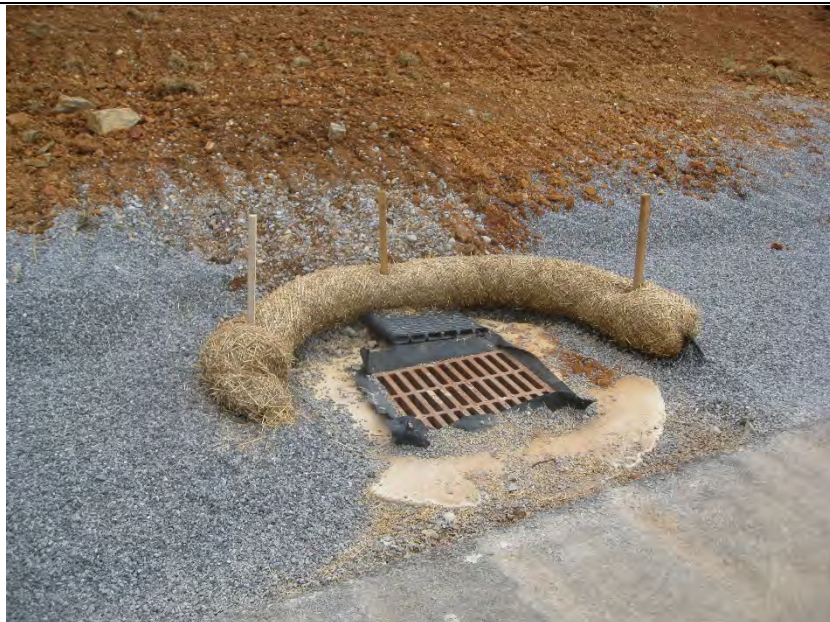
Photo 84
Sta. 32+50 RT
Proposed Haul Route
Project 3

Inlet structure along haul road.
Underdrain/French drain recently installed and slope regraded. Recommend tracking slope perpendicular to prevent creation of rills.
Recommend stabilizing slope as soon as practical.

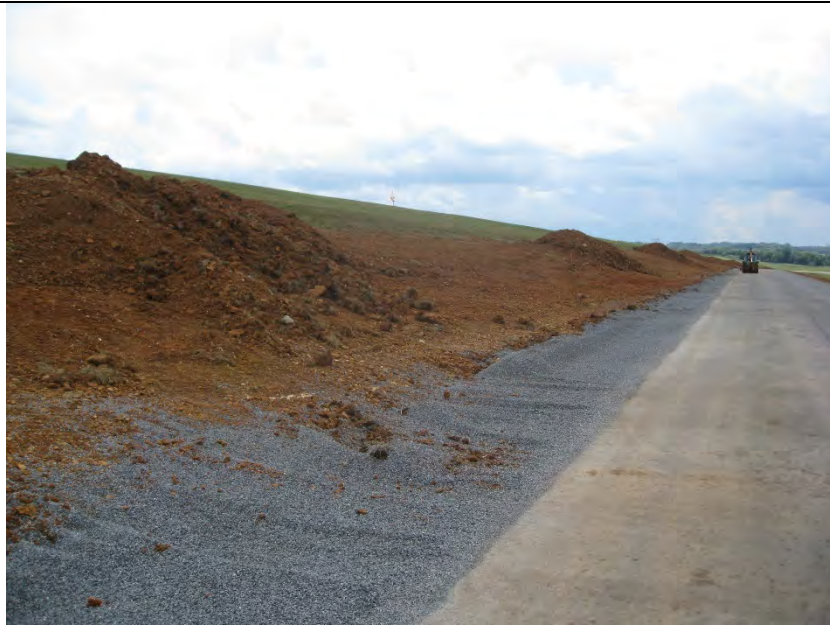
Photo 85
Sta. 32+50 RT
Proposed Haul Route
Project 3

Haul Route.
Underdrain/French drain recently installed and slope regraded. Recommend tracking slope perpendicular to prevent creation of rills.
Recommend stabilizing slope as soon as practical.

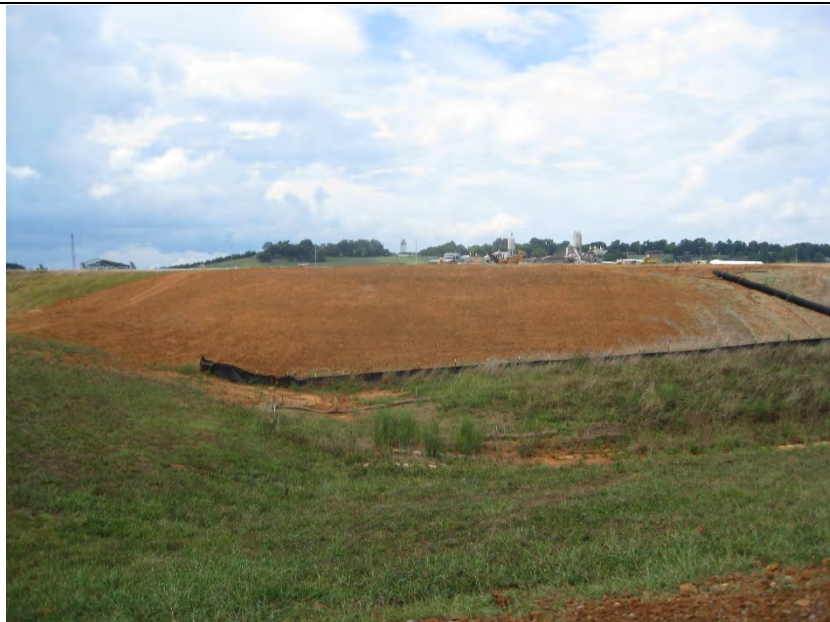
Photo 87
Sta. 302+54
(RW 5L-23R)
Project 2

Above North Lateral Endwall 100.
Sediment has accumulated in front of sediment tubes.
Recommend removing sediment. Recommend replacing sediment tubes.
Recommend stabilizing bare areas.

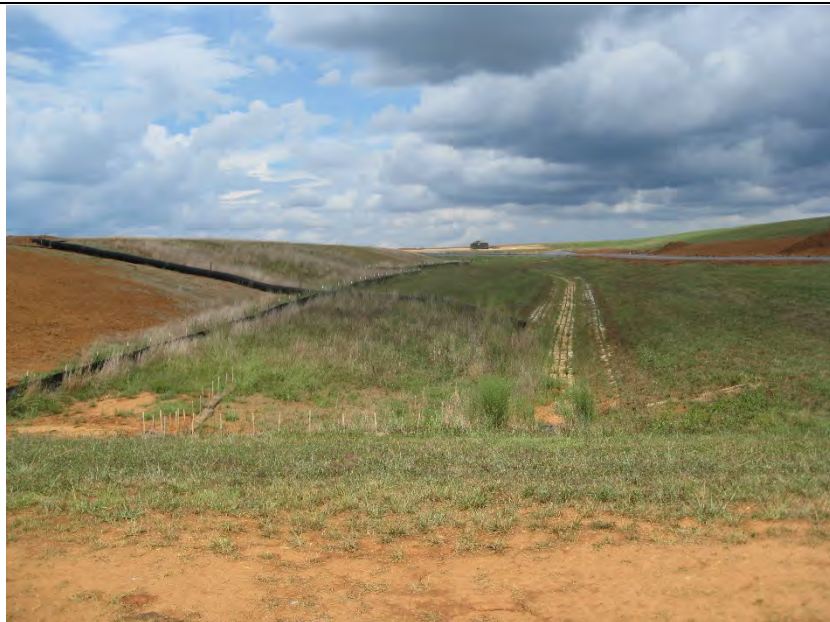
Photo 89
Sta. 302+54
(RW 5L-23R)
Project 2

Soil stockpile area next to haul road at Taxiway B.
Berm has started to erode and sediment has accumulated in front of tubes. Recommend removing accumulated sediment. Recommend adding sediment tubes adjacent to berm.
Recommend stabilizing all bare areas.

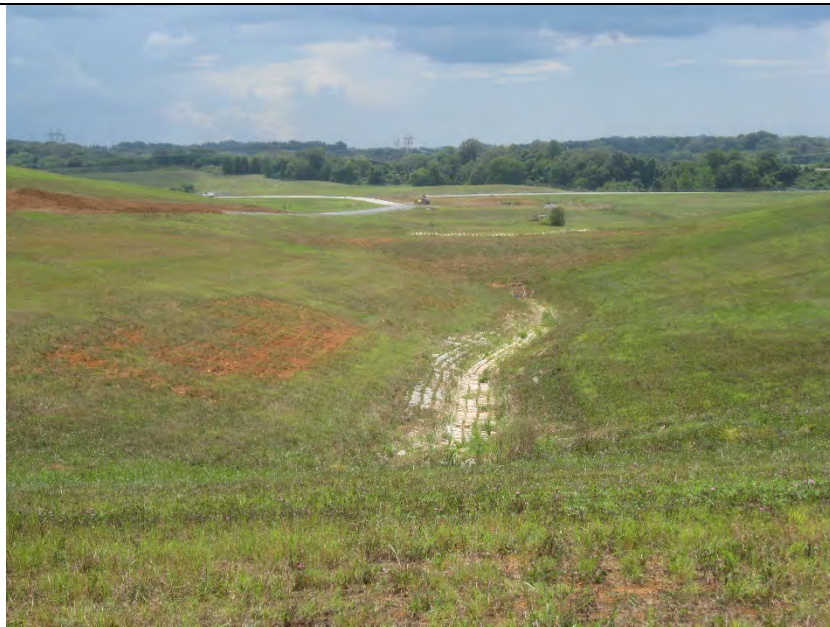
Photo 90
Sta. 302+54 to Sta. 313+50
(RW 5L-23R)
Project 2

North Lateral Endwall 100.
Recommend stabilizing bare areas.

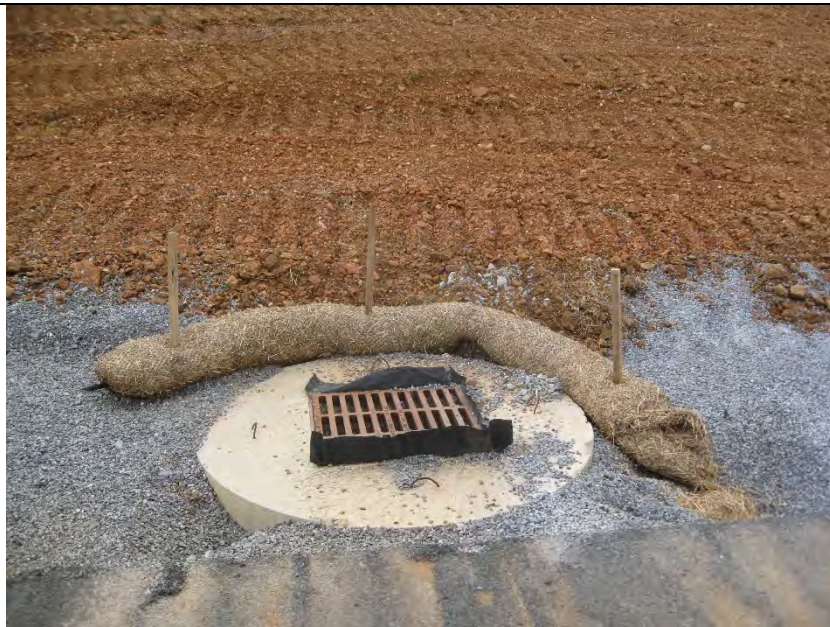
Photo 92
Sta. 29+00 RT
Proposed Haul Route
Project 3

Inlet structure along haul road.
Underdrain/French drain recently installed and slope regraded. Recommend tracking slope perpendicular to prevent creation of rills.
Recommend stabilizing slope as soon as practical.

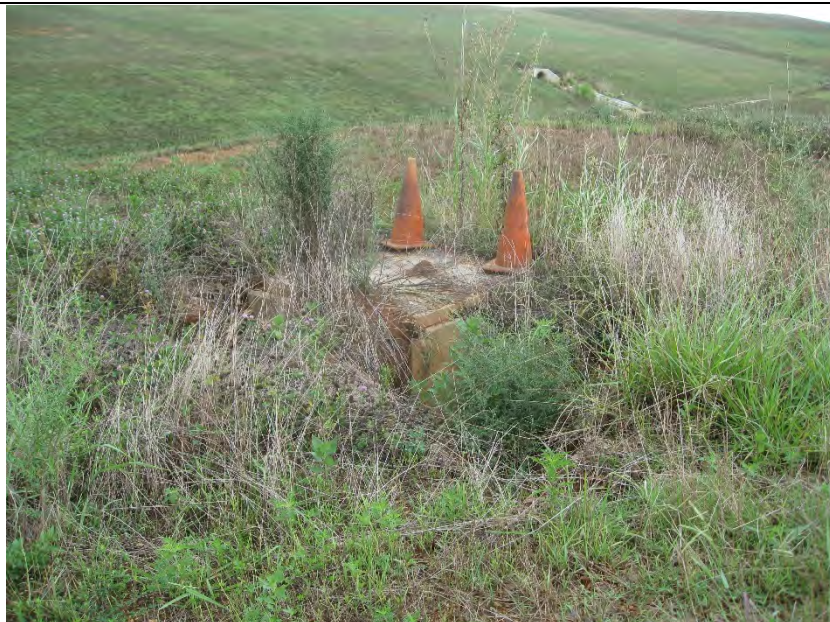
Photo 100
Sta. 284+00 LT
(RW 5L-23R)
Project 2

Existing vault at old Liberty street.
Construction fallout present. Recommend coordinating with CHA on remediation.

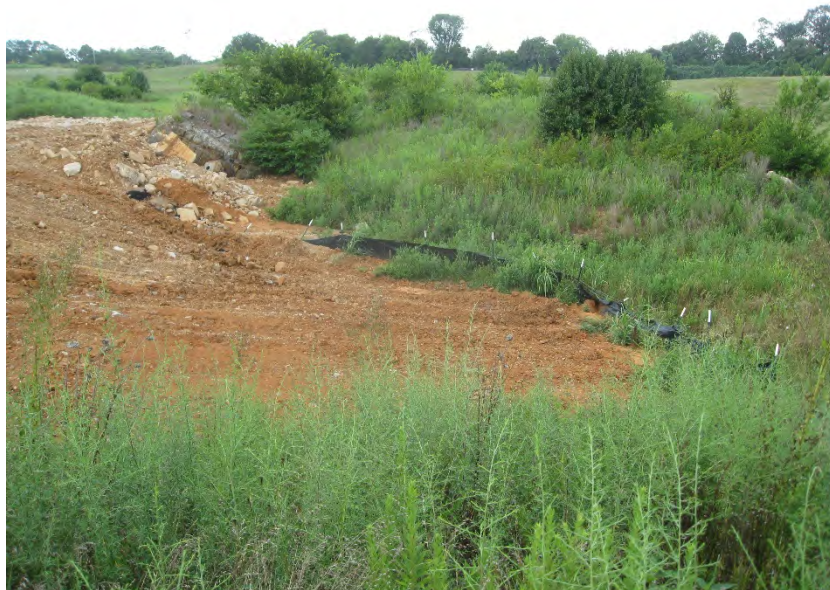
Photo 102
(Repair TWY Lighting)

Fill area adjacent to Liberty Street from Taxiway shoulder removal.
Sediment has migrated to silt fence. Recommend removing accumulated sediment.

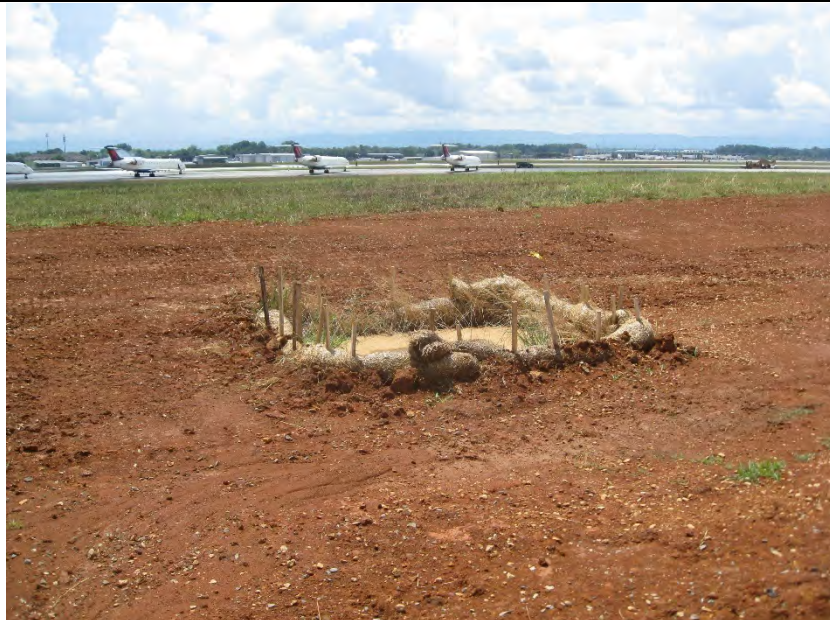
Photo 104
(Repair TWY Lighting)
Existing Structure

Existing structure south of Taxiway G.
Area recently graded and appears to be at finished grade.
Recommend stabilizing bare areas.

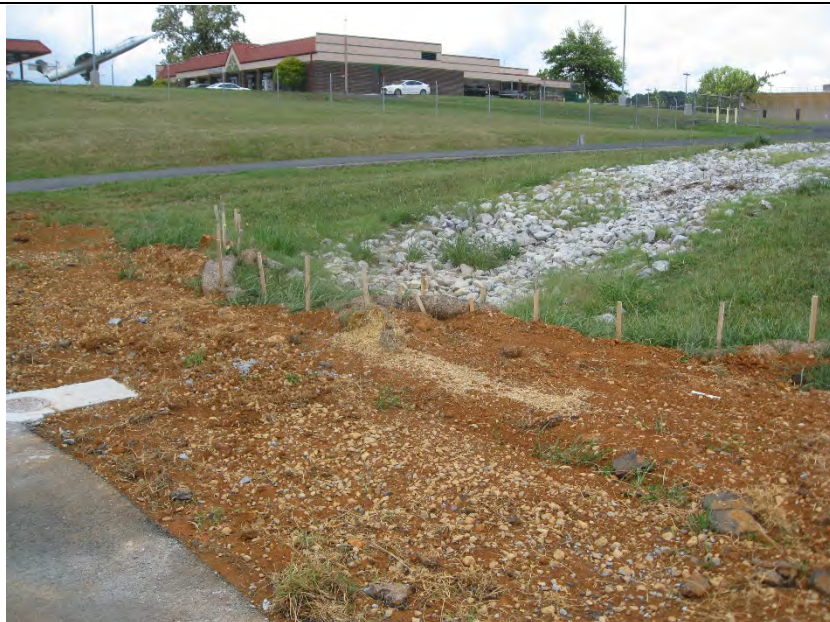
Photo 106
(Repair TWY Lighting)

Existing structure at Upper Apron.
Shoulder graded. Pavement markings being installed.

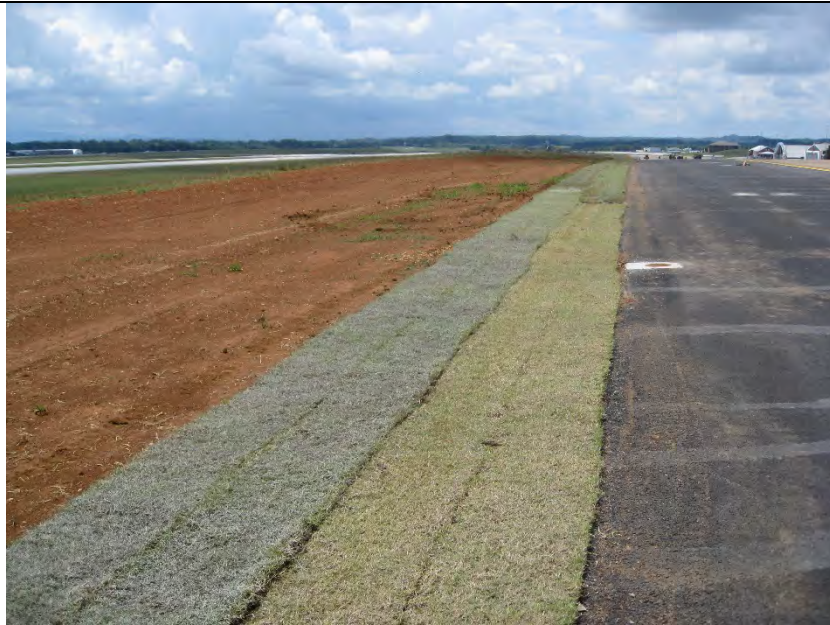
Photo 107
(Repair TWY Lighting)

Sod being installed along Taxiway G at time of inspection.

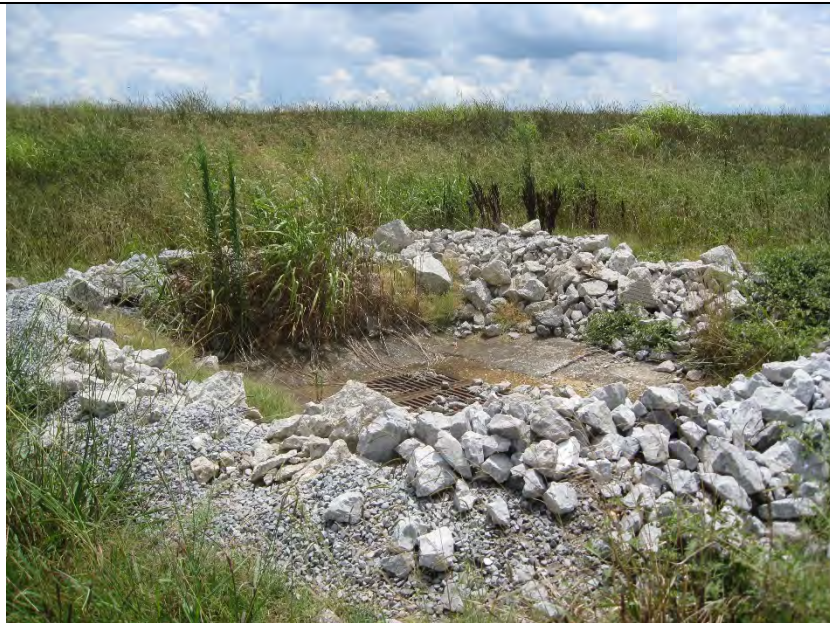
Photo 108
(Repair TWY Lighting)

Existing structure adjacent to demolished Taxiway G4.

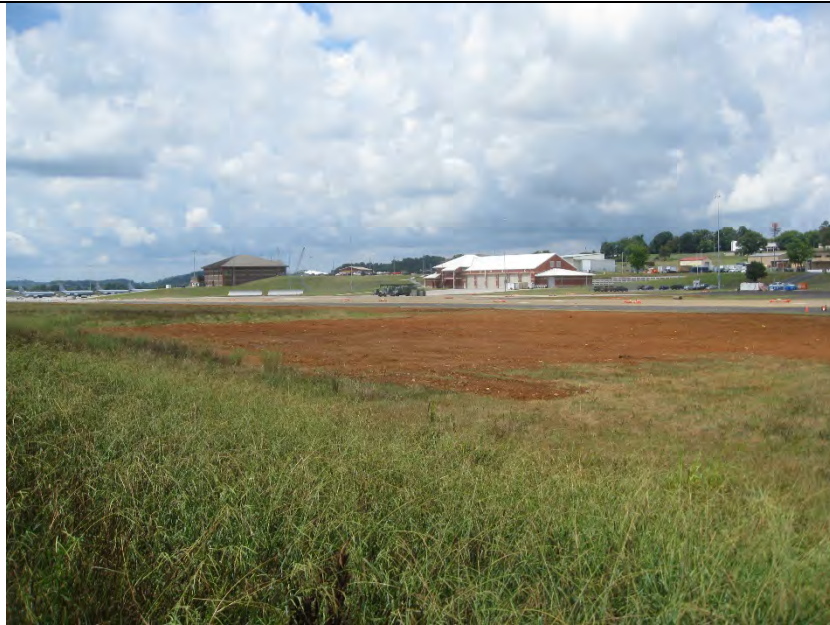
Photo 109
(Repair TWY Lighting)

Demolished old Taxiway G4 and shoulder recently graded.
Recommend stabilizing bare areas.

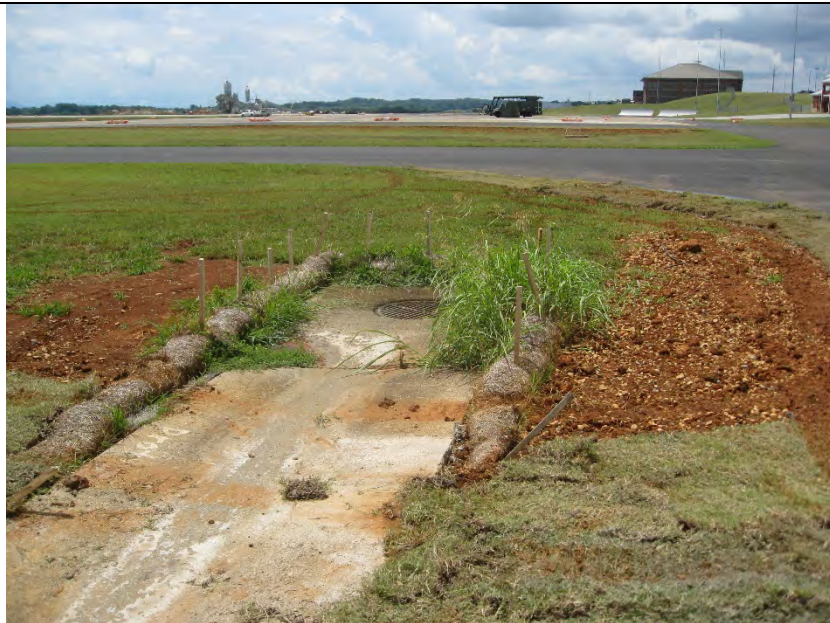
Photo 110
(Repair TWY Lighting)

Existing structure at Upper Apron.
Shoulders recently graded.
Recommend stabilizing bare areas.

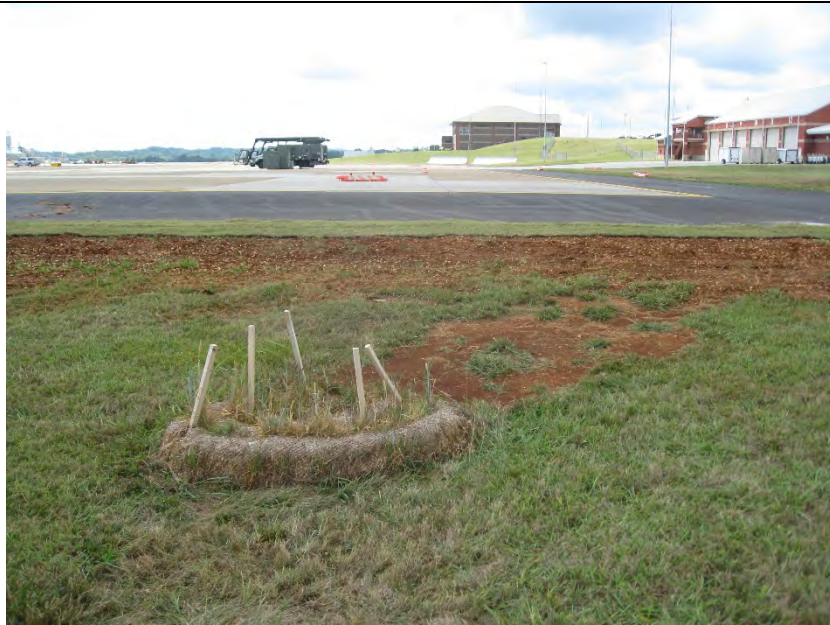
Photo 111
(Repair TWY Lighting)

Existing structure at Middle Apron.
Shoulders recently graded.
Recommend stabilizing bare areas.

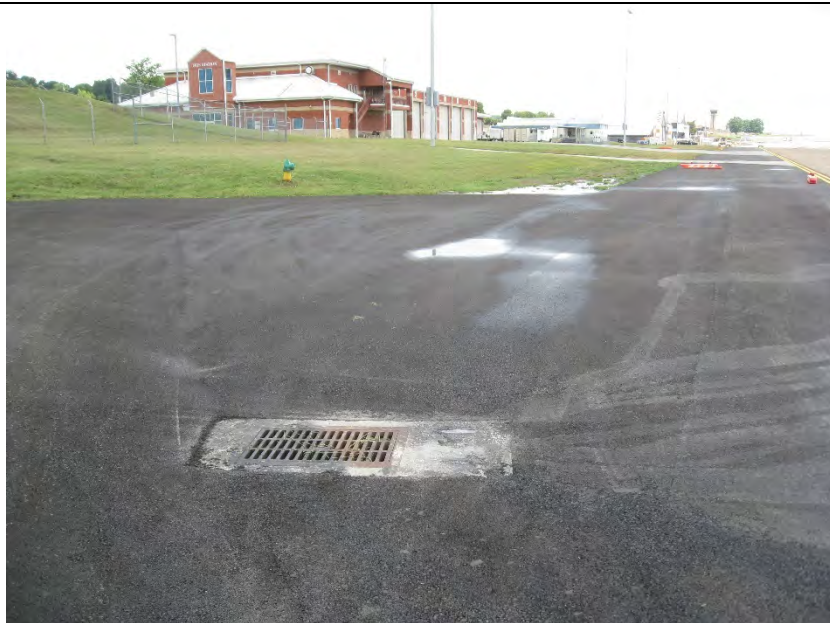
Photo 112
(Repair TWY Lighting)

Existing structure at Middle Apron.

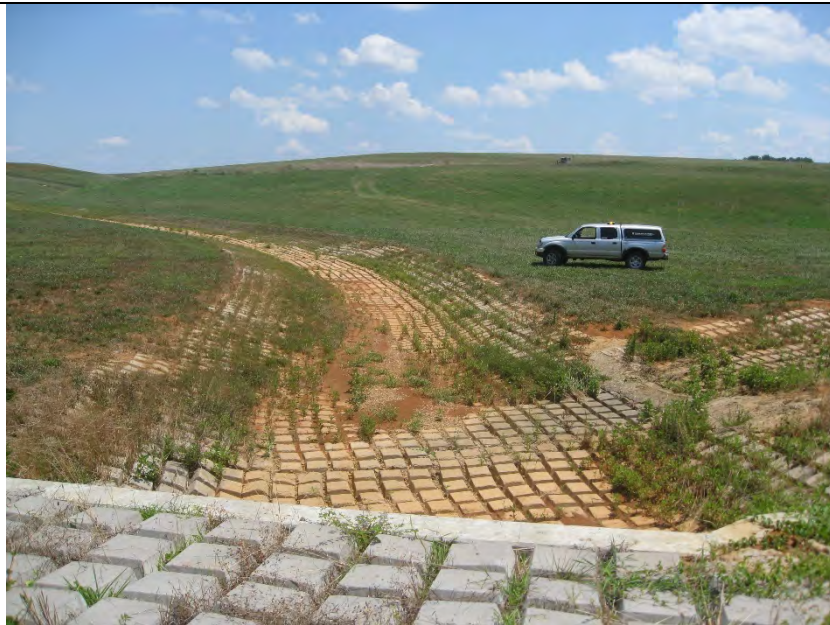
Photo 1
Sta. 111+56 RT
(Line LB)
NLET 01
Project 2

North Lateral End Treatment 01 (Outfall A).

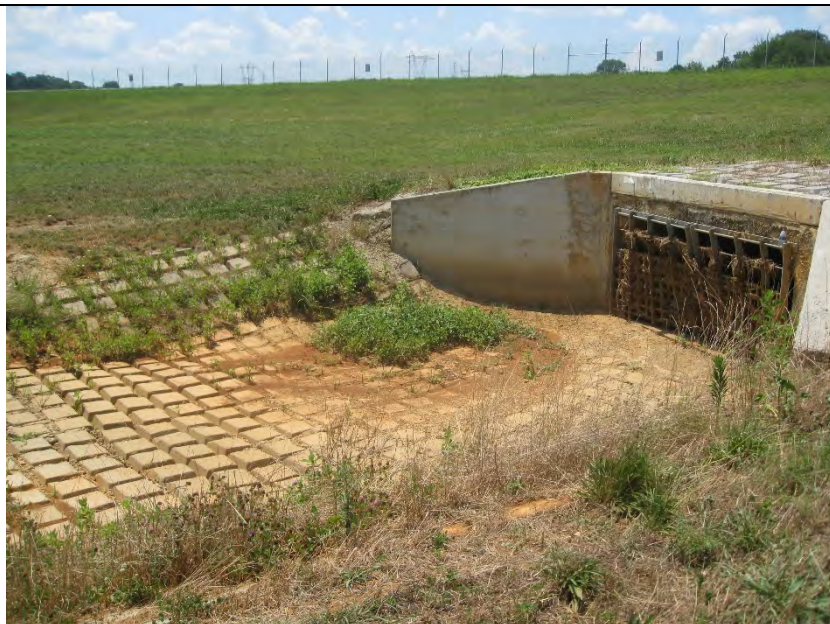
Photo 2
Sta. 111+56 RT
(Line LB)
NLET 01
Project 2

North Lateral End Treatment 01 (Outfall A).

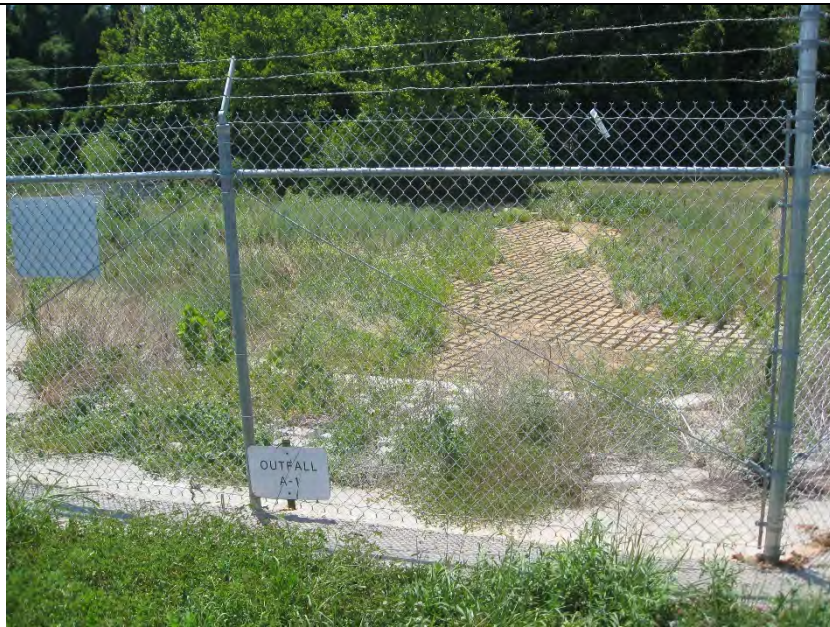
Photo 3
Sta. 111+82 LT
(Line LB)
NLET 02
Project 2

Main outfall to Lackey Creek. This section of the site was inaccessible at time of inspection.

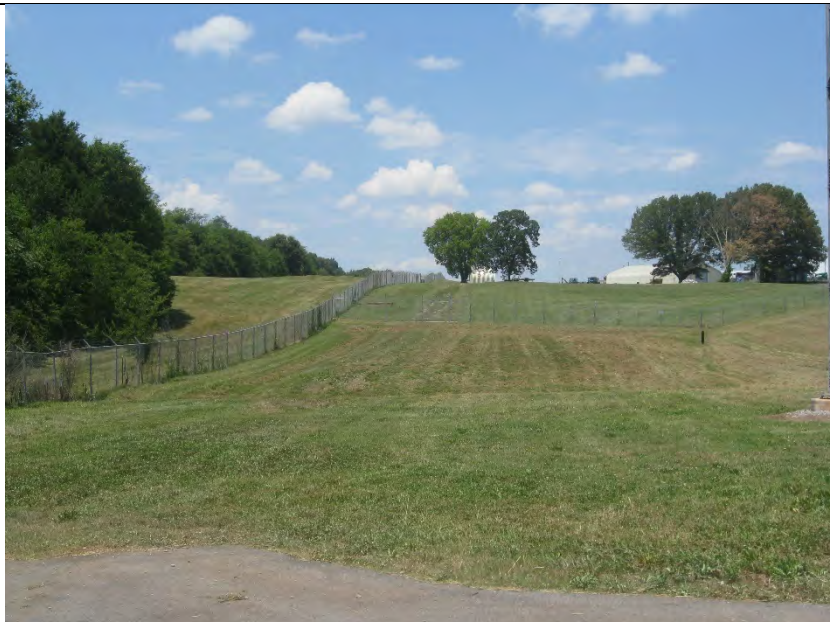
Photo 4
Sta. 115+28 to Sta. 121+45
(Line LB)
Project 2

Grass established at ditch line along Liberty Street.

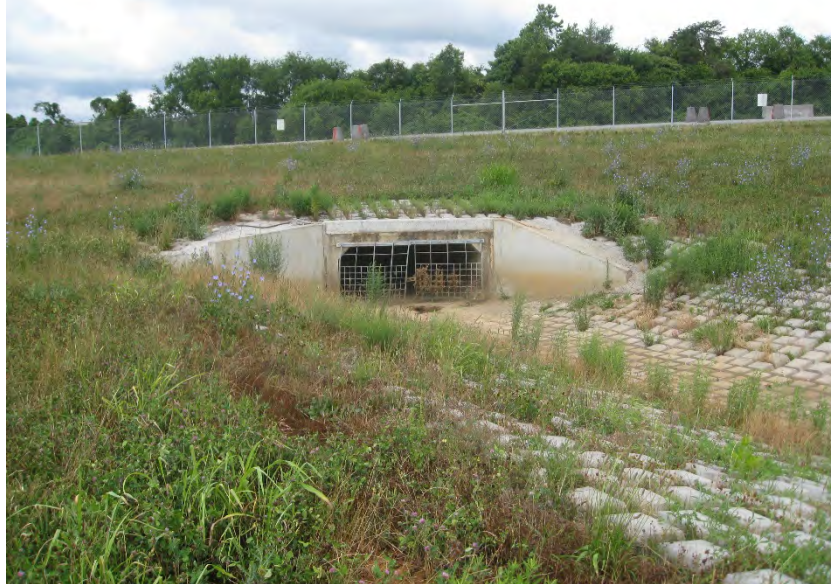
Photo 5
Sta. 117+00
(Line LB)
Project 2

Guard Lateral Ditch (Outfall B).

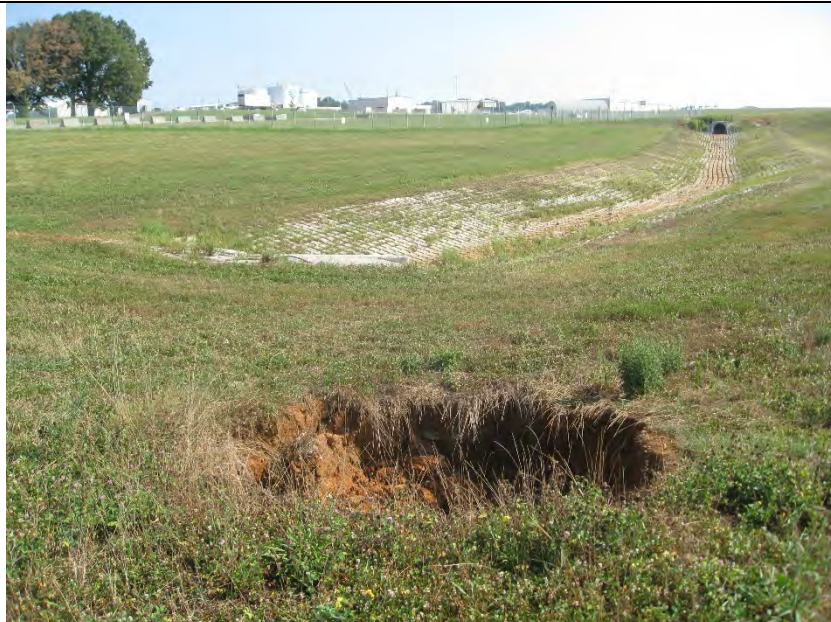
Photo 6
Sta. 117+00
(Line LB)
Project 2

Above the Guard Lateral Ditch (Outfall B).
Construction fall out present. Recommend coordinating remediation with CHA.

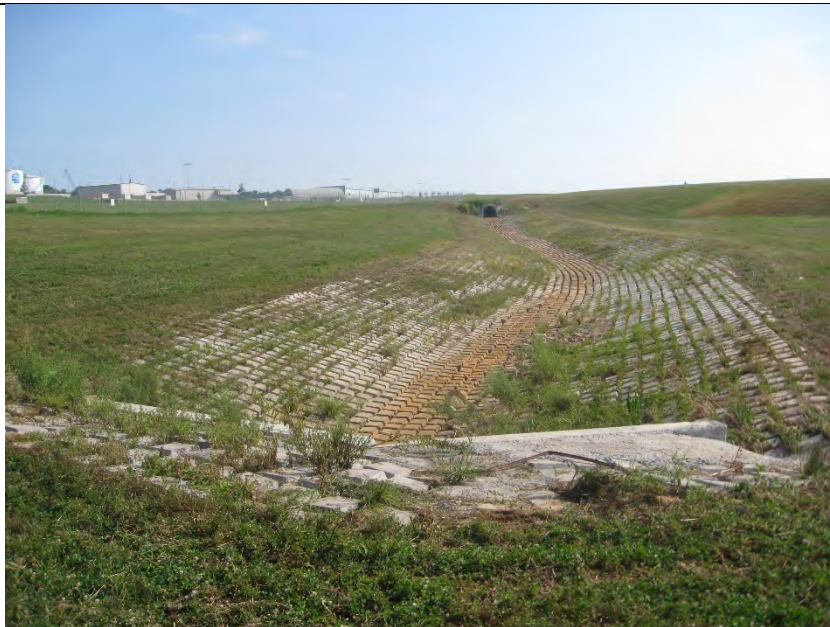
Photo 7
Sta. 117+00
(Line LB)
Project 2

Guard Lateral Ditch (Outfall B).

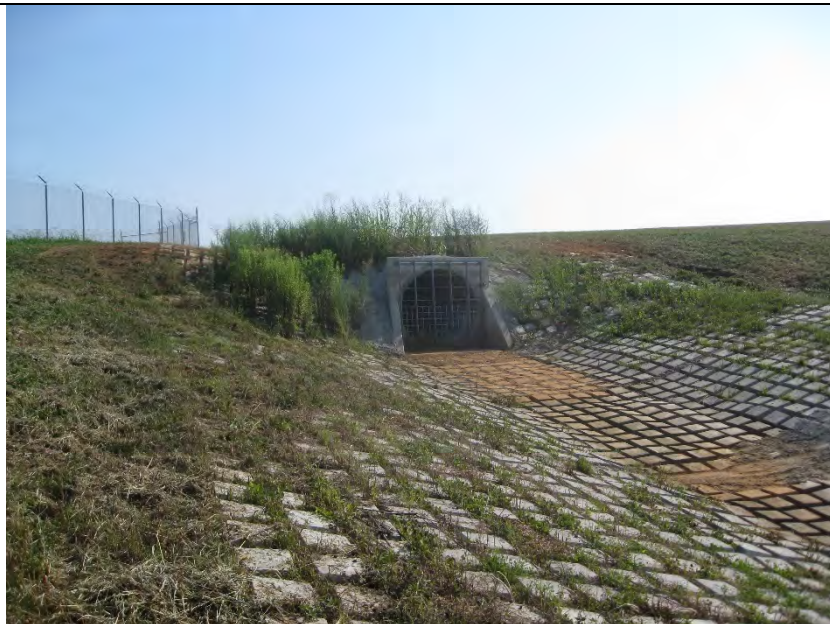
Photo 8
Sta. 117+00 (RT)
Project 2

78" culvert in the Guard Lateral Ditch.

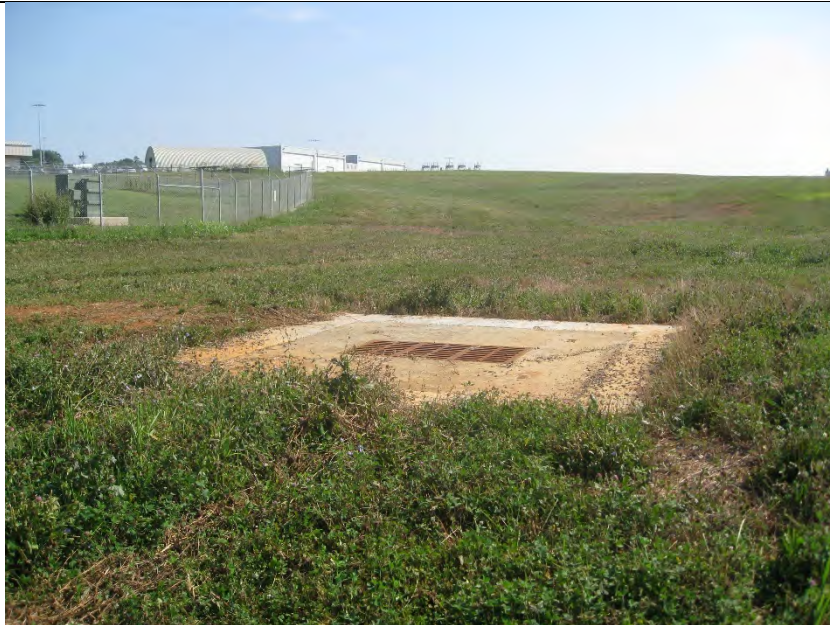
Photo 9
Sta. 287+21 LT
(RW 5L-23R)
Structure 124
Project 3

Structure 124.

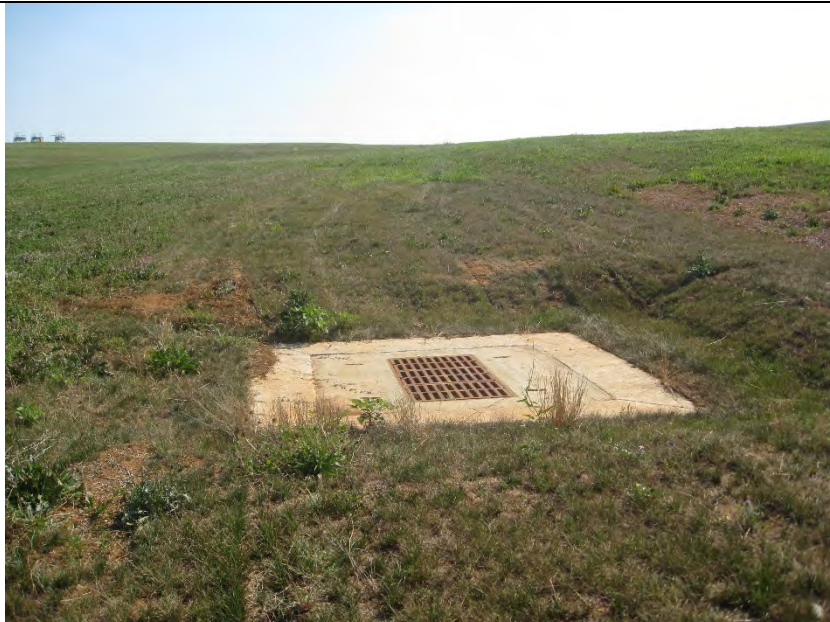
Photo 10
Sta. 289+13 LT
(RW 5L-23R)
Structure 122
Project 3

Structure 122.
Recommend stabilizing remaining bare areas.

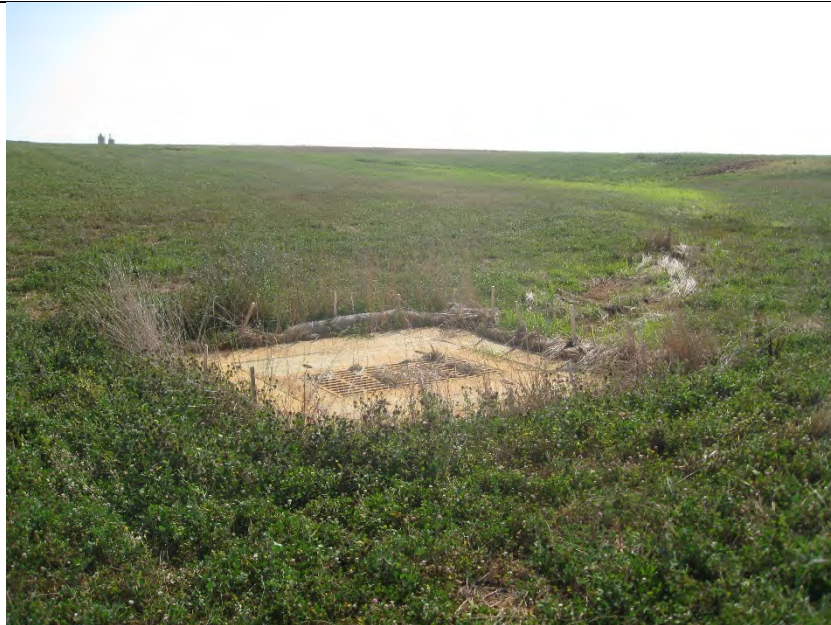
Photo 11
Sta. 291+51 LT
(RW 5L-23R)
Structure 120
Project 3

Structure 120.

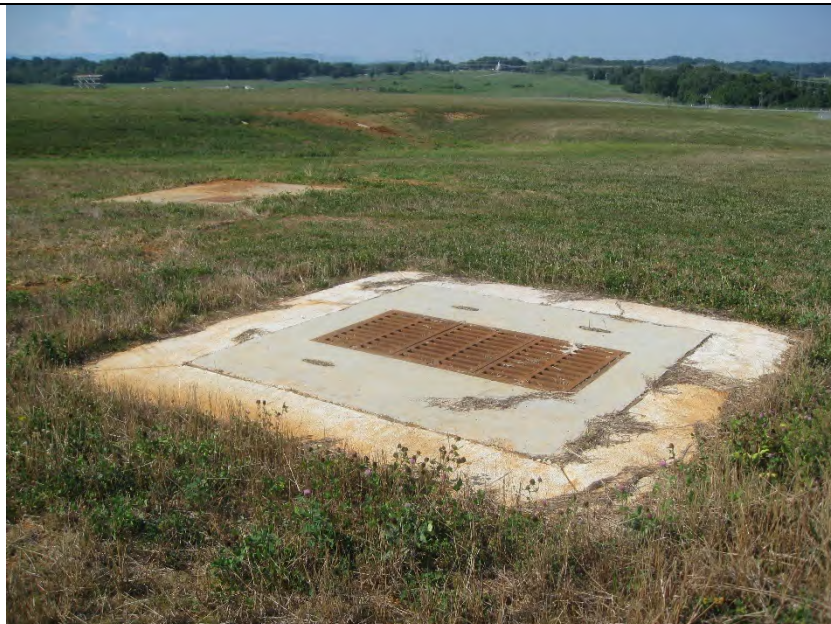
Photo 12
Sta. 294+31 LT
(RW 5L-23R)
Structure 118
Project 3

Structure 118.

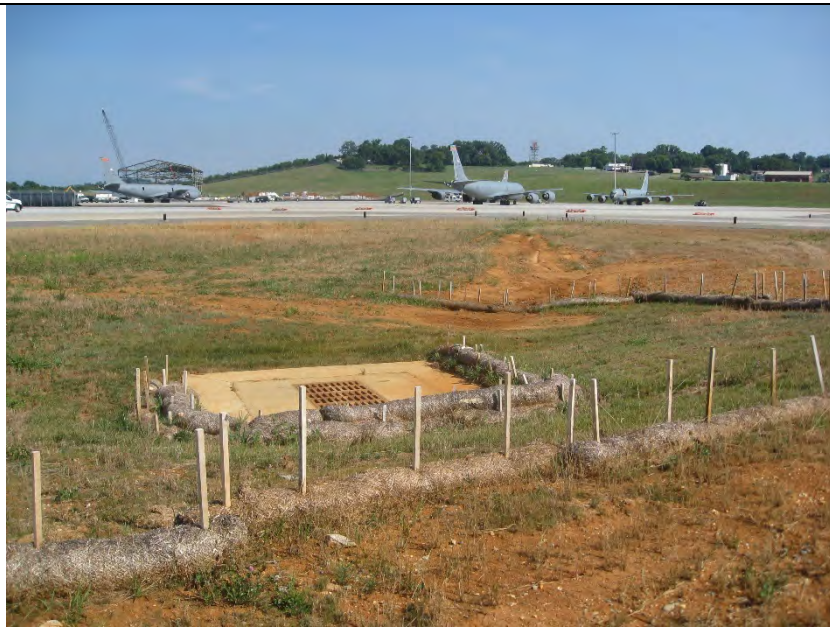
Photo 13
Sta. 298+71 LT
(RW 5L-23R)
Structure 116
Project 3

Structure 116.
Recommend stabilizing bare areas.

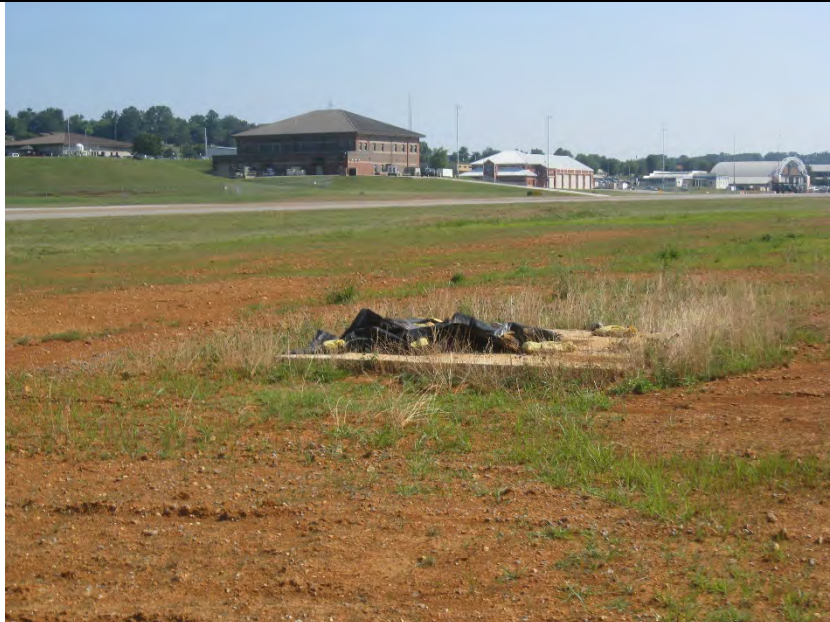
Photo 14
Sta. 302+54 LT
(RW 5L-23R)
Structure 114
Project 3

Structure 114.

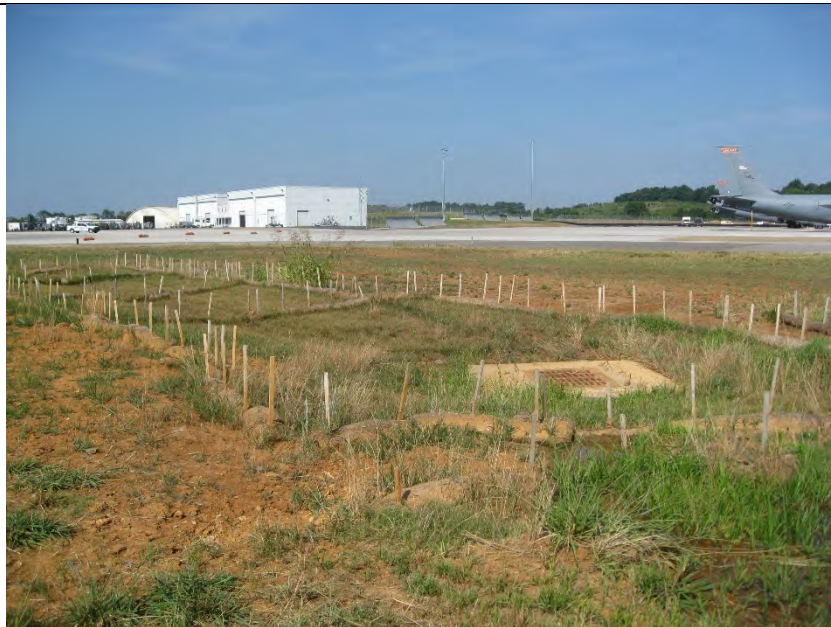
Photo 15
Sta. 303+36 LT
(RW 5L-23R)
Structure 12
Project 3

Structure 12.
Bare areas recently stabilized.

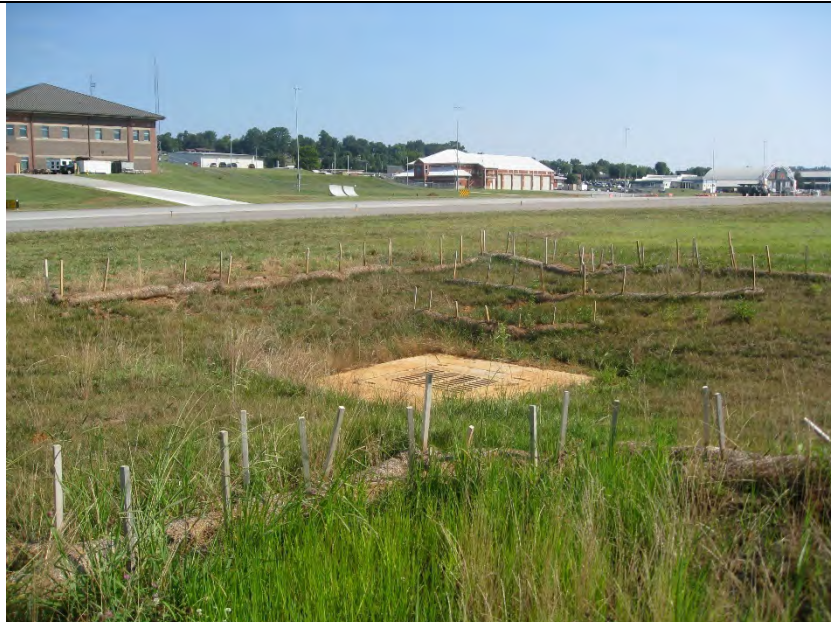
Photo 16
Sta. 310+04 LT
(RW 5L-23R)
Structure 10
Project 3

Structure 10.
Bare areas recently stabilized.

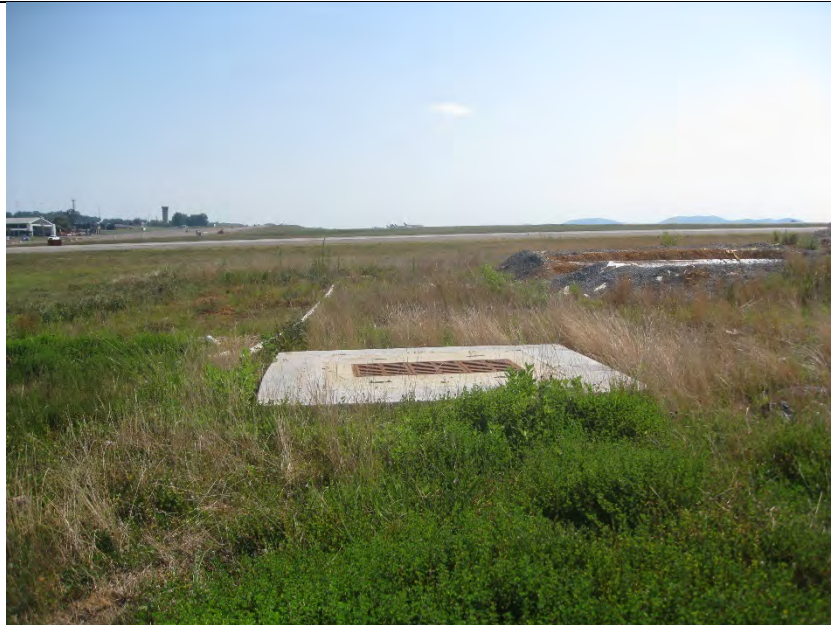
Photo 17
Sta. 310+00 LT
(RW 5L-23R)
Project 3

Structure 112
