**QUALITY ASSURANCE
MONTHLY SITE
ASSESSMENT REPORT**

Airfield Modernization Program
Runway 5L-23R Reconstruction
Project 2 / Project 3

NPDES TN0081868 (Individual)
NPDES TNR134734 (General)

AIRFIELD MODERNIZATION PROGRAM RUNWAY 5L-23R RECONSTRUCTION

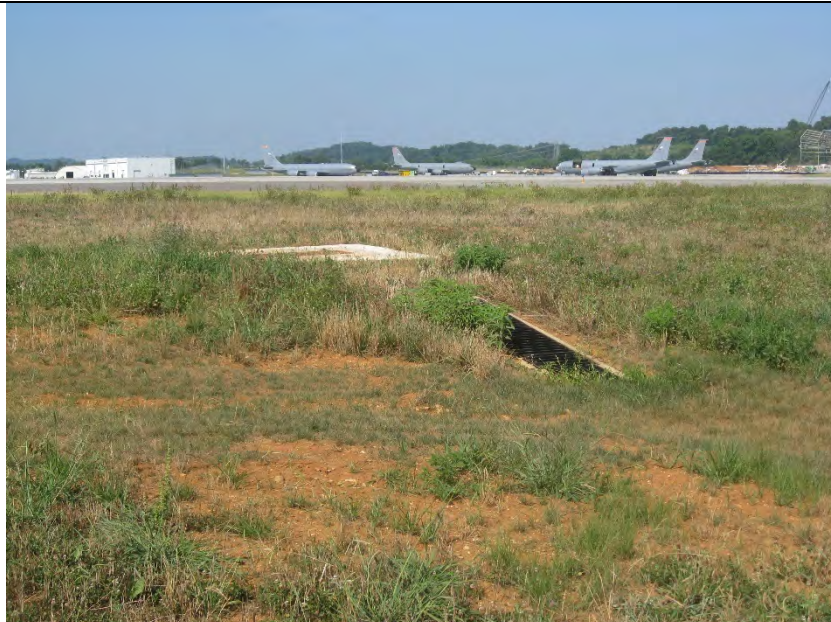
Photo 18
Sta. 314+48 LT
(RW 5L-23R)
ES Endwall 108
Project 3

Enhanced Swale Endwall 108.
Recommend stabilizing remaining bare areas.

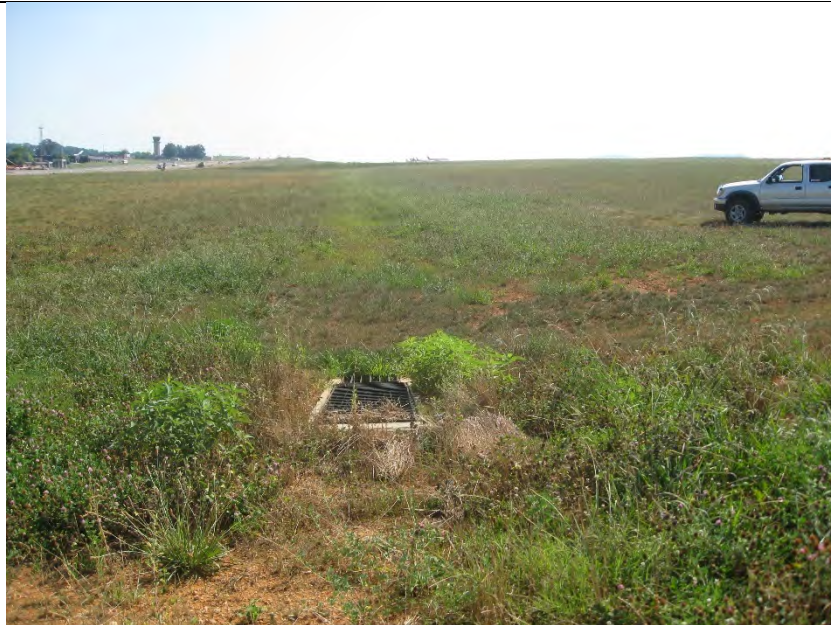
Photo 19
Sta. 314+48 LT
(RW 5L-23R)
ES Endwall 108
Project 3

Enhanced Swale Endwall 108.
Recommend stabilizing remaining bare areas.

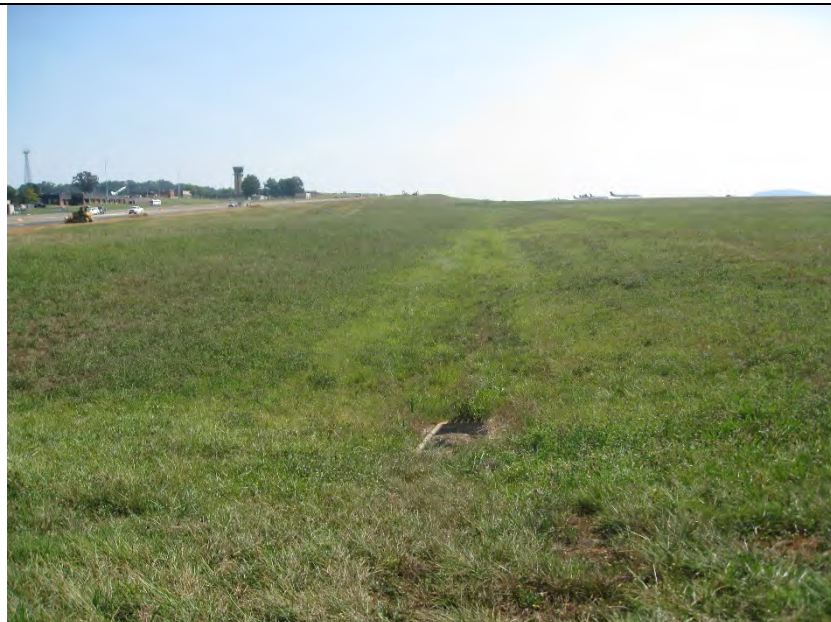
Photo 20
Sta. 324+86 LT
(RW 5L-23R)
ES Endwall 106
Project 3

Enhanced Swale Endwall 106.

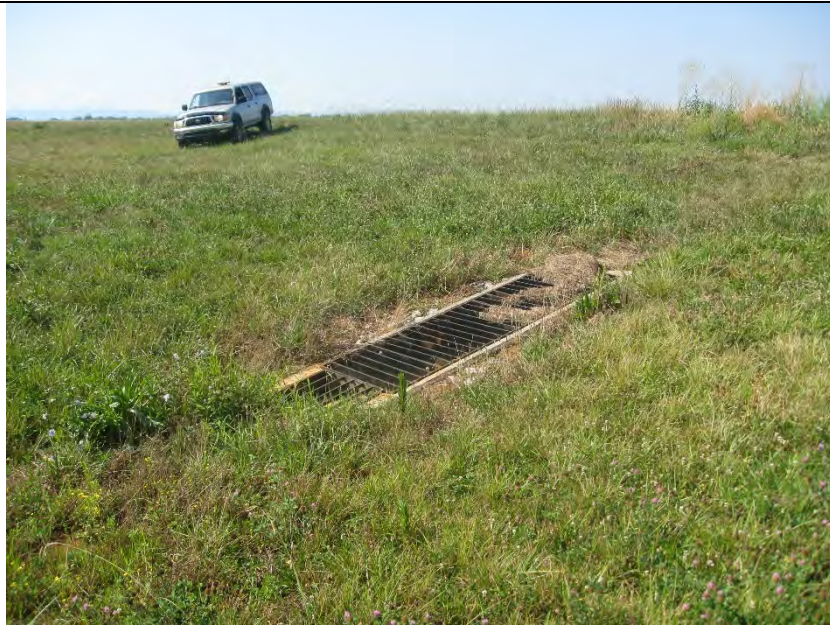
Photo 21
Sta. 324+86 to Sta. 335+73 LT
(RW 5L-23R)
ES Endwall 106
Project 3

Enhanced Swale Endwall 106.

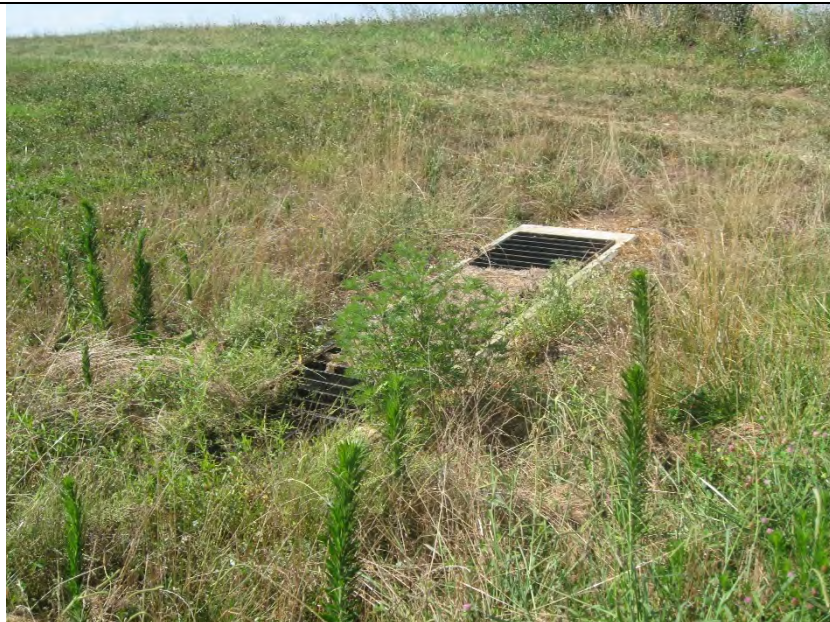
Photo 22
Sta. 335+73 LT
(RW 5L-23R)
ES Endwall 104
Project 3

Enhanced Swale Endwall 104.

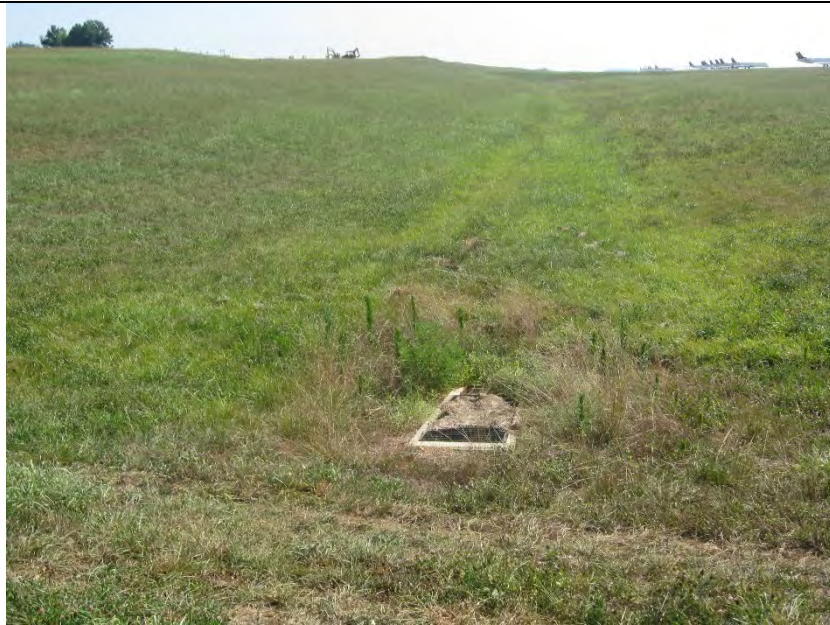
Photo 23
Sta. 335+73 LT
(RW 5L-23R)
ES Endwall 104
Project 3

Enhanced Swale Endwall 104.

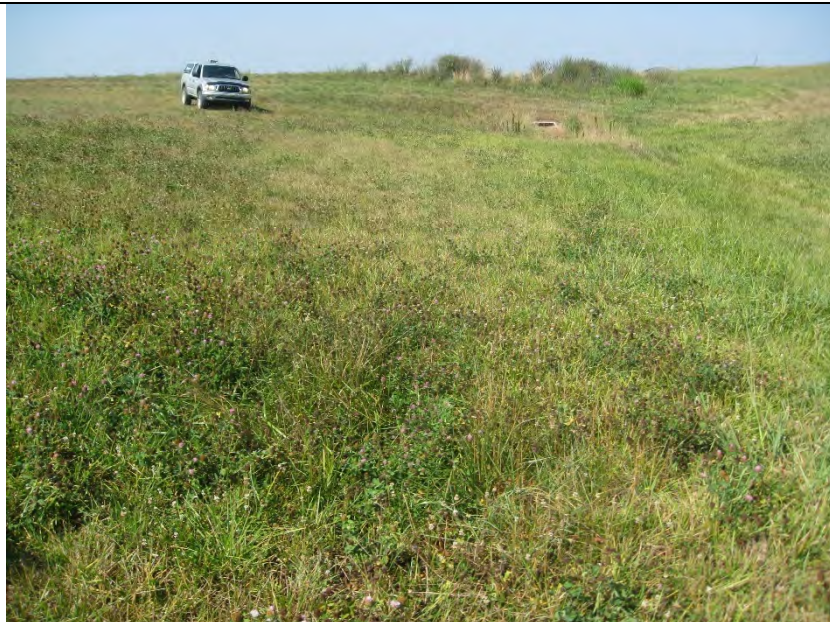
Photo 24
Sta. 341+50 LT
(RW 5L-23R)
Between ES Endwall 104 and 102
Project 3

Potential construction fallout on Storm Line 1 between ES Endwall 104 and 102.

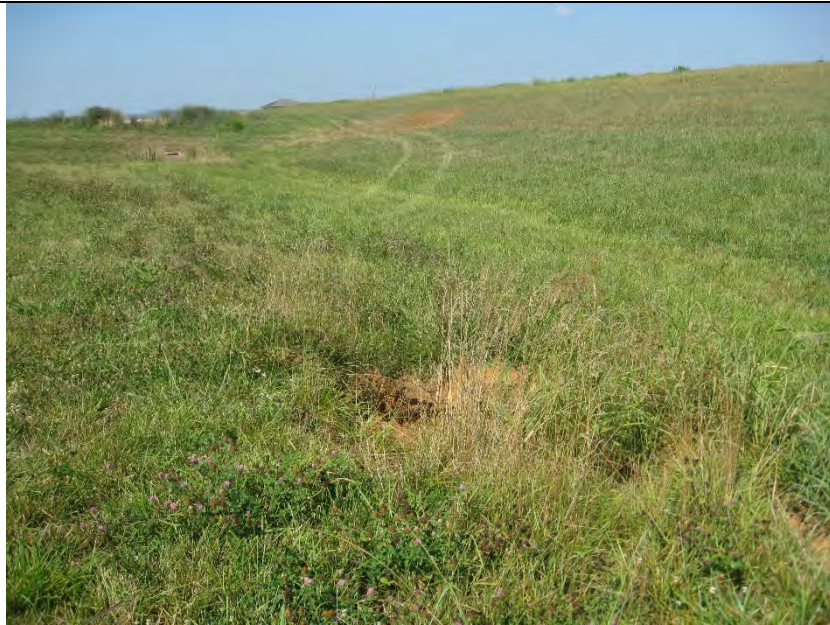
Photo 25
Sta. 341+50 LT
(RW 5L-23R)
Between ES Endwall 104 and 102
Project 3

First construction fallout on Storm Line 1 between ES Endwall 104 and 102.
Coordinate remediation with CHA.

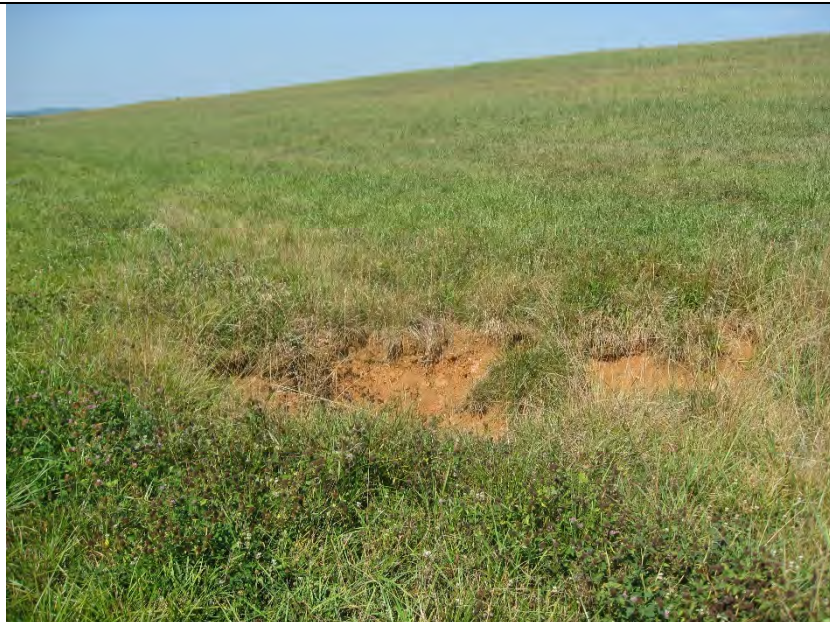
Photo 26
Sta. 341+50 LT
(RW 5L-23R)
Between ES Endwall 104 and 102
Project 3

Second construction fallout on Storm Line 1 between ES Endwall 104 and 102.
Coordinate remediation with CHA.

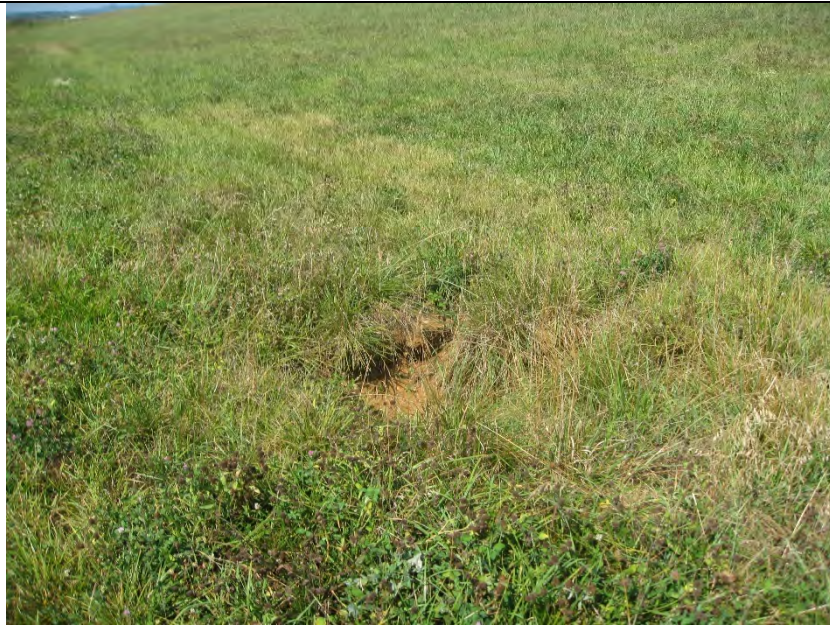
Photo 27
Sta. 341+50 LT
(RW 5L-23R)
Between ES Endwall 104 and 102
Project 3

Third construction fallout on Storm Line 1 between ES Endwall 104 and 102.
Coordinate remediation with CHA.

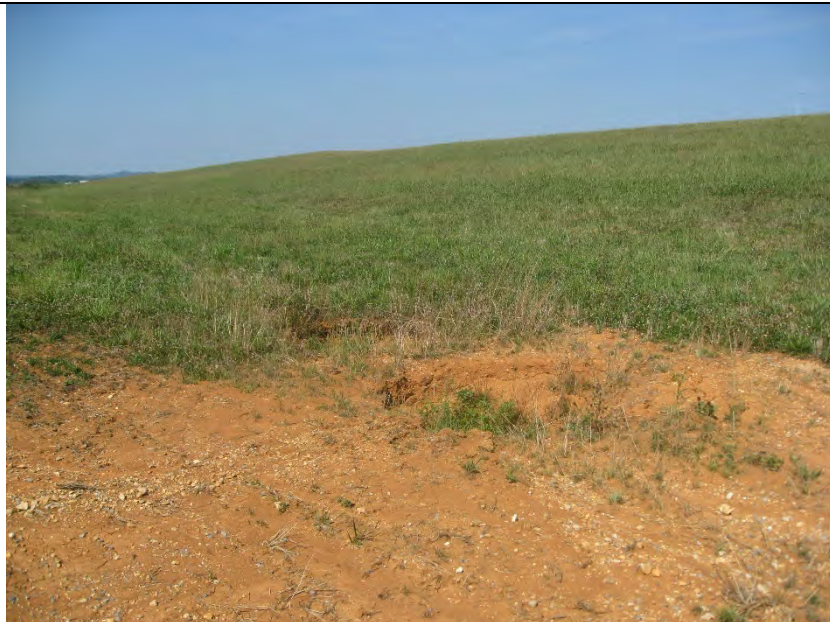
Photo 28
Sta. 341+50 LT
(RW 5L-23R)
Between ES Endwall 104 and 102
Project 3

Fourth construction fallout on Storm Line 1 between ES Endwall 104 and 102.
Coordinate remediation with CHA.

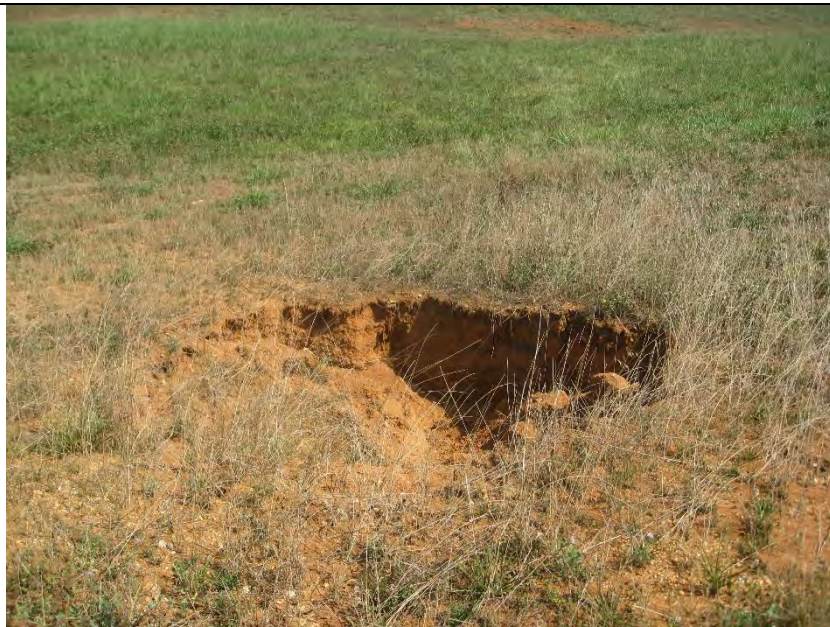
Photo 29
Sta. 341+50 LT
(RW 5L-23R)
Between ES Endwall 104 and 102
Project 3

Fifth construction fallout on Storm Line 1 between ES Endwall 104 and 102.
Coordinate remediation with CHA.

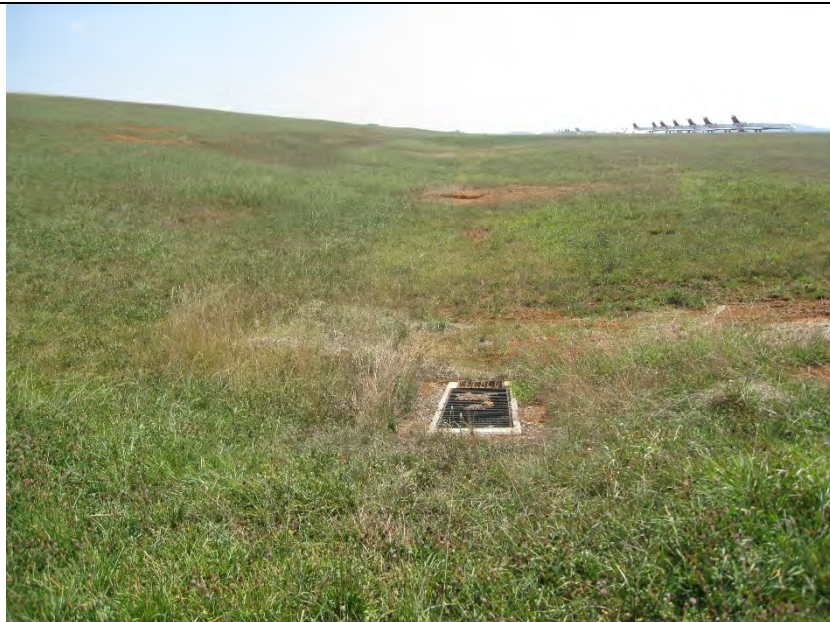
Photo 30
Sta. 347+31 LT
(RW 5L-23R)
ES Endwall 102
Project 3

Enhanced Swale Endwall 102.
Recommend stabilizing remaining bare areas.

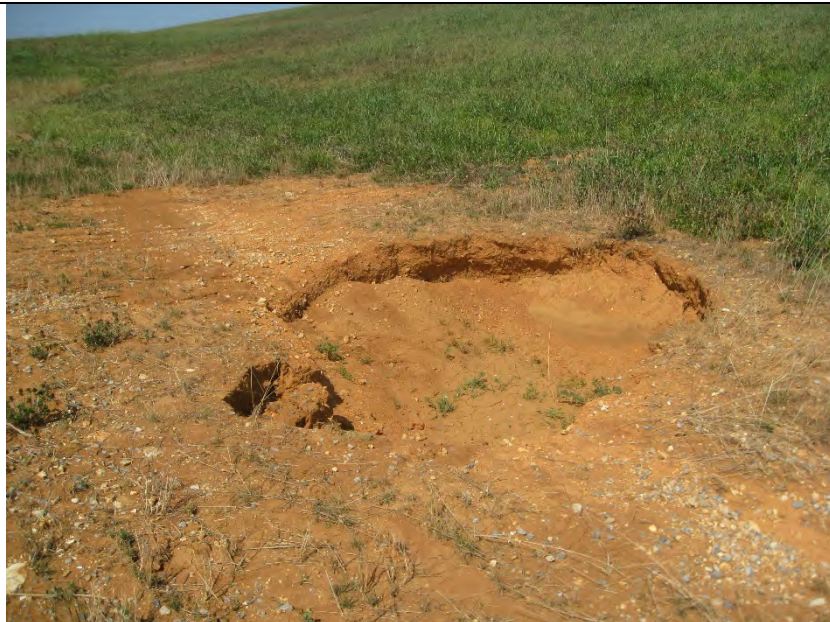
Photo 31
Sta. 347+31 LT
(RW 5L-23R)
ES Endwall 102
Project 3

Enhanced Swale Endwall 102.
Recommend stabilizing remaining bare areas.

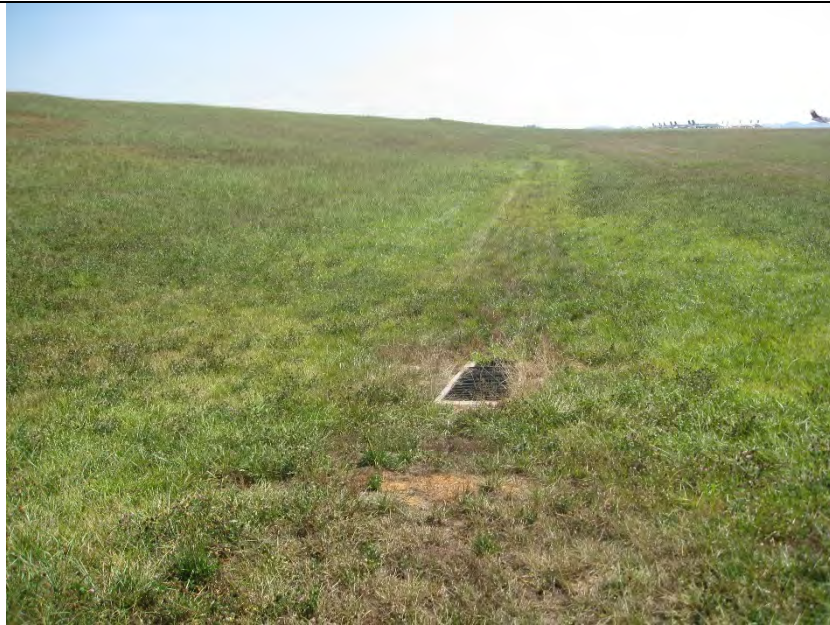
Photo 32
Sta. 341+50 LT
(RW 5L-23R)
ES Endwall 102
Project 3

Construction fallout on Storm Line 1 between ES Endwall 102 and 100.
Coordinate remediation with CHA.

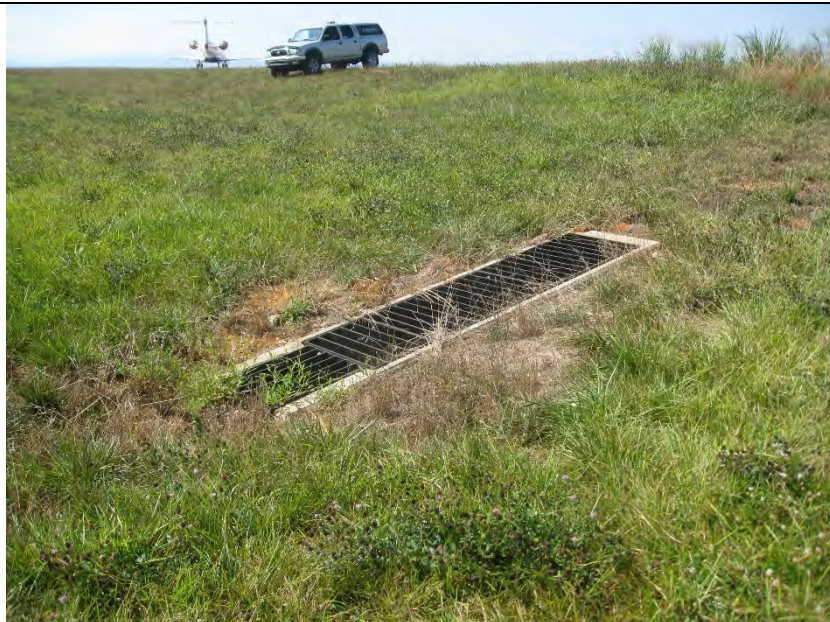
Photo 33
Sta. 354+75 LT
(RW 5L-23R)
ES Endwall 100
Project 2

Enhanced Swale Endwall 100.

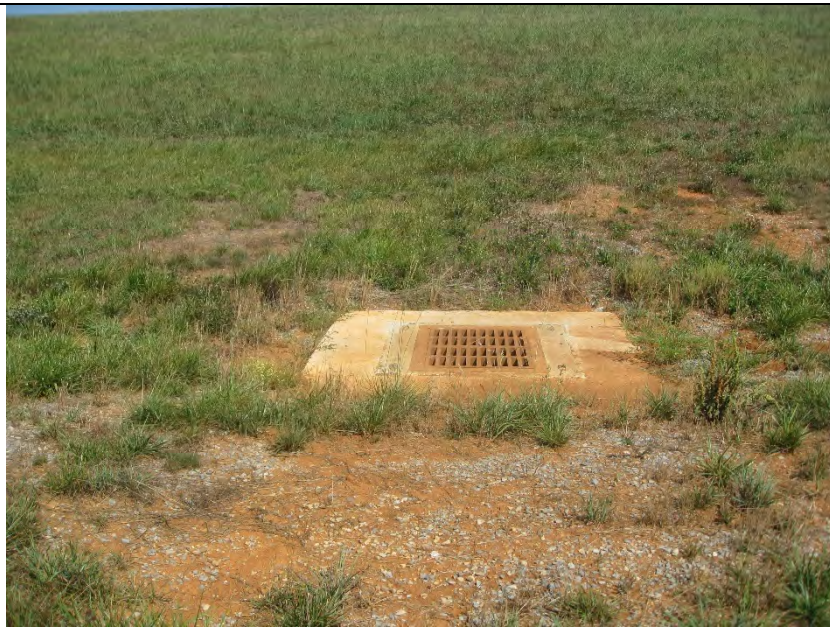
Photo 34
Sta. 354+75 LT
(RW 5L-23R)
ES Endwall 100
Project 3

Enhanced Swale Endwall 100.

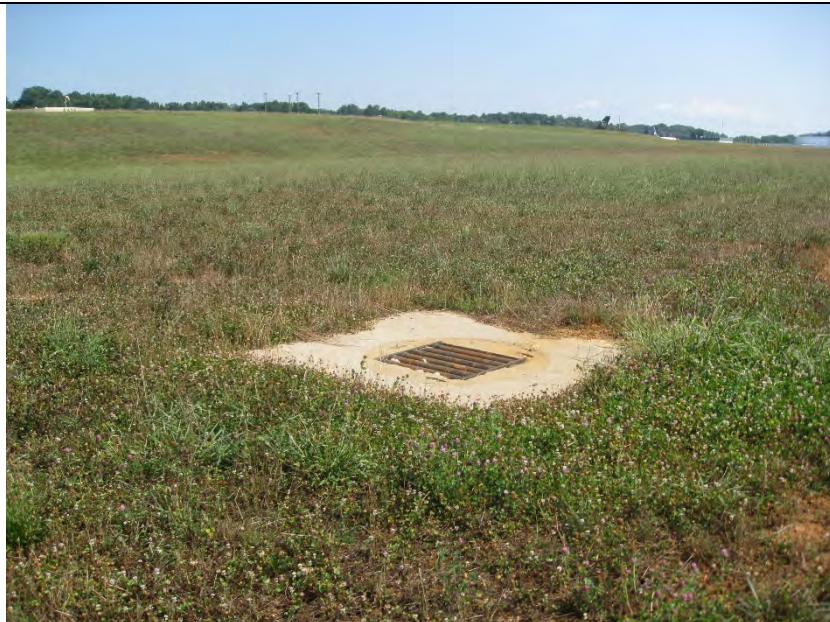
Photo 35
Sta. 361+39 LT
(RW 5L-23R)
Structure 100
Project 3

Structure 100.
Recommend stabilizing remaining bare areas.

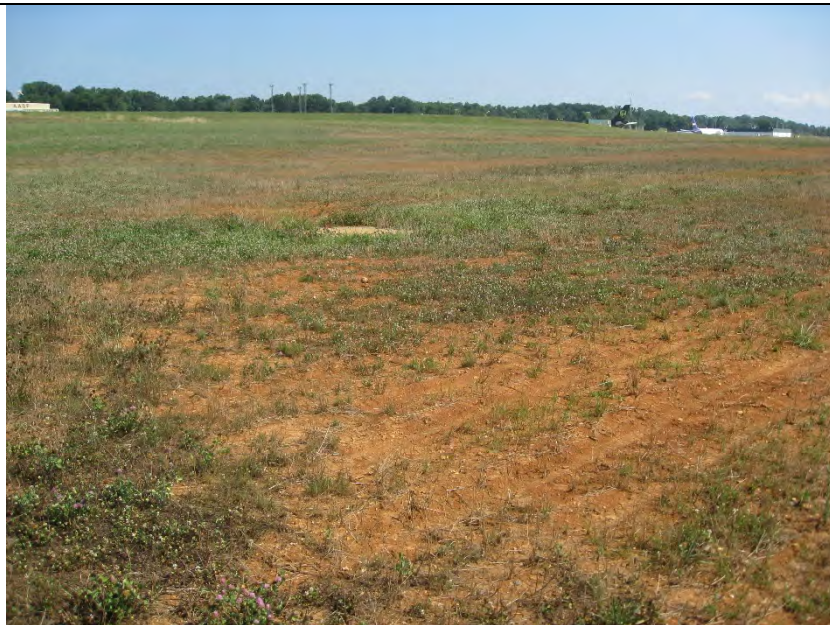
Photo 36
Sta. 363+35 LT
(RW 5L-23R)
Existing Structure
Project 2

Existing Structure.

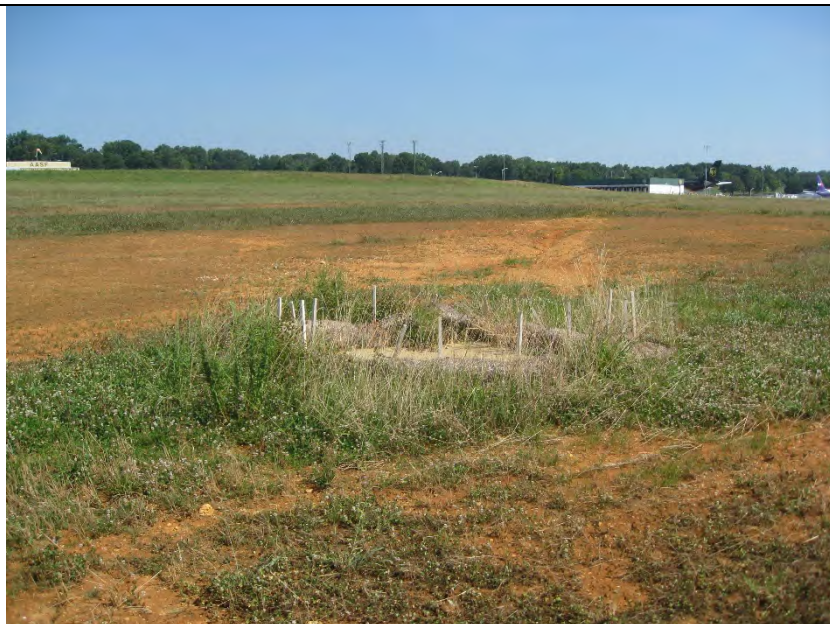
Photo 37
Sta. 366+25 LT
(RW 5L-23R)
Existing Structure
Project 2

Existing Structure.
Recommend stabilizing bare areas.

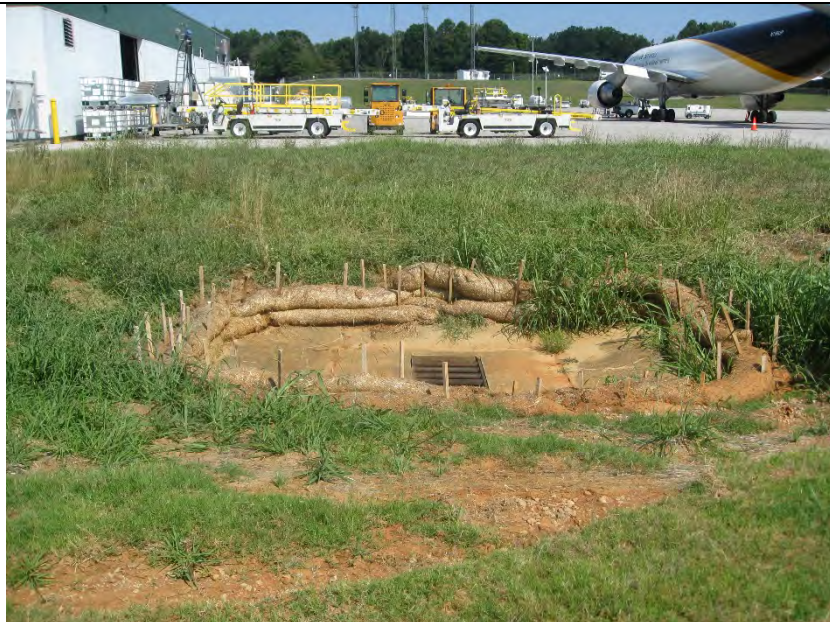
Photo 40
Sta. 677+00 RT
(RW 5L-23R)
Project 4

Structure between Taxiway G and UPS Facility.

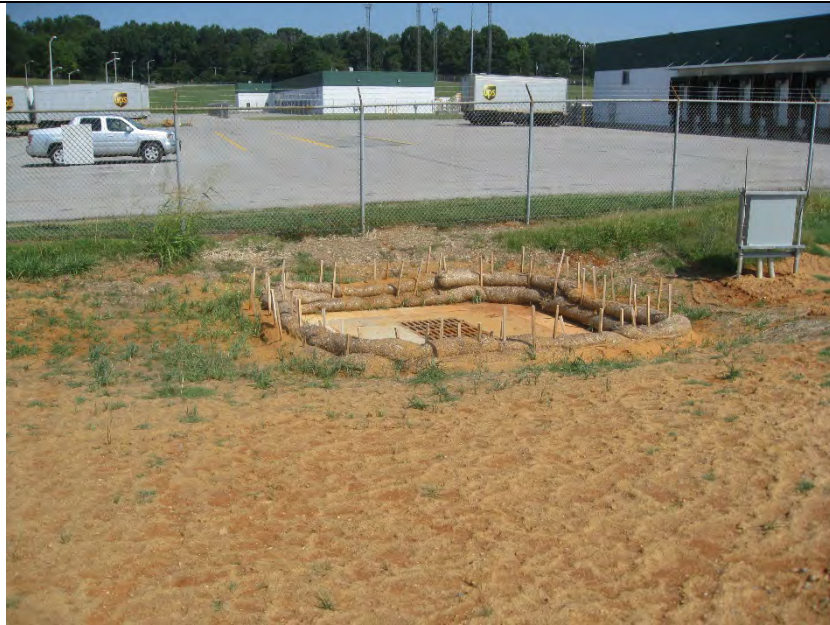
Photo 41
Sta. 676+00 RT
(RW 5L-23R)
Project 4

New structure recently placed.
Area recently backfilled, inlet protection installed, and erosion control blanket installed.

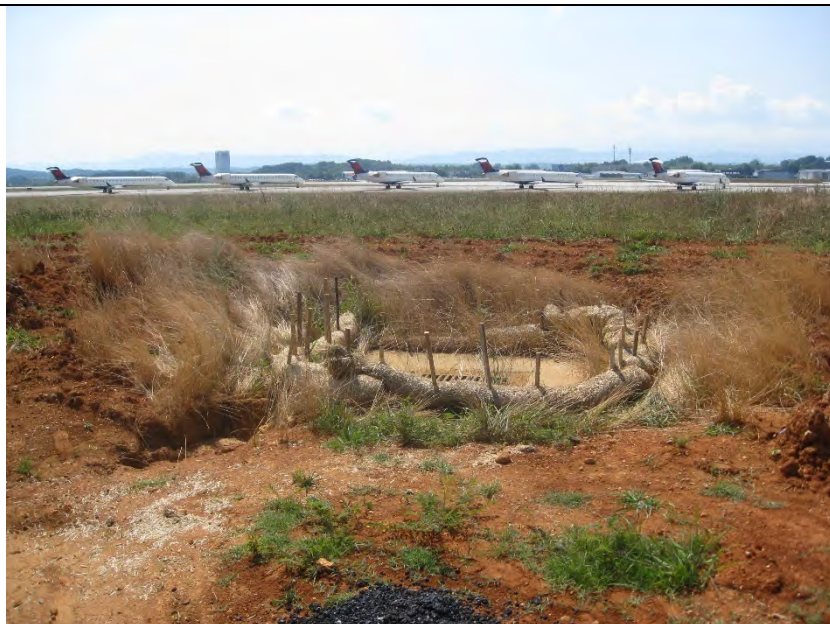
Photo 44
(RW 5L-23R)
Existing Structure
Project 4

Existing structure south of Taxiway G.

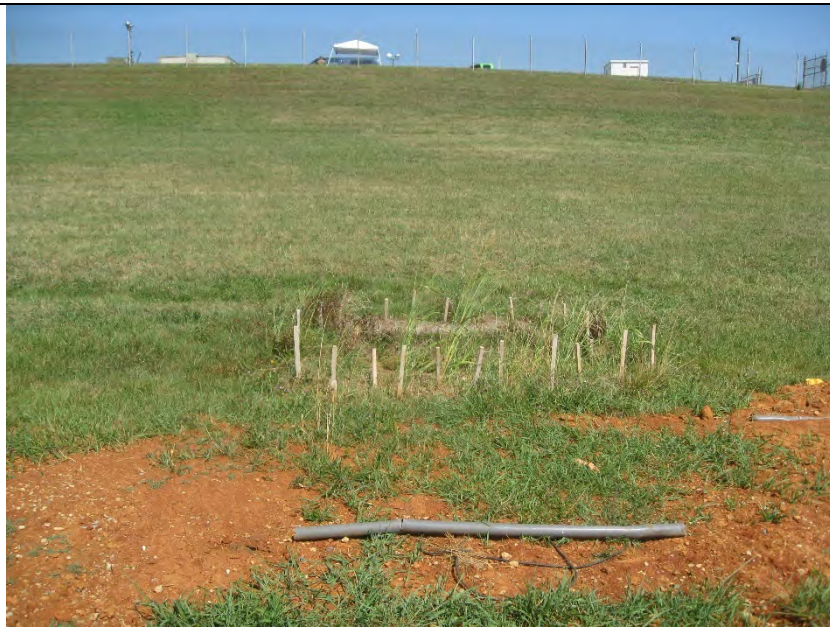
Photo 45
(RW 5L-23R)
Existing Structure
Project 4

Existing structure north of Taxiway G.

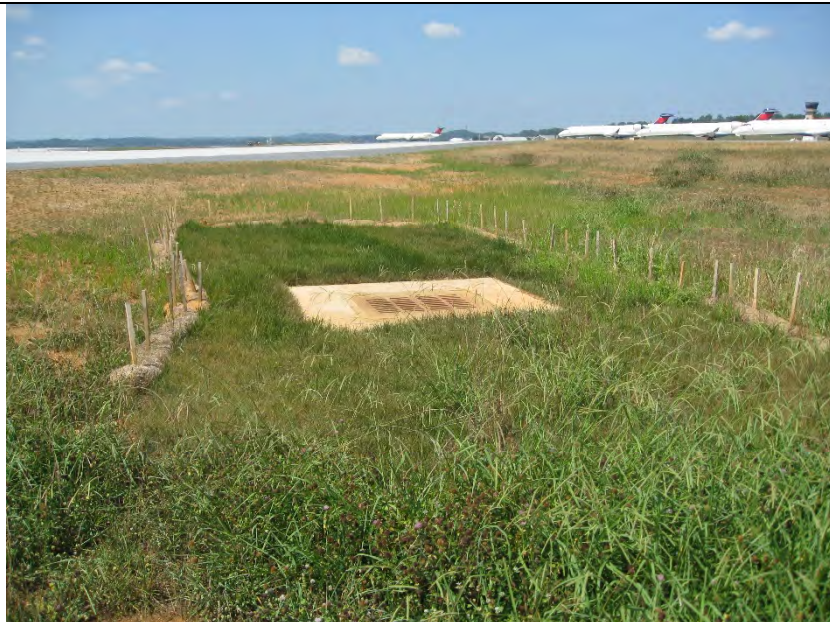
Photo 48
Sta. 365+69 RT
(RW 5L-23R)
Structure 300
Project 4

Structure 300

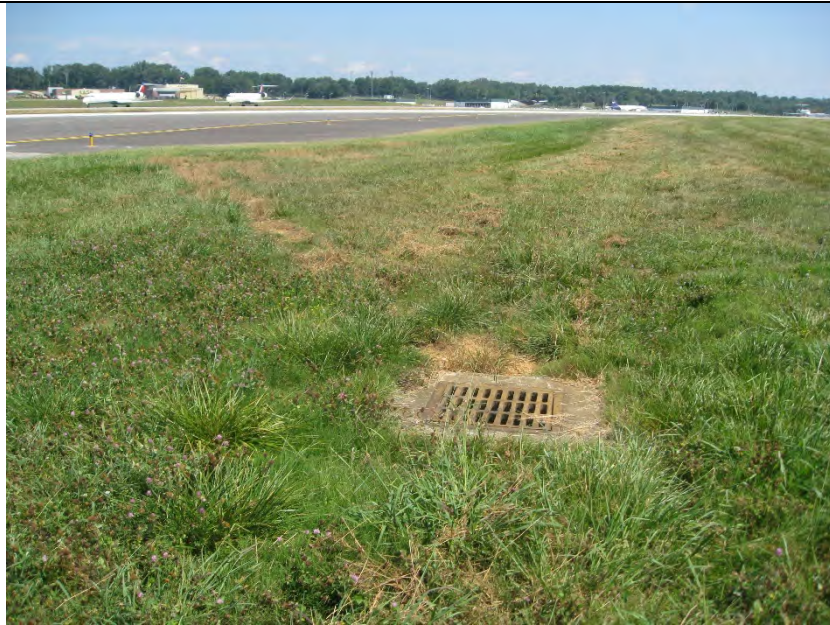
Photo 49
(RW 5L-23R)
TWY Y Tie-in
Project 4

Existing structure north of Taxiway Y.

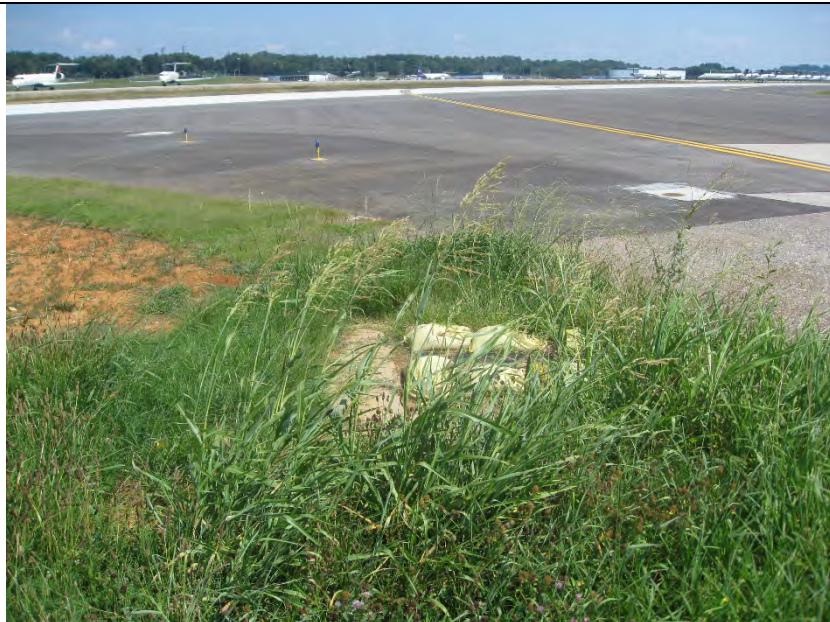
Photo 50
(RW 5L-23R)
TWY Y Tie-in
Project 4

Existing structure south of Taxiway Y.
Bare areas recently stabilized.

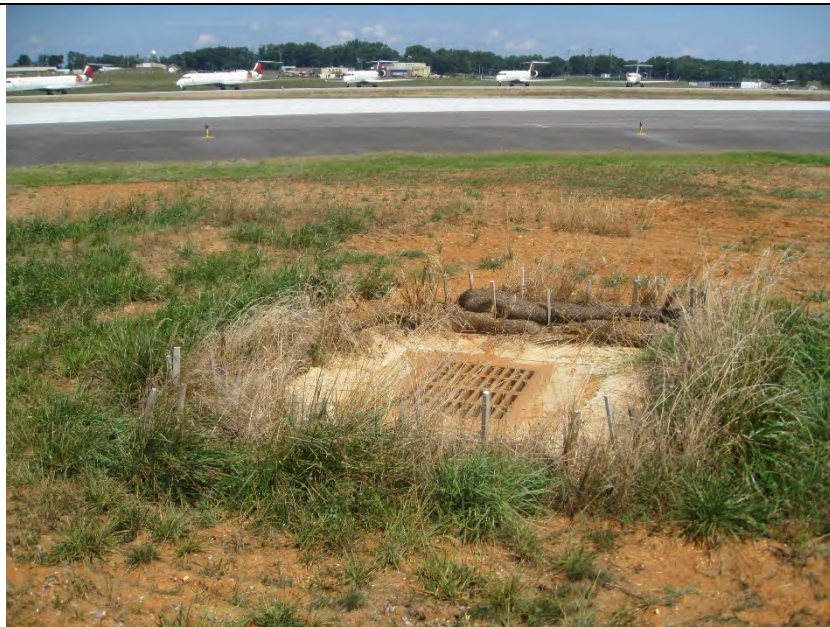
Photo 51
Sta. 362+02 LT
(RW 5L-23R)
Structure 400
Project 4

Structure 400.
Bare areas recently stabilized.

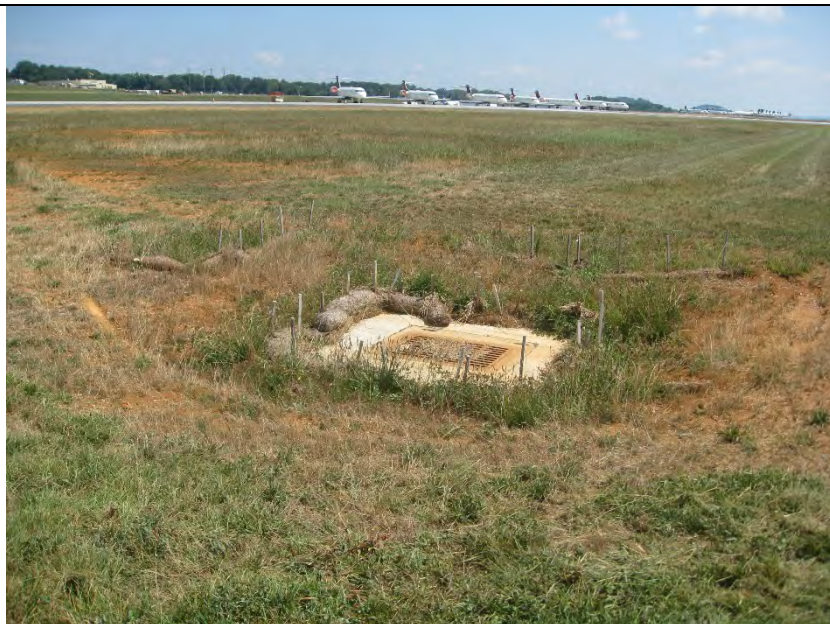
Photo 54
Sta. 353+56 RT
(RW 5L-23R)
Structure 200
Project 4

Structure 200.

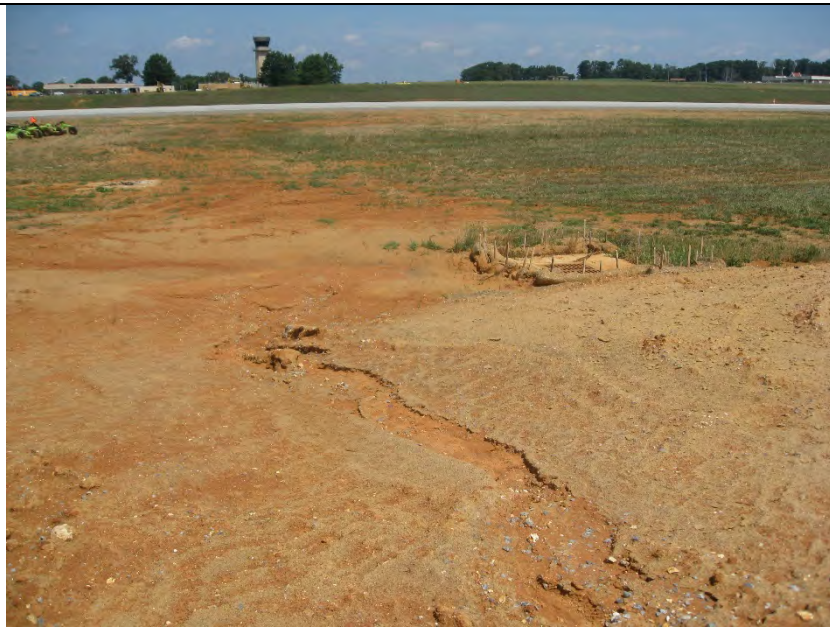
Photo 55
Sta. 347+26 RT
(RW 5L-23R)
Structure 202
Project 4

Structure 202.
Rills and sediment migration occurred after recent storm events.

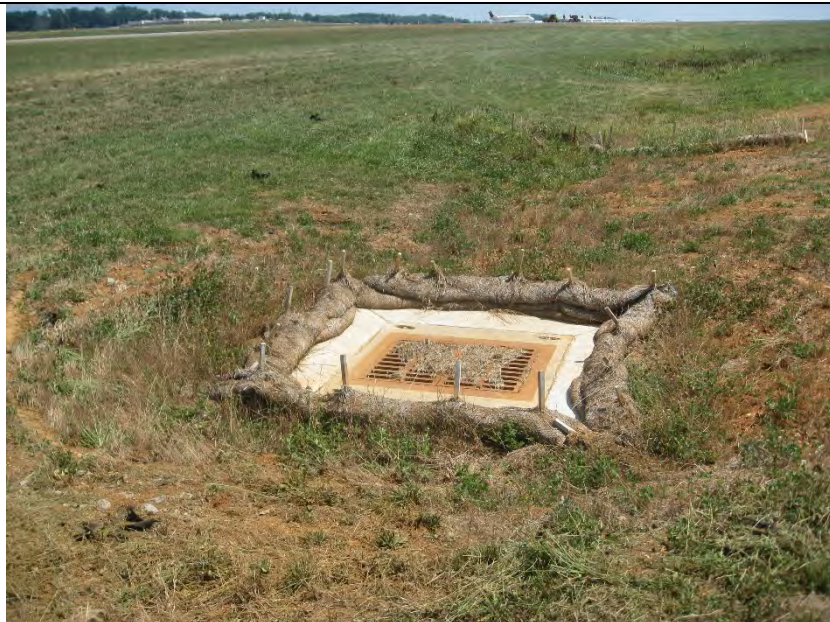
Photo 58
Sta. 338+02 RT
(RW 5L-23R)
Structure 206
Project 4

Structure 206.

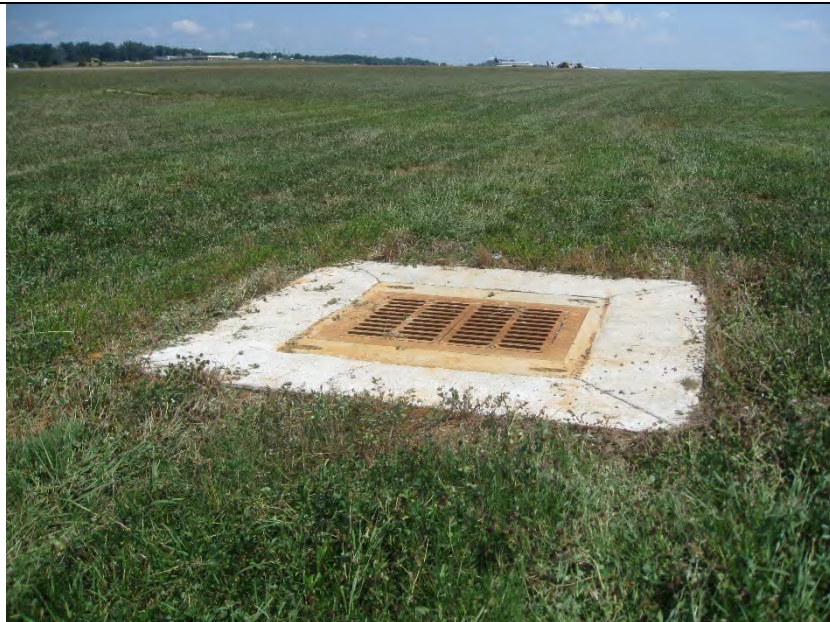
Photo 60
Sta. 338+02 RT
(RW 5L-23R)
Structure 208
Project 4

Structure 208.

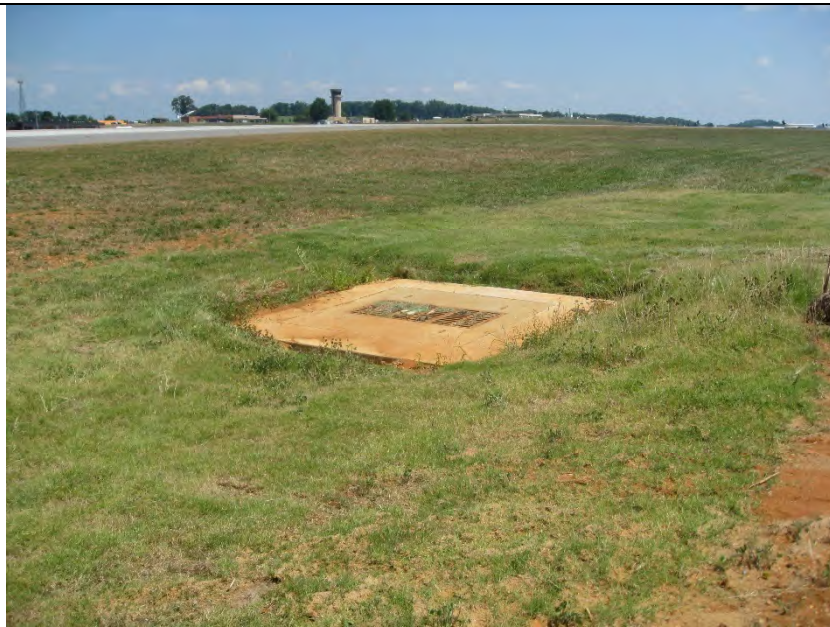
Photo 61
Sta. 329+86 RT
(RW 5L-23R)
Structure 210
Project 3

Structure 210.
Bare areas recently stabilized.

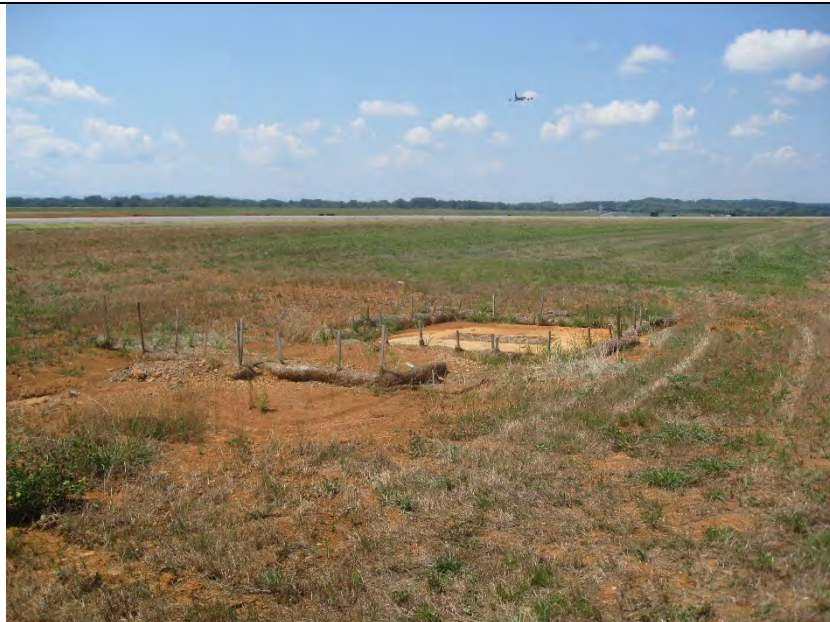
Photo 62
Sta. 321+73 RT
(RW 5L-23R)
Structure 212
Project 3

Structure 212.
Recommend removing accumulated sediment and replacing damaged sediment tubes.

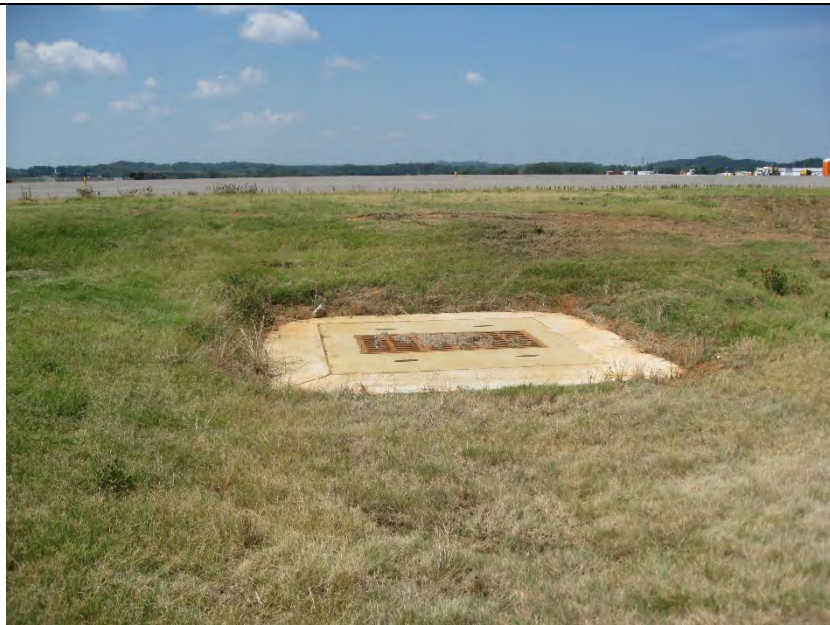
Photo 63
Sta. 314+32 RT
(RW 5L-23R)
Structure 214
Project 3

Structure 214.

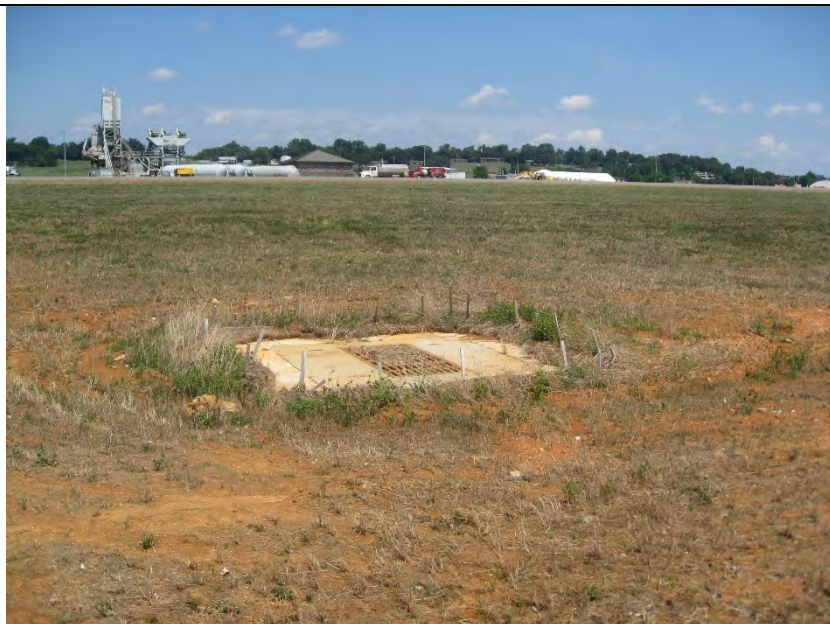
Photo 64
Sta. 307+99 RT
(RW 5L-23R)
Structure 216
Project 3

Structure 216.

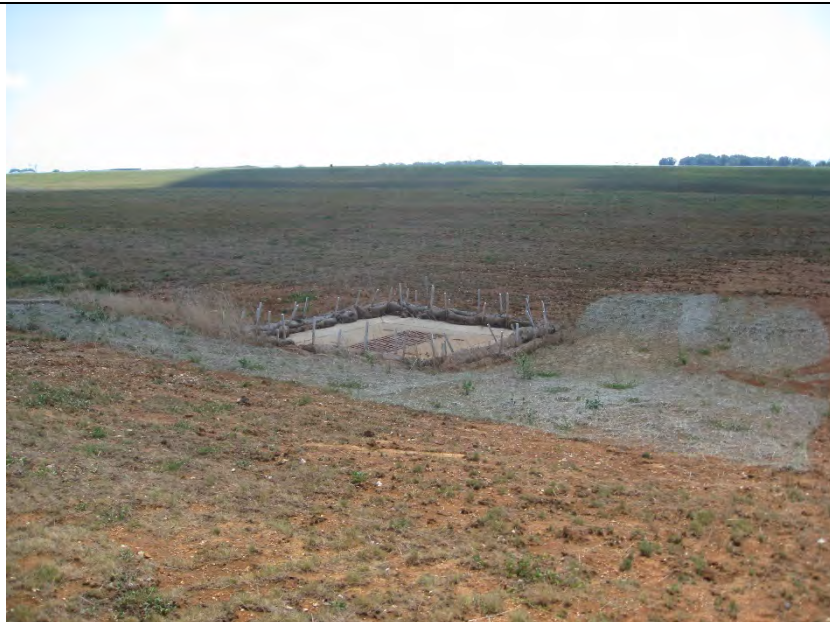
Photo 66
Sta. 296+83 RT
(RW 5L-23R)
Structure 220
Project 2

Structure 220.
Recommend stabilizing remaining bare areas.

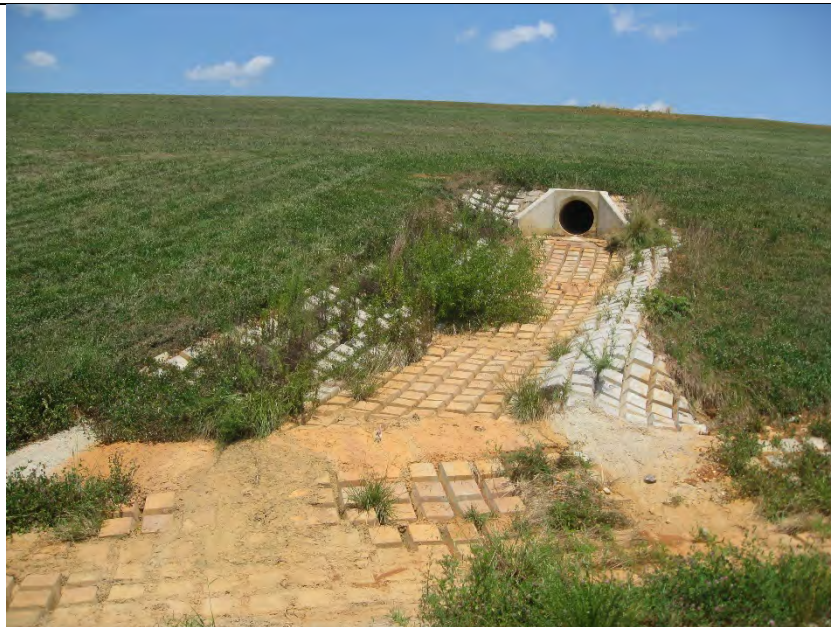
Photo 67
Sta. 288+26
(RW 5L-23R)
Structure 224
Project 2

Structure 224.

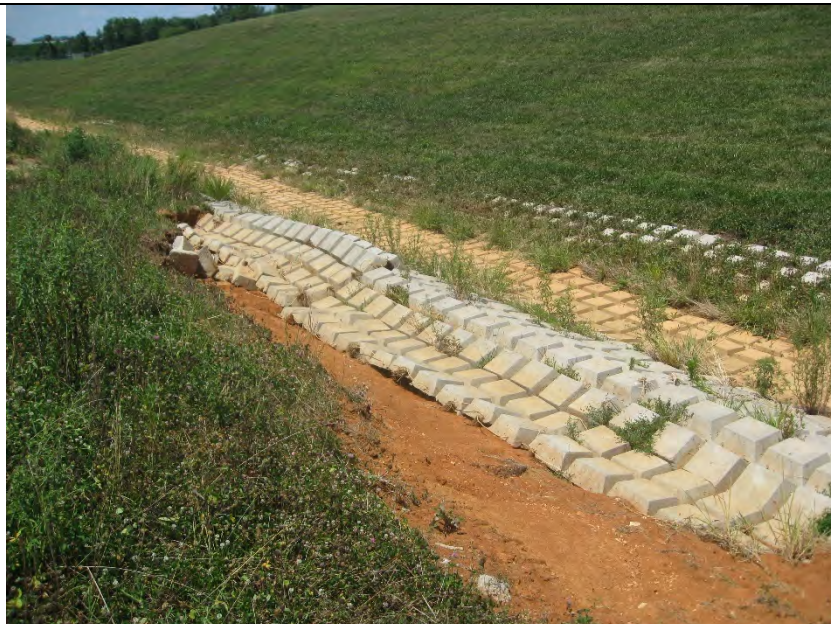
Photo 68
Sta. 288+26
(RW 5L-23R)
Structure 224
Project 2

Below structure 224.
Side slope has severely eroded.
CHA, Harper and KMAA were already aware of the issue as discussed in a progress meeting dated 07/16/2020.

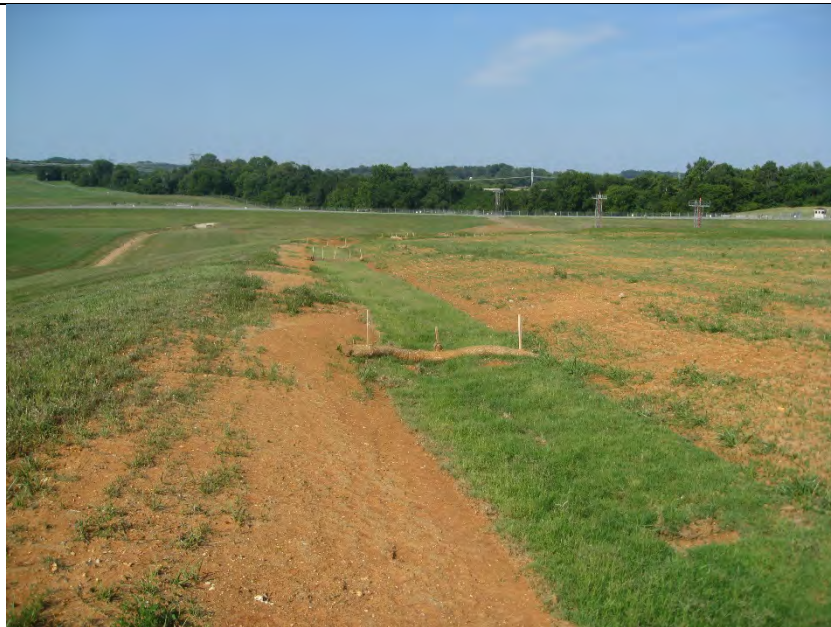
Photo 71
Sta. 290+26 RT
(RW 5L-23R)
Structure 600 Ditch
Project 2

Structure 600 ditch.
Bare areas recently stabilized.

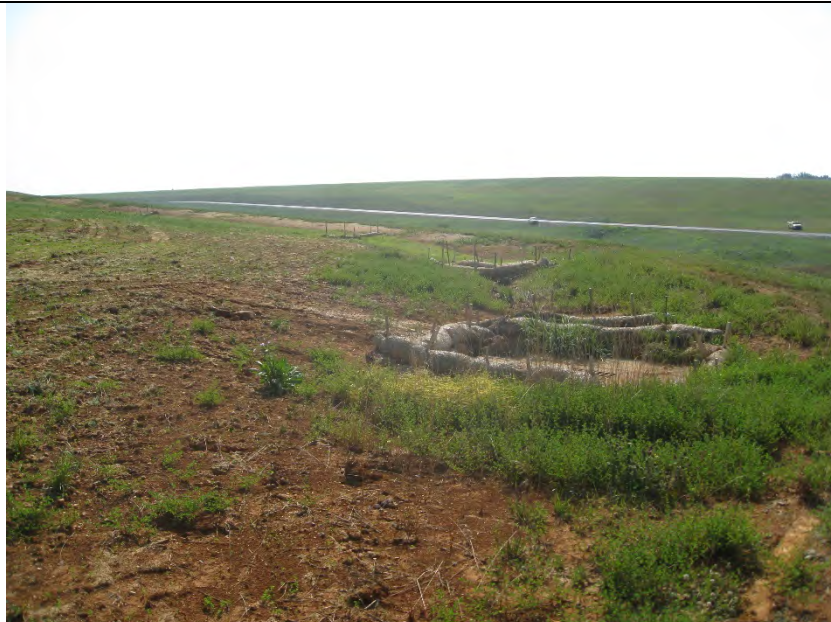
Photo 72
Sta. 284+59
(RW 5L-23R)
Structure 600
Project 3

Structure 600.
Bare areas recently stabilized.

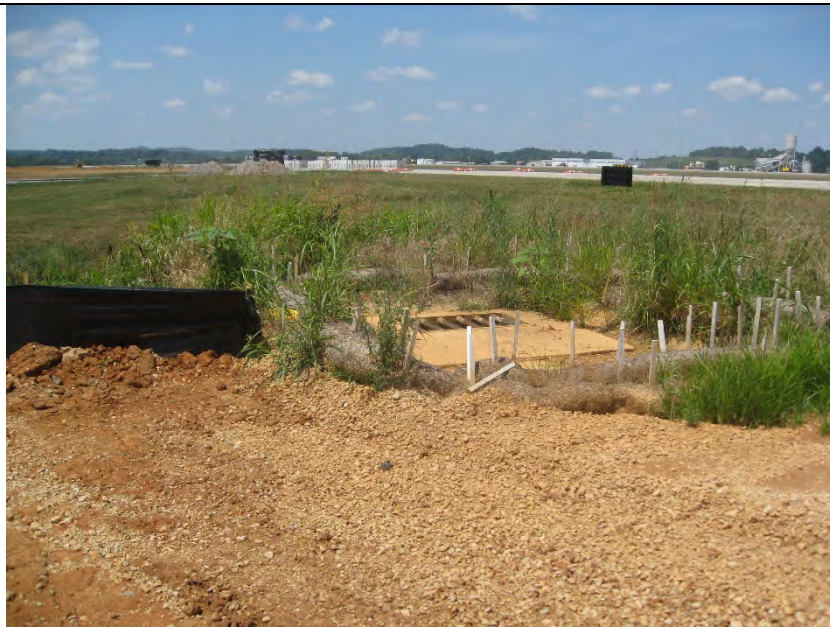
Photo 73
(RW 5L-23R)
Project 3

Existing structure at stone stockpile area.
