**QUALITY ASSURANCE
MONTHLY SITE
ASSESSMENT REPORT**

Airfield Modernization Program
Runway 5L-23R Reconstruction
Project 2 / Project 3

NPDES TN0081868 (Individual)
NPDES TNR134734 (General)

AIRFIELD MODERNIZATION PROGRAM RUNWAY 5L-23R RECONSTRUCTION

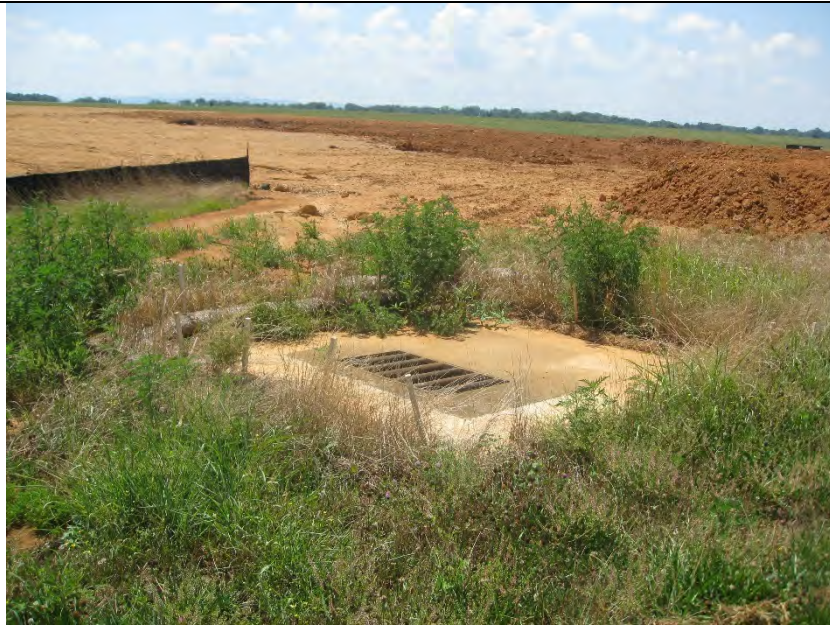
Photo 75
(RW 5L-23R)
Project 3

Existing structure.

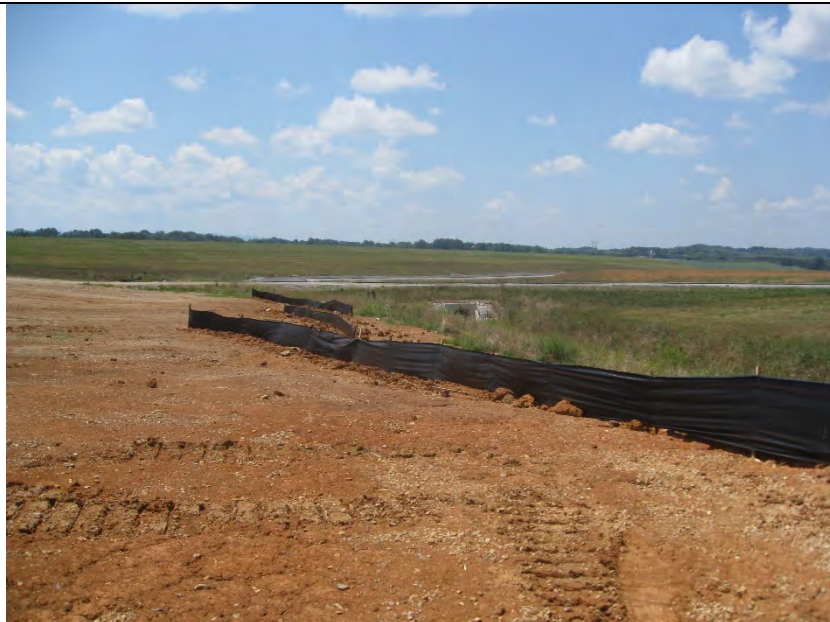
Photo 76
(RW 5L-23R)
Project 3

Silt fence recently installed.

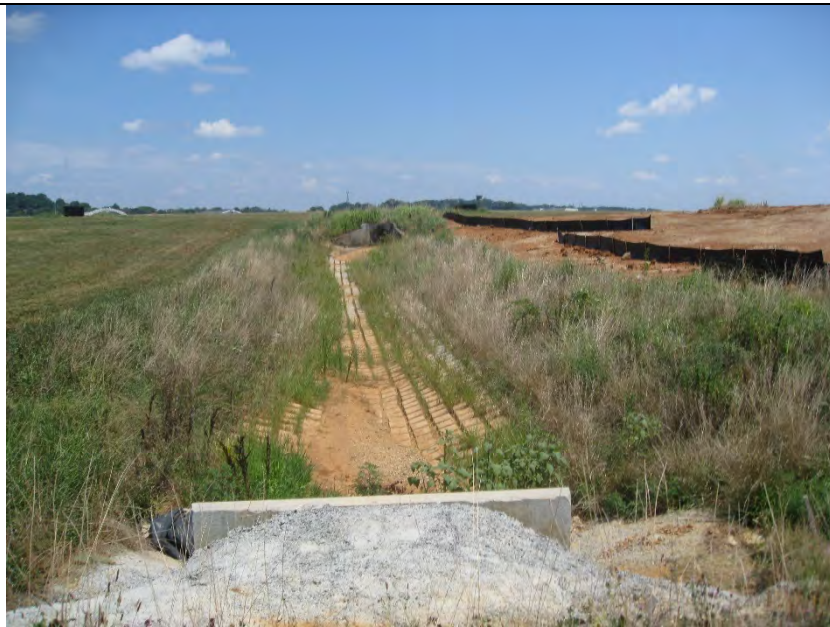
Photo 77
Sta. 39+00 CL
Proposed Haul Route
Project 3

Inlet side of 54" haul route crossing culvert.

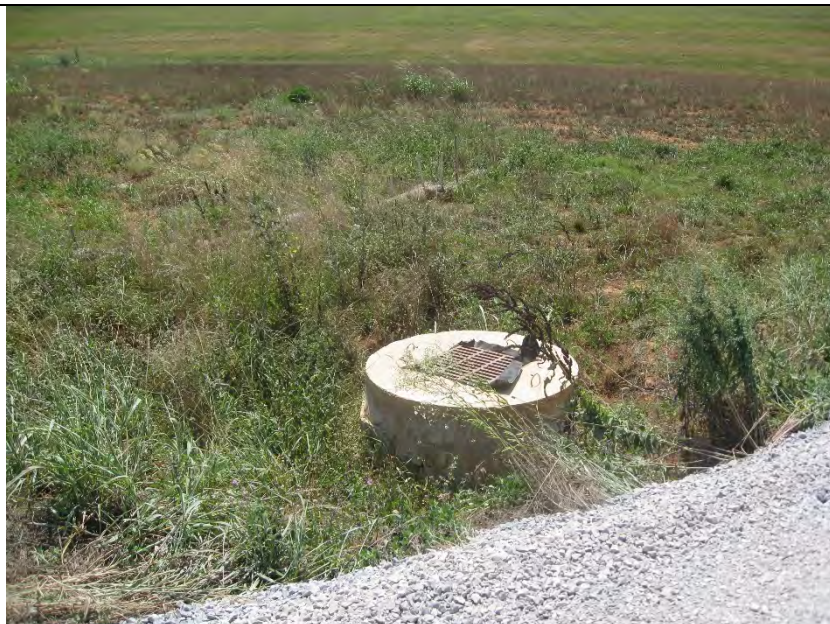
Photo 78
Sta. 37+25 RT
Proposed Haul Route
Project 3

Inlet structure along haul road.

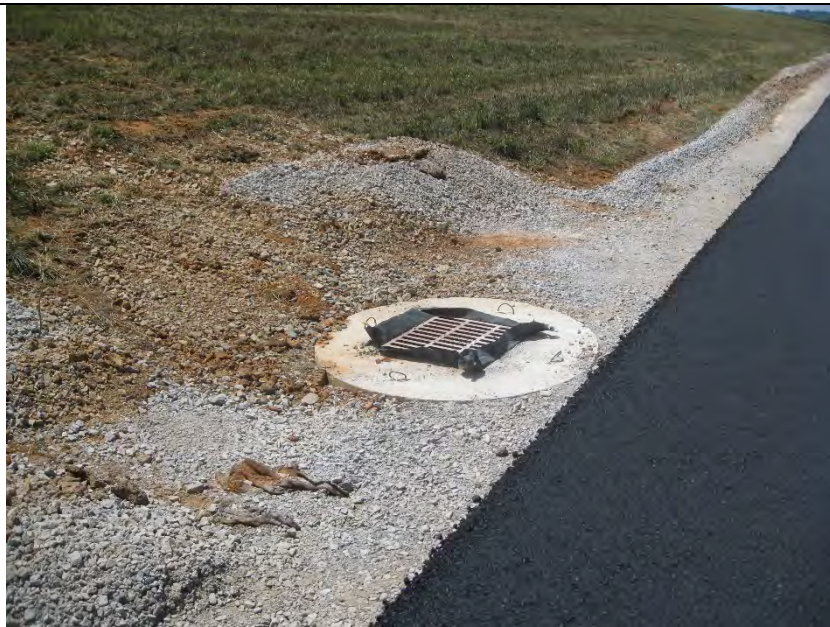
Photo 79
Sta. 32+50 RT
Proposed Haul Route
Project 3

Inlet structure along haul road.
Asphalt recently installed.

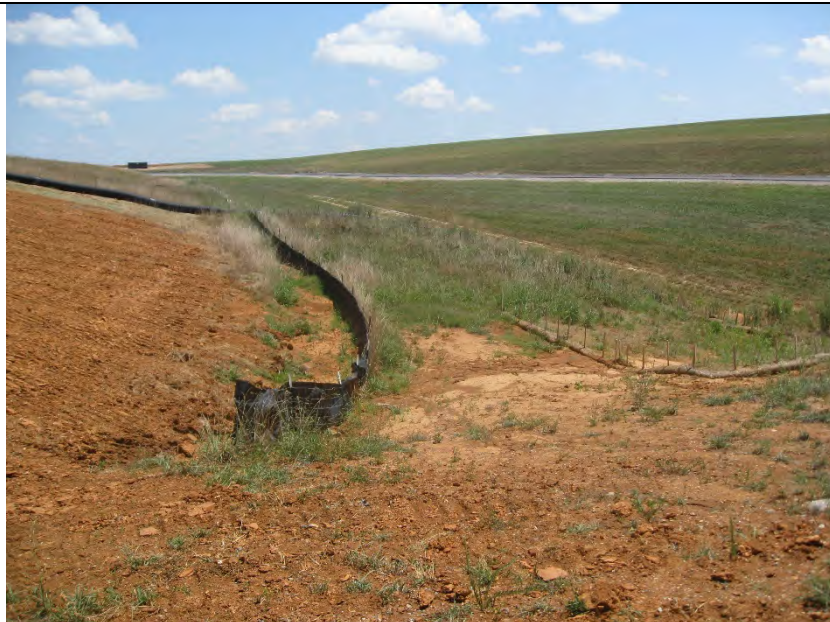
Photo 80
Sta. 302+54
(RW 5L-23R)
Project 2

Above North Lateral Endwall 100.
Recommend stabilizing bare areas.

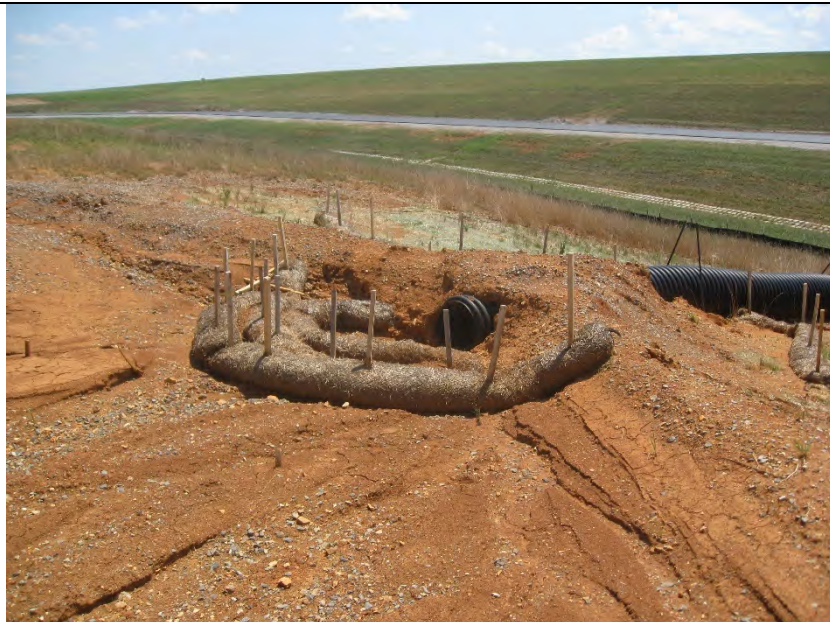
Photo 81
Sta. 302+54
(RW 5L-23R)
Project 2

Above North Lateral Endwall 100.
Slope recently regraded.
Recommend stabilizing bare areas.

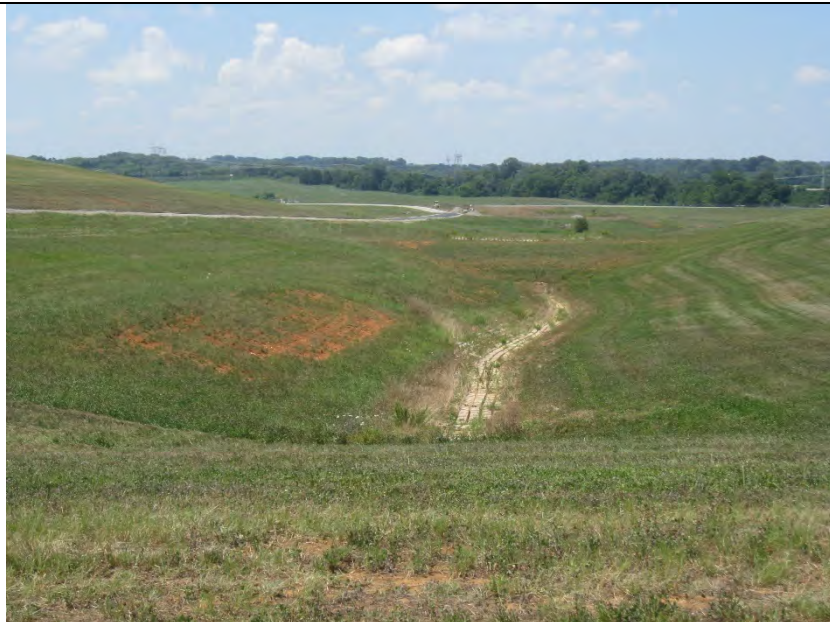
Photo 83
Sta. 302+54 to Sta. 313+50
(RW 5L-23R)
Project 2

North Lateral Endwall 100.
Recommend stabilizing bare areas.

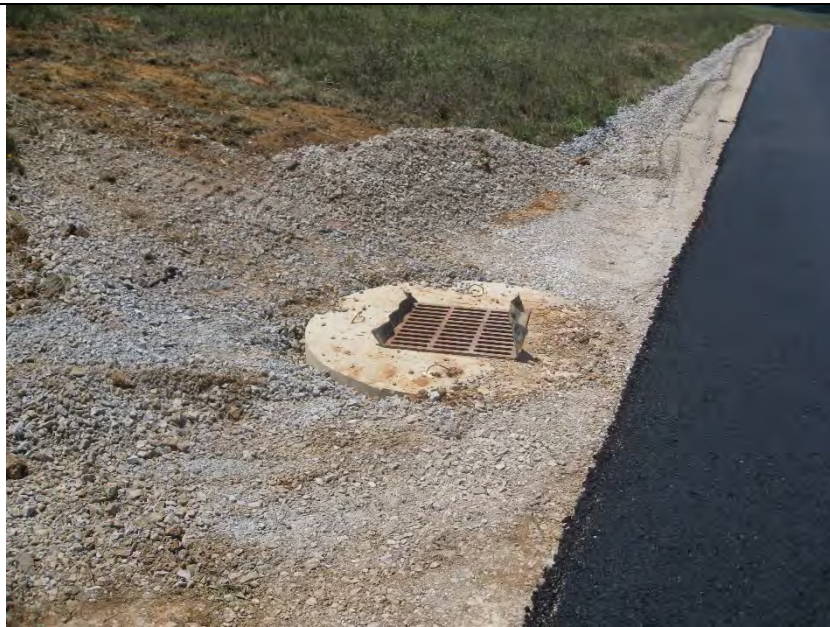
Photo 84
Sta. 300+60
(RW 5L-23R)
Project 2

North Lateral Endwall 102.

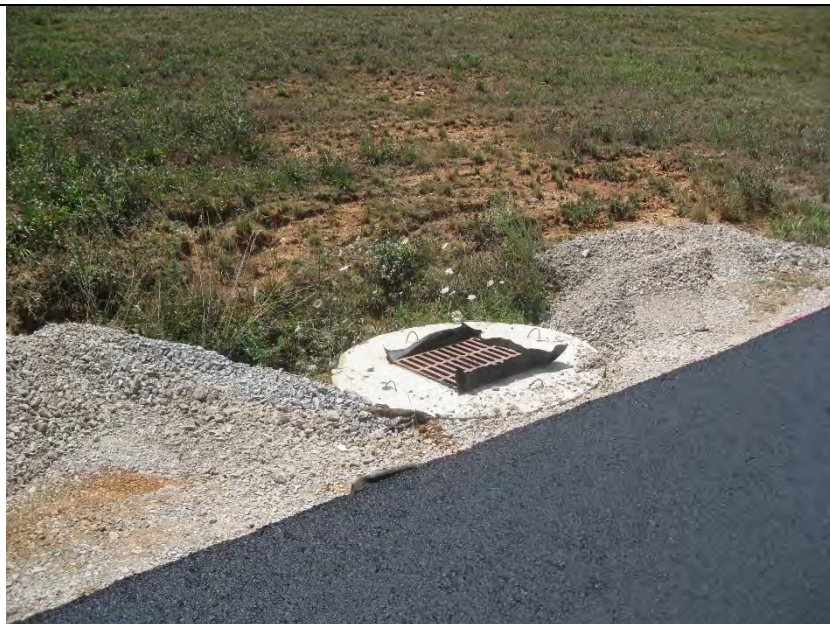
Photo 85
Sta. 29+00 RT
Proposed Haul Route
Project 3

Inlet structure along haul road.

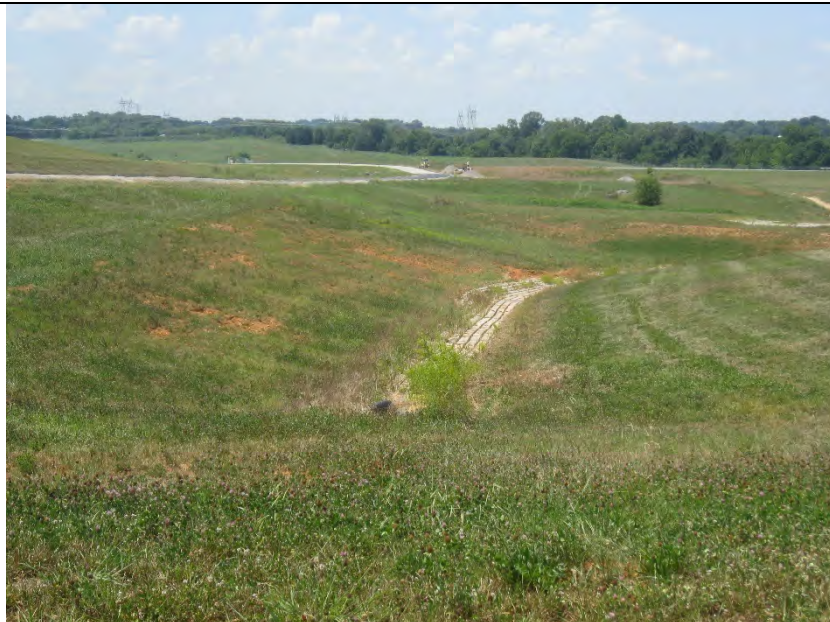
Photo 87
Sta. 297+01
(RW 5L-23R)
Project 2

North Lateral Endwall 104.

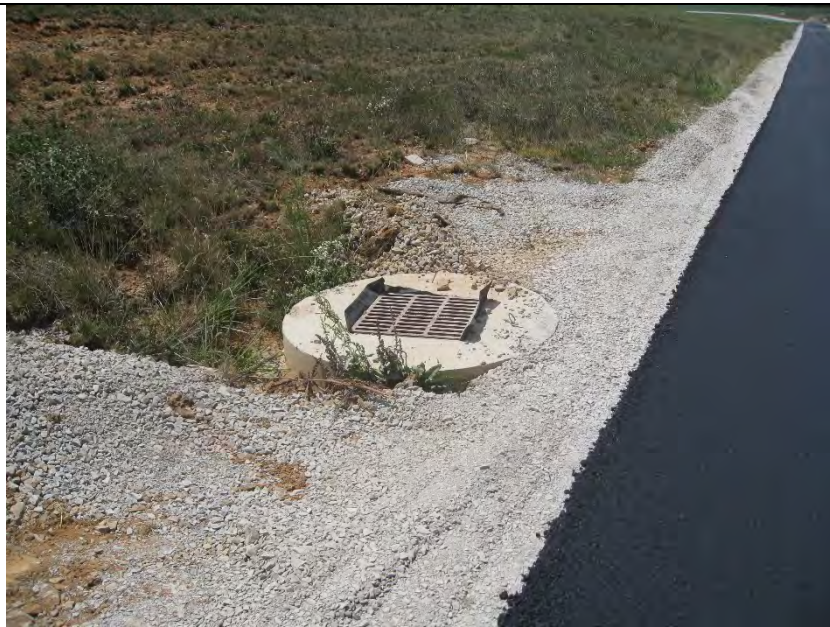
Photo 88
Sta. 295+10
(RW 5L-23R)
Project 2

North Lateral Endwall 106.

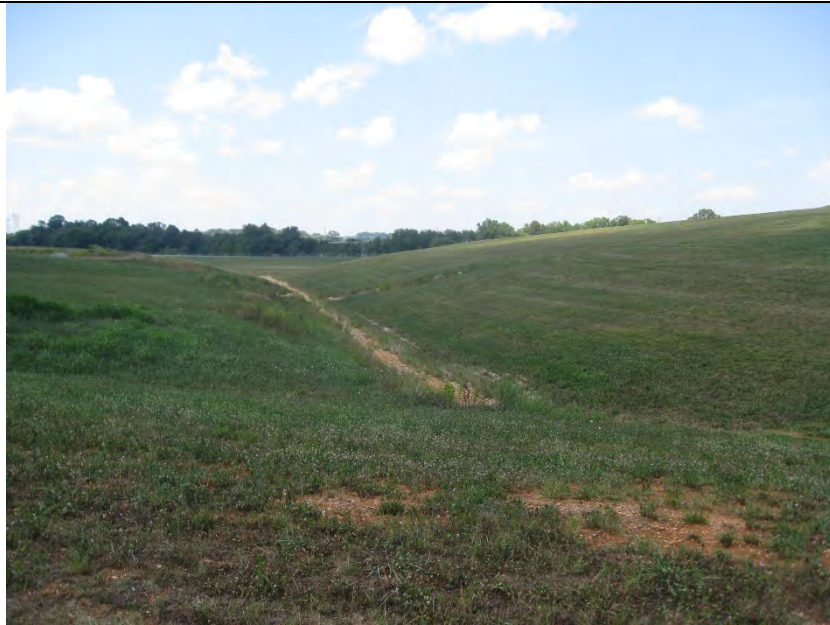
Photo 90
Sta. 292+08
(RW 5L-23R)
Project 2

North Lateral Endwall 108.

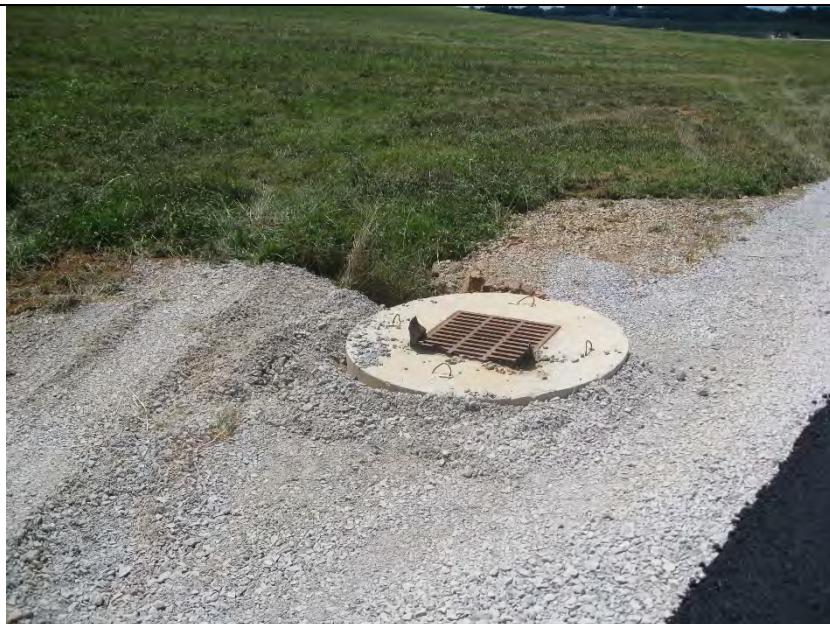
Photo 91
Sta. 290+50 LT
(RW 5L-23R)
Project 2

North Lateral Endwall 110.

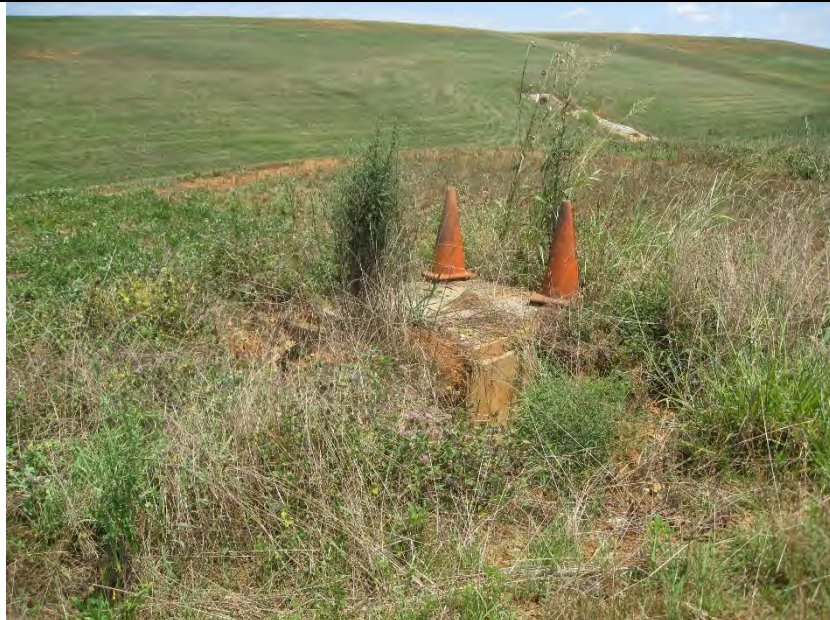
Photo 93
Sta. 282+45 to 288+26 LT
(RW 5L-23R)
Project 2

North Lateral Ditch.

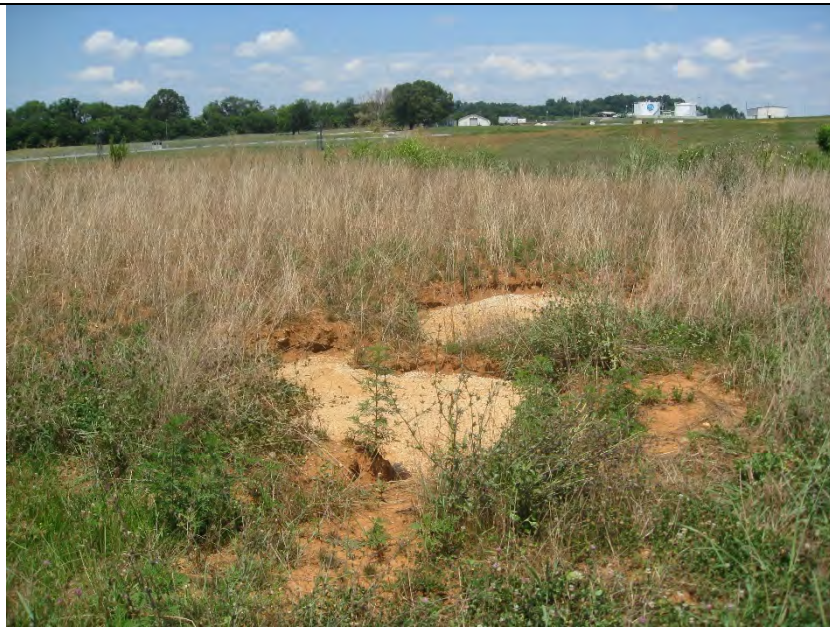
Photo 94
Sta. 284+00 LT
(RW 5L-23R)
Project 2

Existing vault at old Liberty street.
Construction fallout present. Recommend coordinating with CHA on remediation.

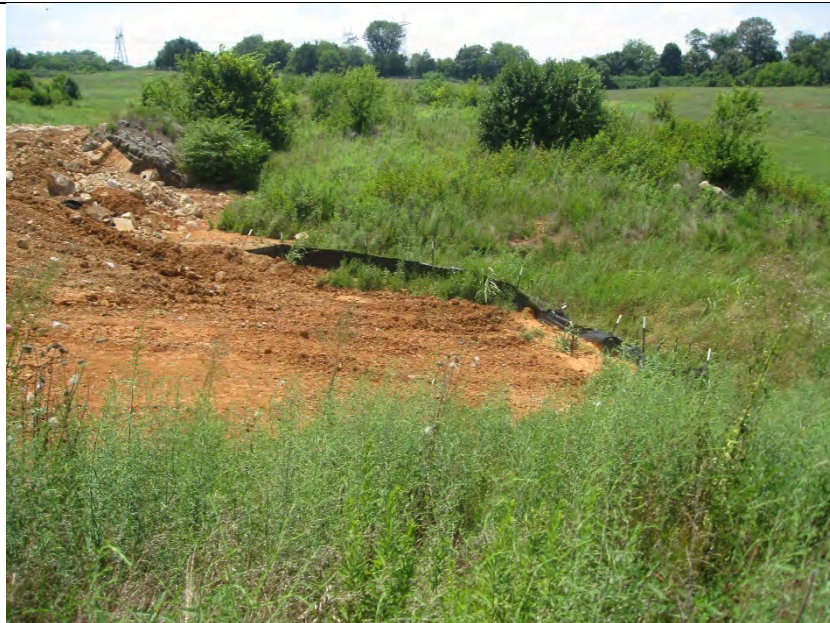
Photo 95
Sta. 284+00 LT
(RW 5L-23R)
Project 2

Previous soil stockpile at old Liberty Street.
Construction fallout appears to have been filled with concrete.

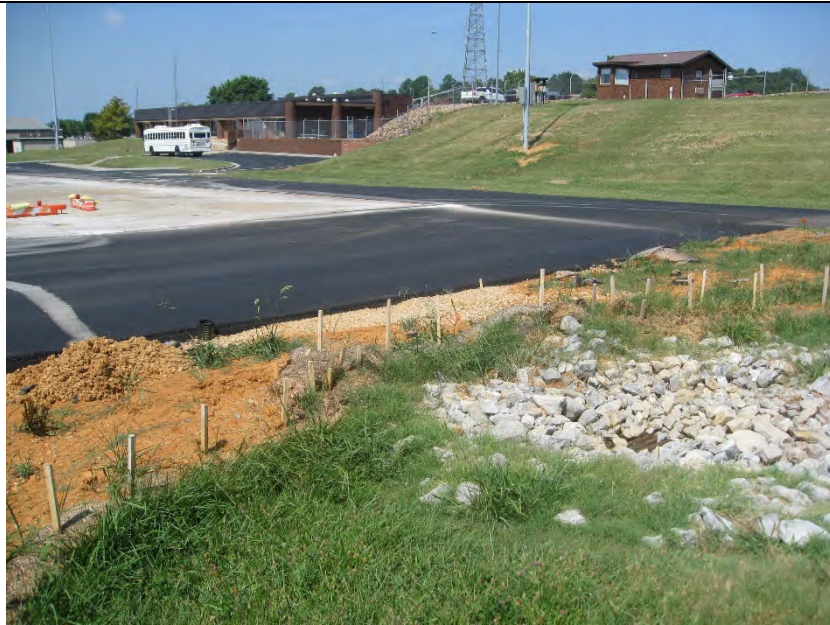
Photo 96
(Repair TWY Lighting)

Fill area adjacent to Liberty Street from Taxiway shoulder removal.

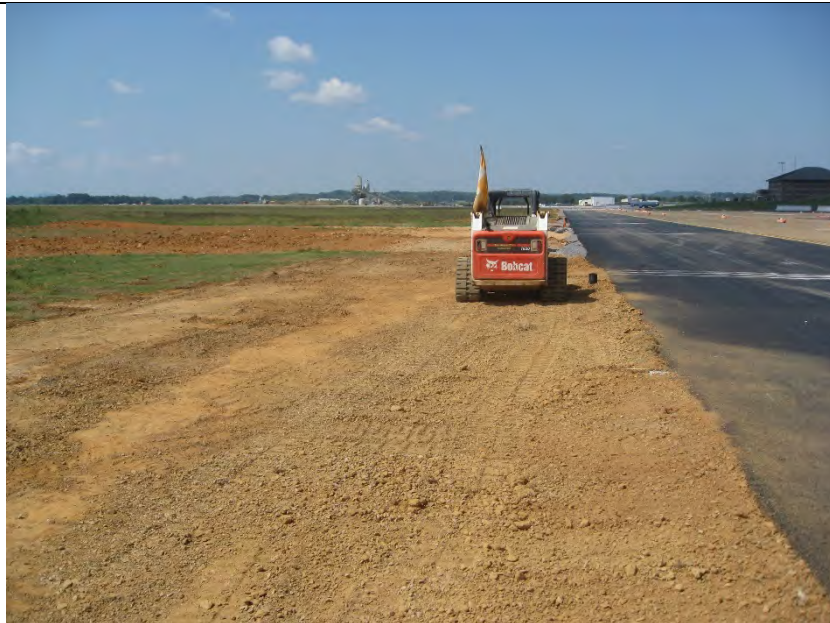
Photo 97
(Repair TWY Lighting)
Sheet EC2.1.7

Existing structure at Upper Apron.
Asphalt recently installed.

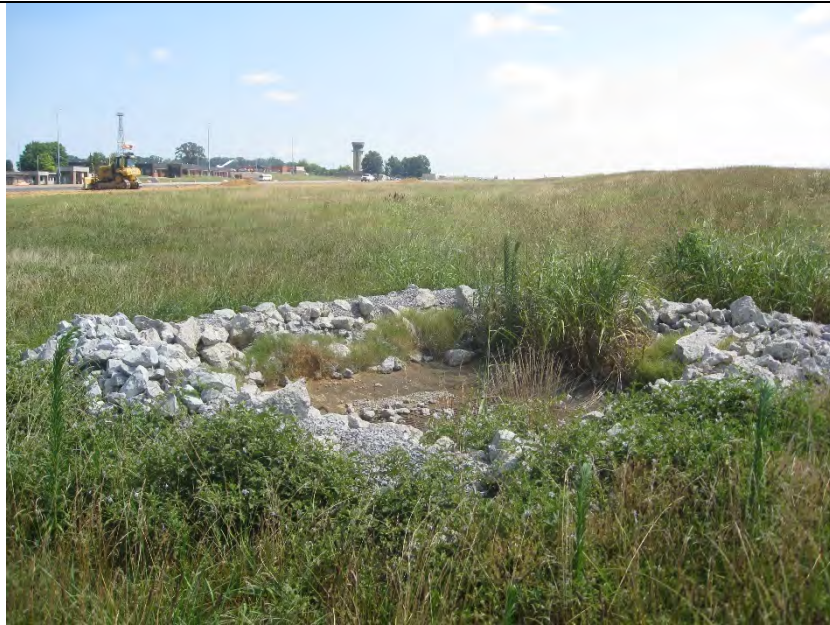
Photo 98
(Repair TWY Lighting)
Sheet EC2.1.6

Existing remaining Taxiway G4 and shoulder being graded at time of inspection.

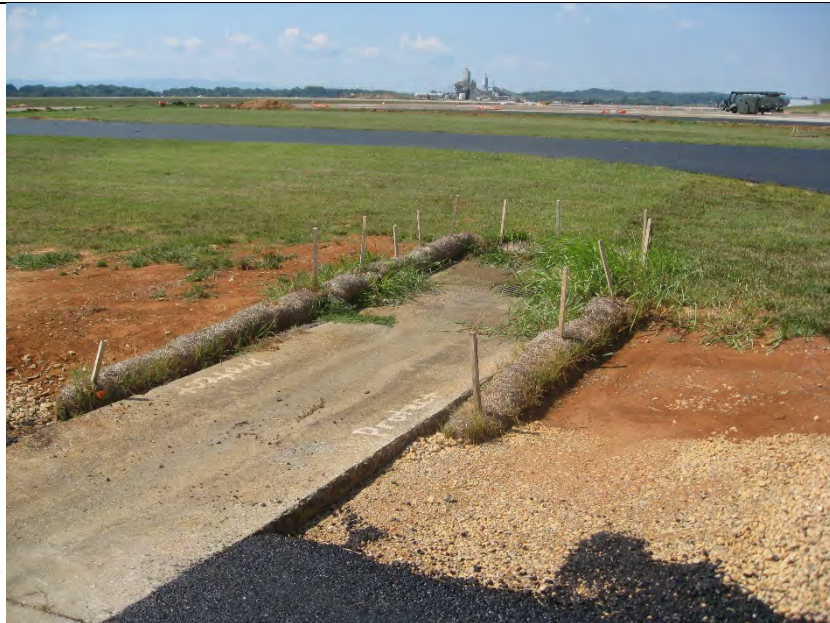
Photo 99
(Repair TWY Lighting)
Sheet EC2.1.6

Existing structure adjacent to demolished Taxiway G4.

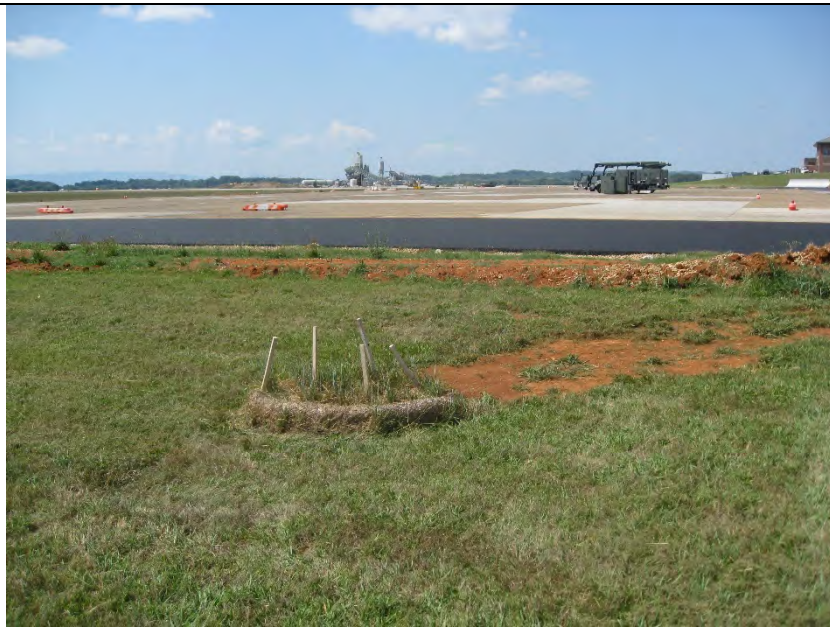
Photo 100
(Repair TWY Lighting)
Sheet EC2.1.5

Existing structure at Upper Apron.
Asphalt recently installed.
